Examination of an Irradiated Fuel Pin Segment by Laser Scanning Profilometry, Gamma Spectrometry and Neutron Radiography

Abstract. Paul Scherrer Institute (PSI) conducts post irradiation examinations (PIE) on fuel pins irradiated in nuclear power plants. During pool-side inspections of the nuclear fuel at one of these plants, an intact fuel pin showed a small deviation in diameter along several mm of the axial elevation. The pin was added to the fuel delivery transport to PSI in the frame of a surveillance program. To detect the exact dimensions of the pin section, a laser scanning profilometer was adapted for hot cell use by mirroring the laser beam. The examined length of the found clad necking matched the nominal length of one fuel pellet, indicating a missing or diameter reduced pellet. Axial gamma spectrometry confirmed the match of the neckings's length with the pellet gaps indicated by higher cesium count rates. The azimuthal variation in cladding diameter was confirmed by gamma spectrometry angle-dependent mappings. To investigate the pellet integrity without destructive methods, a neutron radiography was decided for. After cutting a segment of the pin, the radiography at

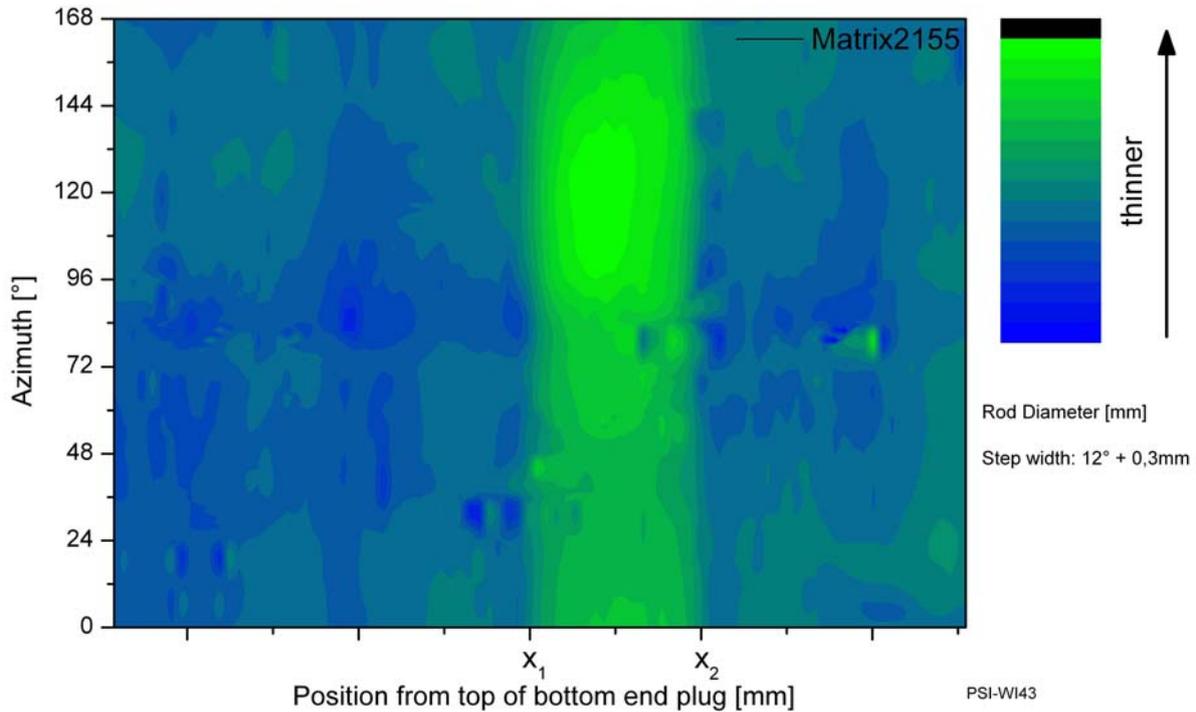
The axial and azimuthal scanning of the fuel rod confirmed that the axial length of the necking matches the height of a single fuel pellet while the diameter was varying in circumferential direction with a pronounced minimum at one side of the rod (Fig. 3.1).

FIG. 3.1. Azimuthal diameter plot of the fuel rod necking; axial length determined to one pellet [$x_1; x_2$] and pronounced on one side of the rod.

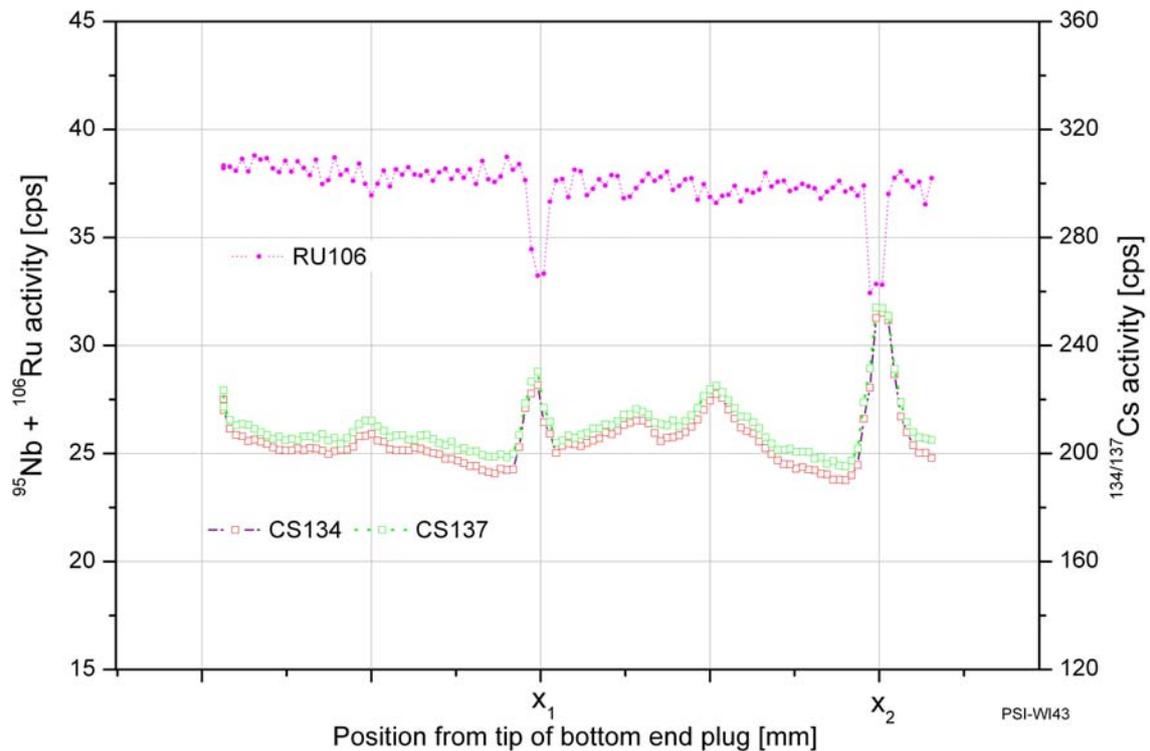
As the volatile cesium accumulates at positions of lower temperature, pellet gaps and areas of better thermal conductivity or lower heat generation are indicated by higher count rates. As ruthenium is kept fixed in the fuel matrix, inhomogenities in the fuel are detected. The plots of count rate against fuel rod elevation of these nuclides are compared in Fig. 3.2. The observed pellet gaps matched perfectly with the area of reduced diameter of the necking, and the higher count rates of ^{134}Cs and ^{137}Cs observed at mid pellet height can be attributed to positions of closer contact of pellet and cladding. On the other hand, the quite stable count rate of ^{106}Ru indicates no hint for fuel imperfection.

FIG. 3.2. Plot of axial count rate of cesium and ruthenium, indicating the gaps between the pellet matching the necking position.

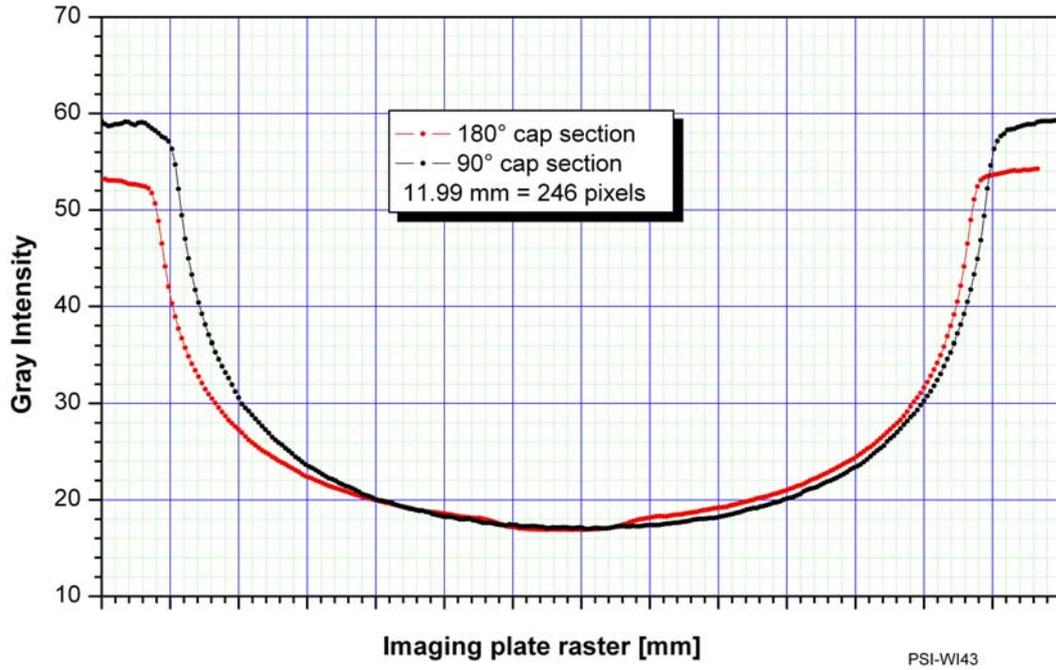
FIG. 3.4. Diametral grayscale intensity of segment end cap, used for scaling the neutron image.

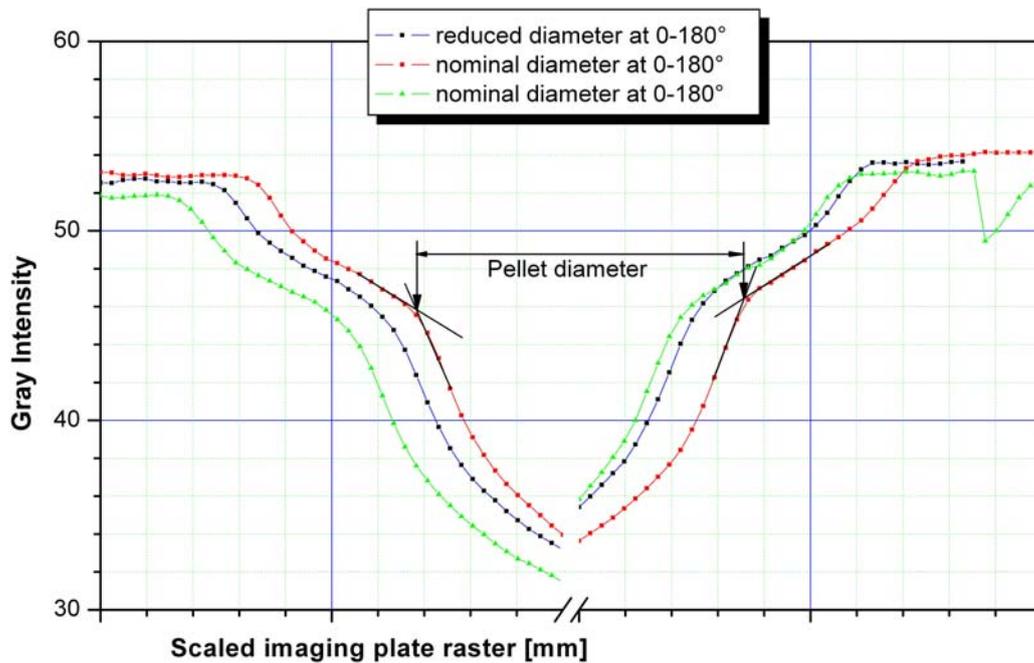
FIG. 3.5. Fuel pellet diameter determination by neutron radiography. Gray intensity levels of imaging plates exposed by the attenuated neutron beam allow the distinction between fuel and cladding.

Different image manipulation techniques like conversion to black/white and shifting the respective threshold values or enhancing the contrast and shifting the histogram values, showed no major defects inside the pellet. Consequently, the examination focused on the diameter of the pellet. The slight magnification of the images due to the collimation ratio of the neutron beam was accounted for by scaling against the known diameter of the segment end caps. Scaling was possible by counting the number of pixels of the diametral grayscale value, where the neutron beam was attenuated by solid material (Fig. 3.4). Regarding the examined pellet, the gray intensity of diametral lines was measured at different segment elevations comprising the neighbouring pellets (Fig. 3.5). Clear distinction was possible between cladding and fuel, allowing the determination of the pellet diameters. Although the resolution was restricted to 50 μm by the readout raster, a reduction of diameter at the considered pellet was confirmed. Through analyzing the radiographs at different beam angles, a picture of the pellets outer shape and its position in the cladding was derived.

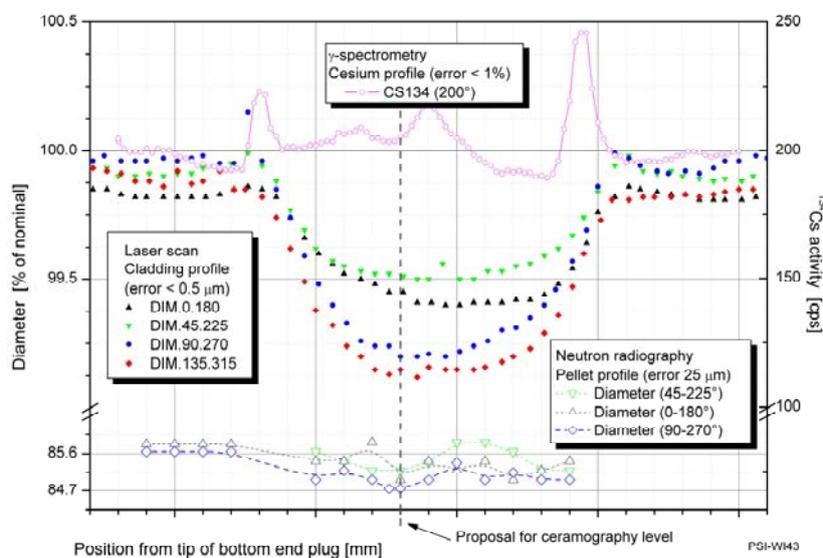
Comparison of the results of the three non-destructive methods reveals a minimum diameter of the pellet at a certain rod elevation. The cladding tube has crept down to the fuel surface with closest contact at positions of higher cesium count rates (Fig. 4.1). Neighbouring areas of the imperfect pellet are confirmed to be in a state as expected regarding the rod's burn-up. The elevation of highest deviation in diameter was chosen as level for ceramography, and the ongoing investigations indicate an irregularity of the manufacturing process.

FIG. 4.1. Combined laser profilometry, gamma spectrometry and neutron radiography measurements.
