**WORKING GROUP "HOT LABORATORY AND REMOTE HANDLING"
PLENARY MEETING 1991**

LHMA-Services to the Nuclear Industry

**L.H.M.A.
TEC/39.NRE39/23/JVdV/fq
June 1991**

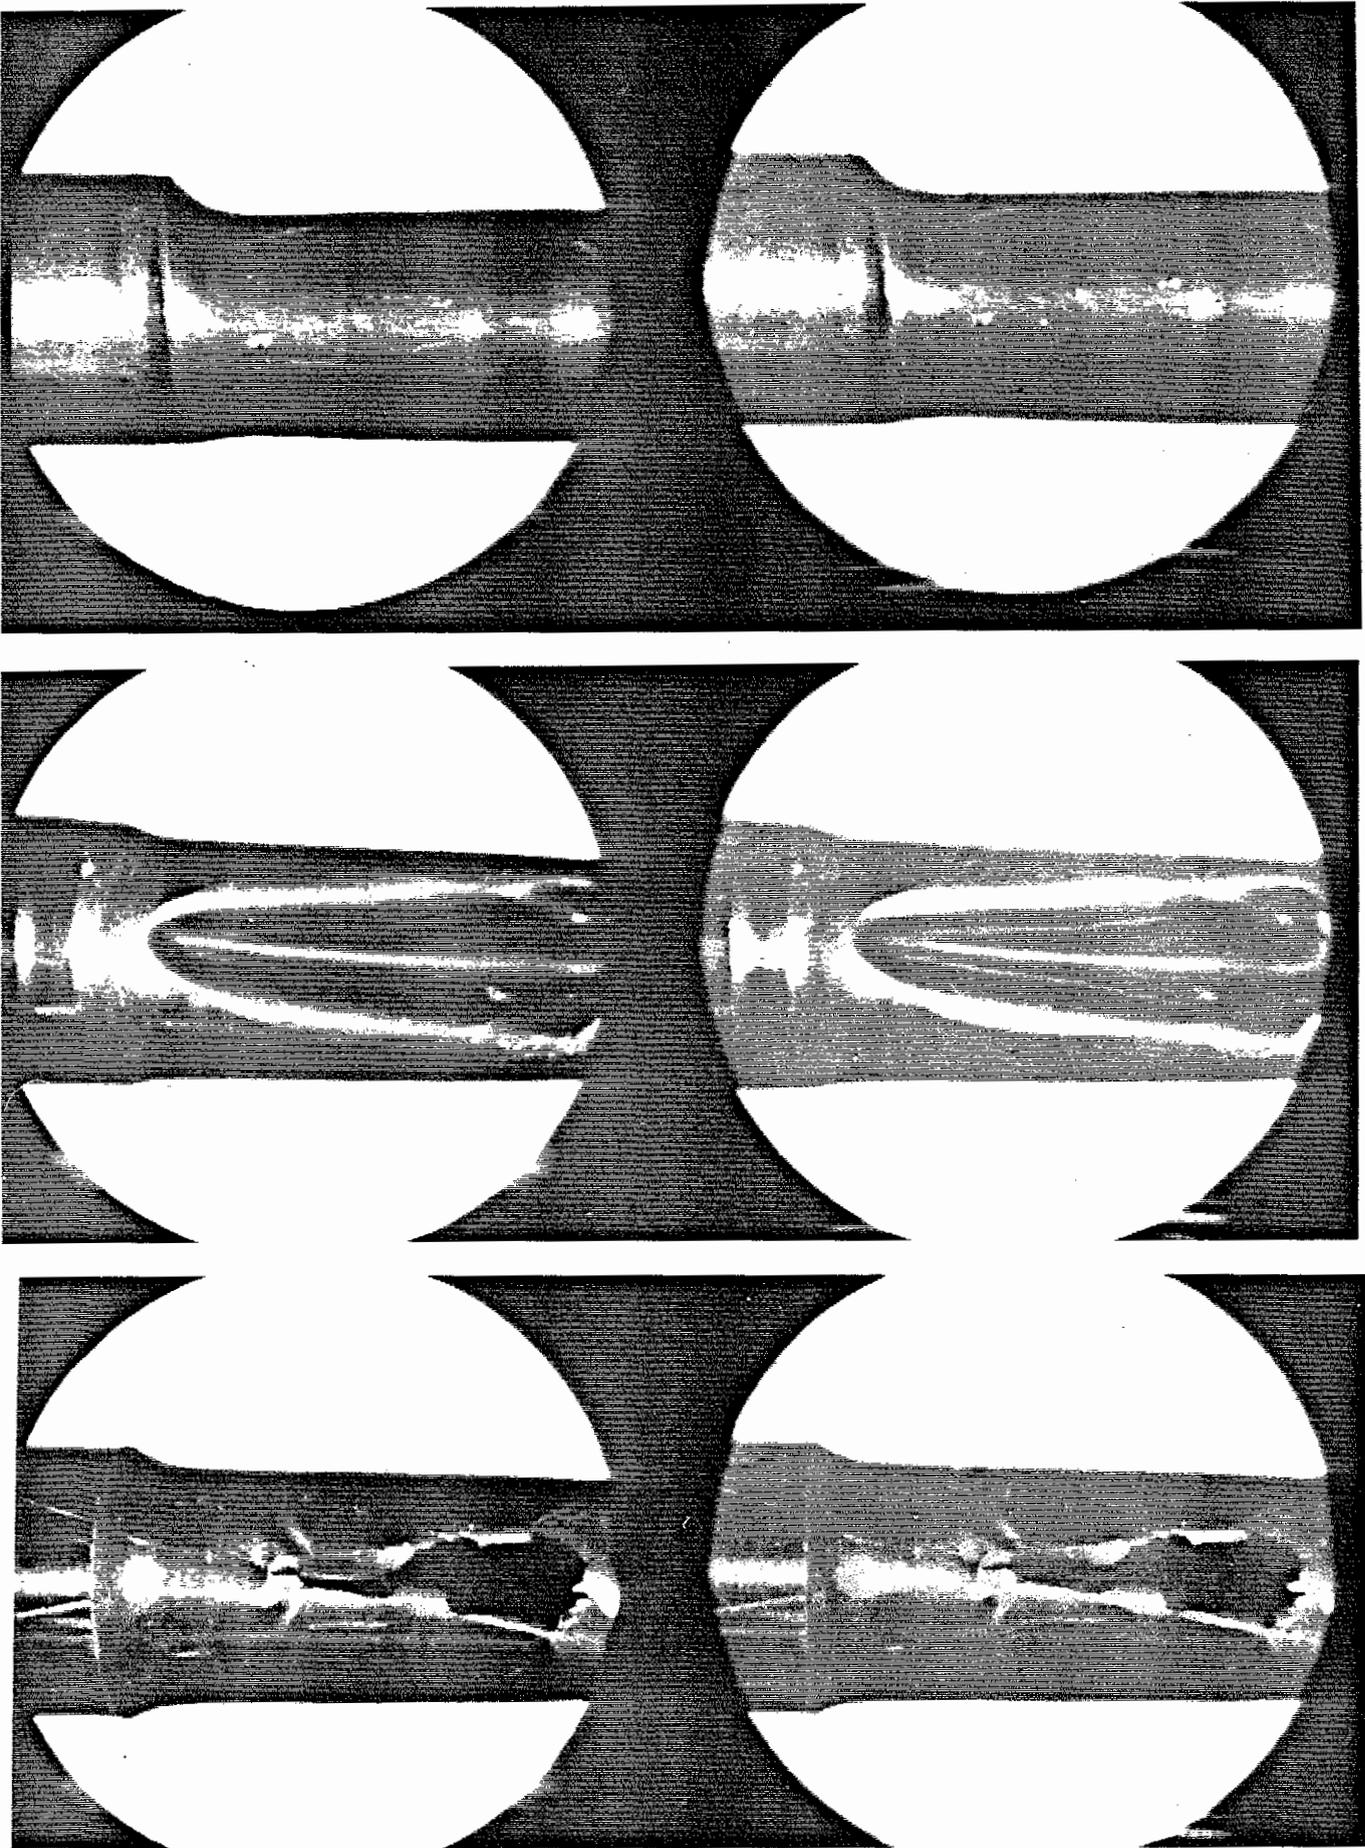
Thimble tube sections (304 stainless steel material) showing extended wear after limited operation, as well as their corresponding flow limiters - installed on the lower core plate in order to reduce the vibration level - have been examined in the hot cell facilities. Fig. 2 illustrates the observed degradation.

- pronounced wear areas up to tube wall perforation;
- wear located over the entire tube circumference, but not uniformly;

- wear depth changes very smoothly;
- outside the degraded areas, the thimble tube remains intact;
- aspects of wear-tapering is measured on the corresponding tube flow limiters;
- localised tube deformation due to coolant pressure is observed in areas where the remaining tube wall is very thin (collapse effect);
- optical microscopy provides no microstructural evidence for the abrasion, which is attributed to tube-to-flow limiter wear;
- no basic microstructural changes occur in the stainless steel and no variation in grain size is observed;
- microhardness measurements on both irradiated thimbles and reference tubes confirm the similarity.

Fig. 2. Thimble tube wear and perforation.

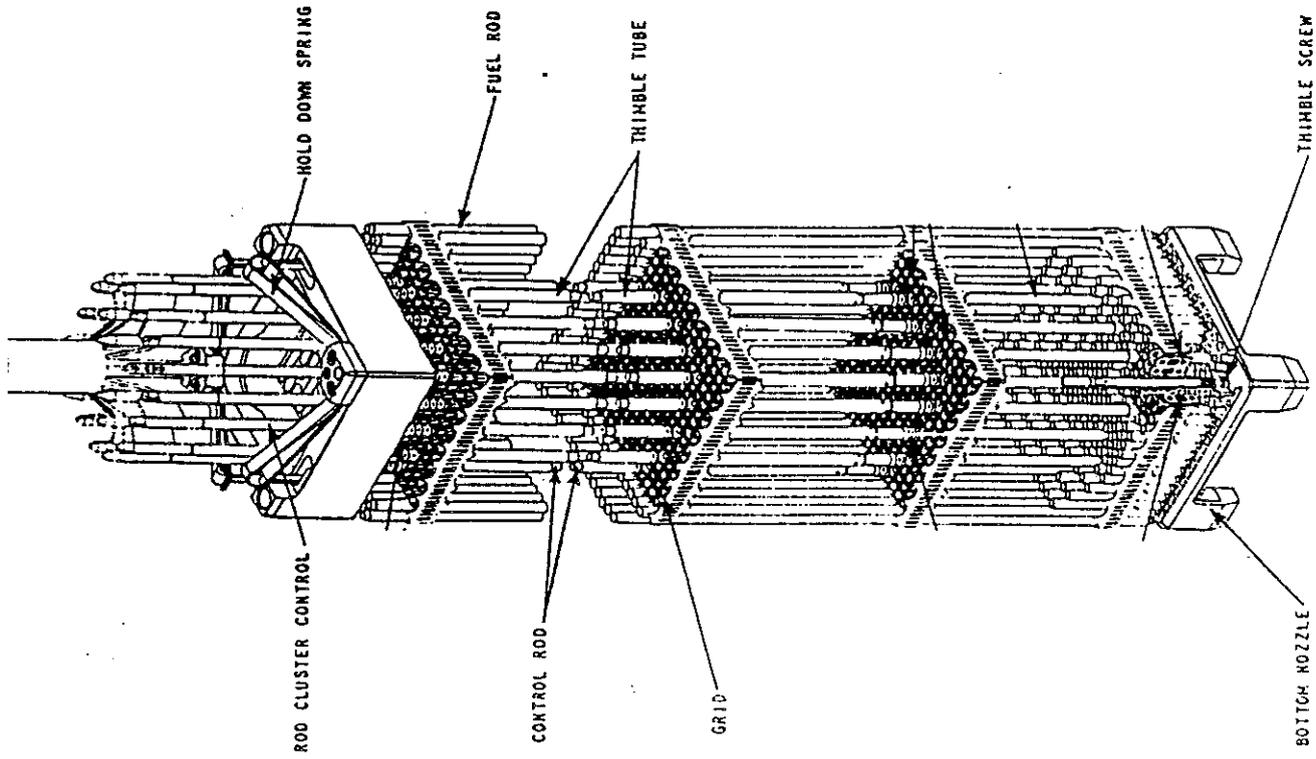
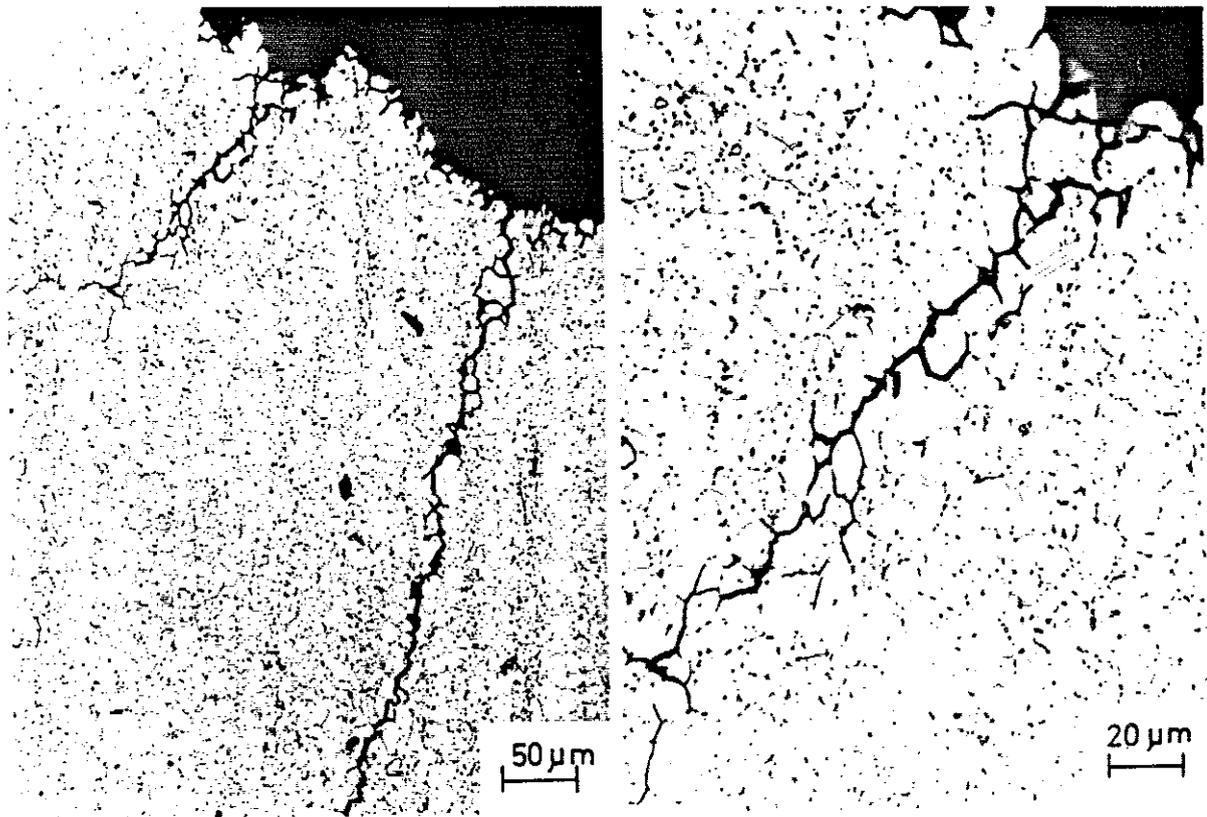
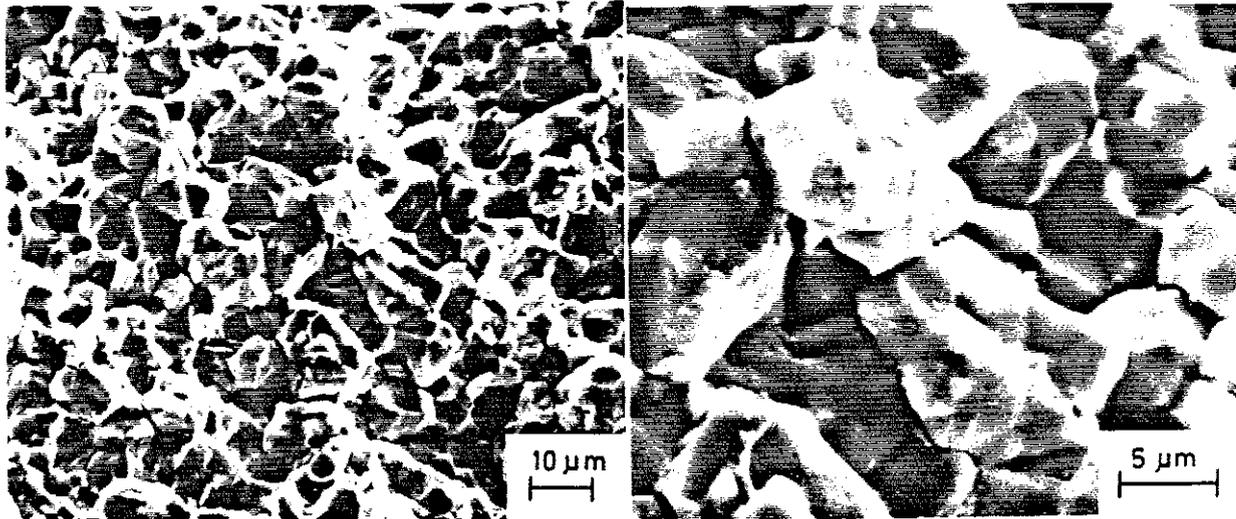
- intergranular stress corrosion cracking (SCC) is responsible for the observed damage in the Inconel 600 bolts in primary cooling water at operating temperatures;
- residual surface stresses induced by the peculiar bolt manufacturing techniques at (and close to) the head-shaft connection, are the major source of the stresses required for the SCC mechanism;
- the microstructure of the bolt material is typical of a rather vulnerable Inconel 600 condition;
- on-site ultrasonic testing is not very efficient to identify cracked bolts.

Bottom : Branch of in-service crack, mixed
nital-phosphoric acid etch. Longitudinal
banding is visible at lower magnification.

deposit-free intergranular in-service fracture

Fig.4. Microstructure and SEM examination.

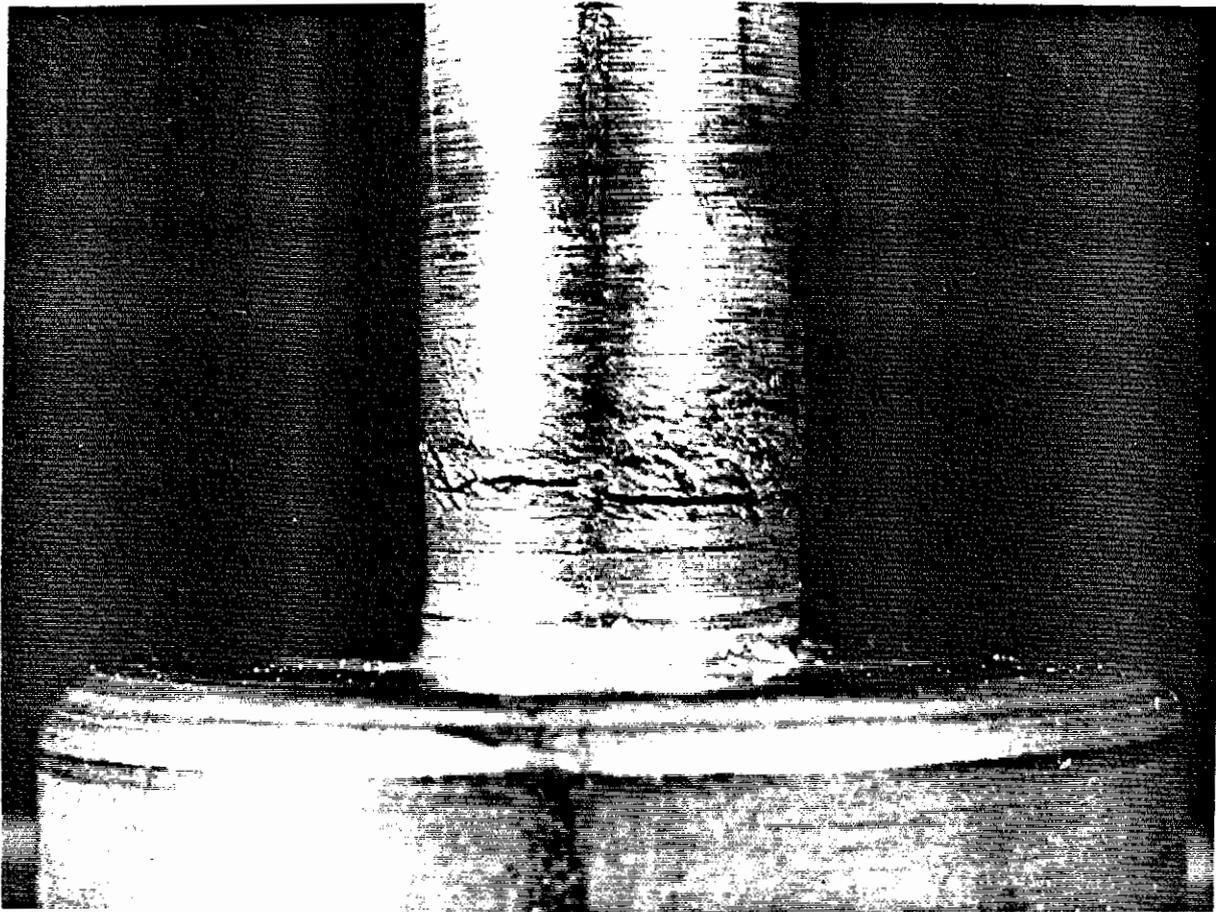
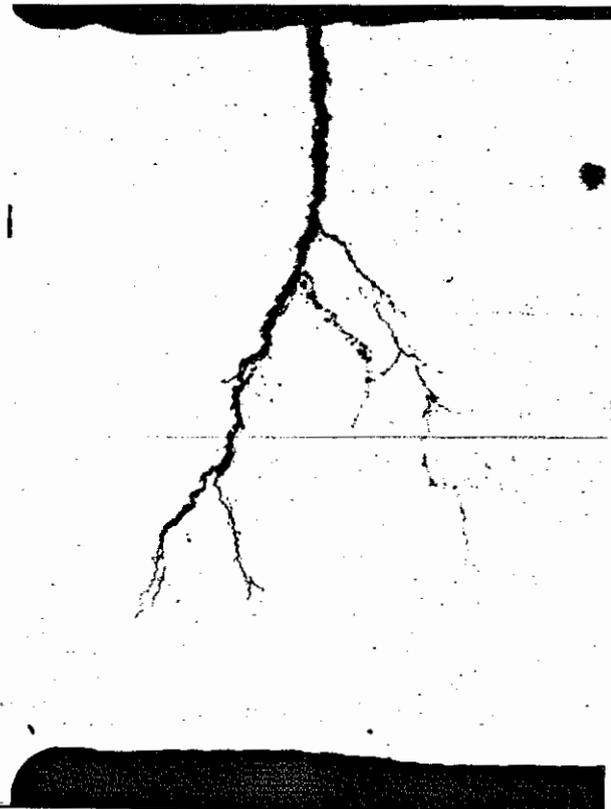
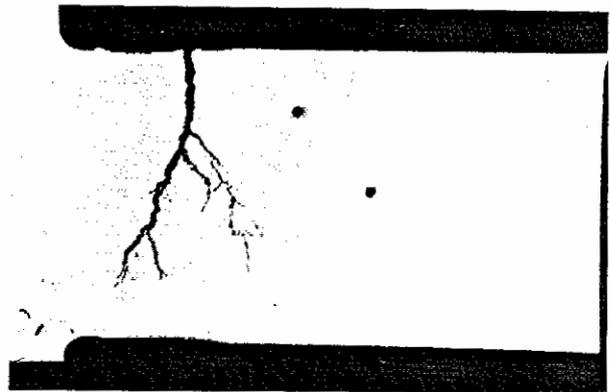
All observations indicated that failure has been caused by the slow progression of a brittle intergranular crack, with no indication typical of a fatigue mechanism.

Stress corrosion cracking was therefore proposed as the failure mechanism.

It was found that initiation and growth of the cracks occurs in the shaft-flexure head transition.

Potentially aggressive elements, such as Cl and S, have been detected at the fracture surface; the origin of these contaminants was however not clear.

Fig.6. Flexure pin cracking and microstructure analysis.

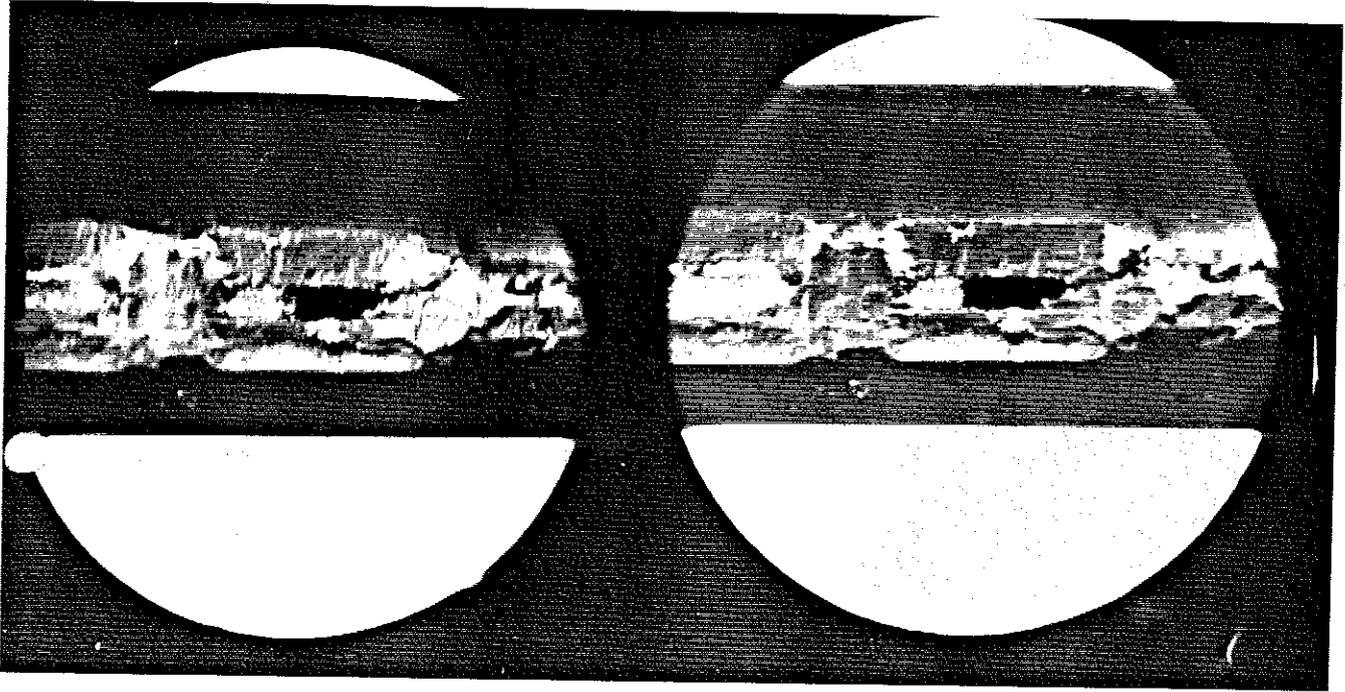
Wear related defects were observed at the lower part of the array, caused by displacements and vibrations of the control rod in contact with the adjacent fuel assemblies. Fig. 8 shows some rod perforations. In supplement to these fretting features however, cracks have been observed in the weldings of the ferrules against the rods at different levels, as well as longitudinal cracks in rod segments. See Fig. 9.

Fig.8. Wear and rod perforations.

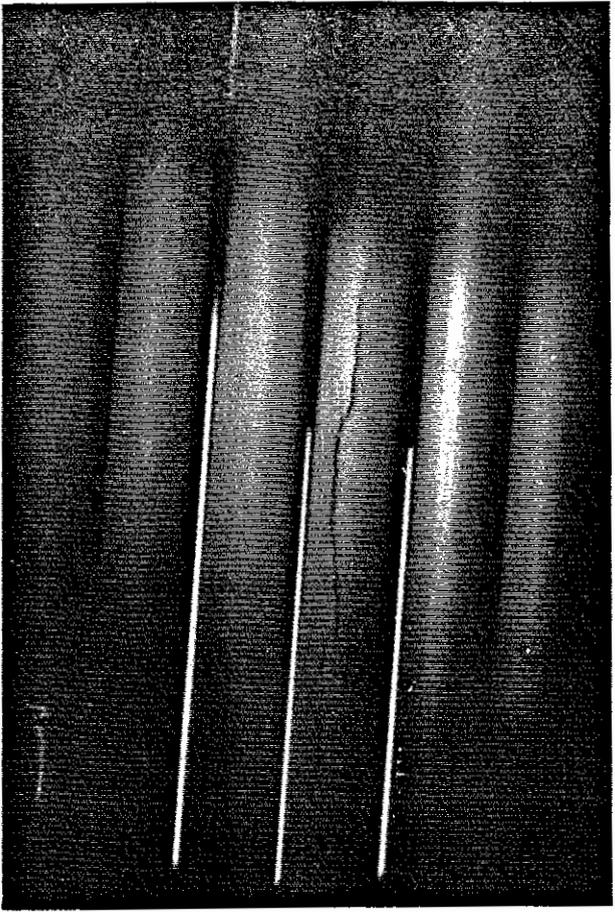
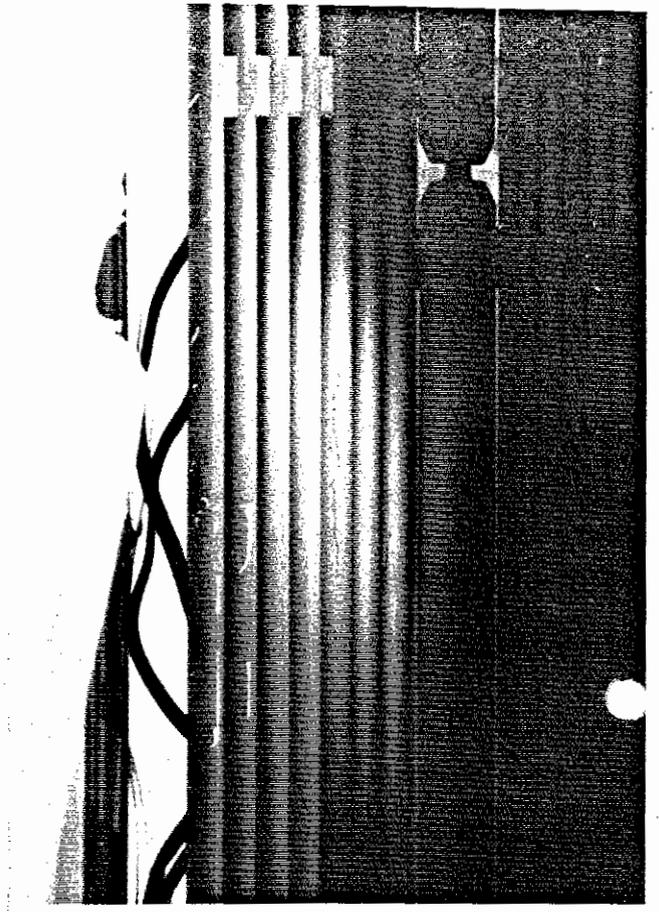
These defects have been related to constraints resulting of vibration and of interactions between the absorbant and the cladding.

Irradiation-induced swelling of the absorbant, as well as plastic deformation due to the axial impact forces during the insertions and extractions of the control rod, promote stress increase in the cladding. Embrittlement of the cladding at the lower part of the array is also to be considered as contributing to the cracking process.

Metallographic- and SEM examinations have revealed typical intergranular cracks, initiating at the outer surface of the cladding.

Fig.9. Cracks in welded ferrules and longitudinal cracks in rods.

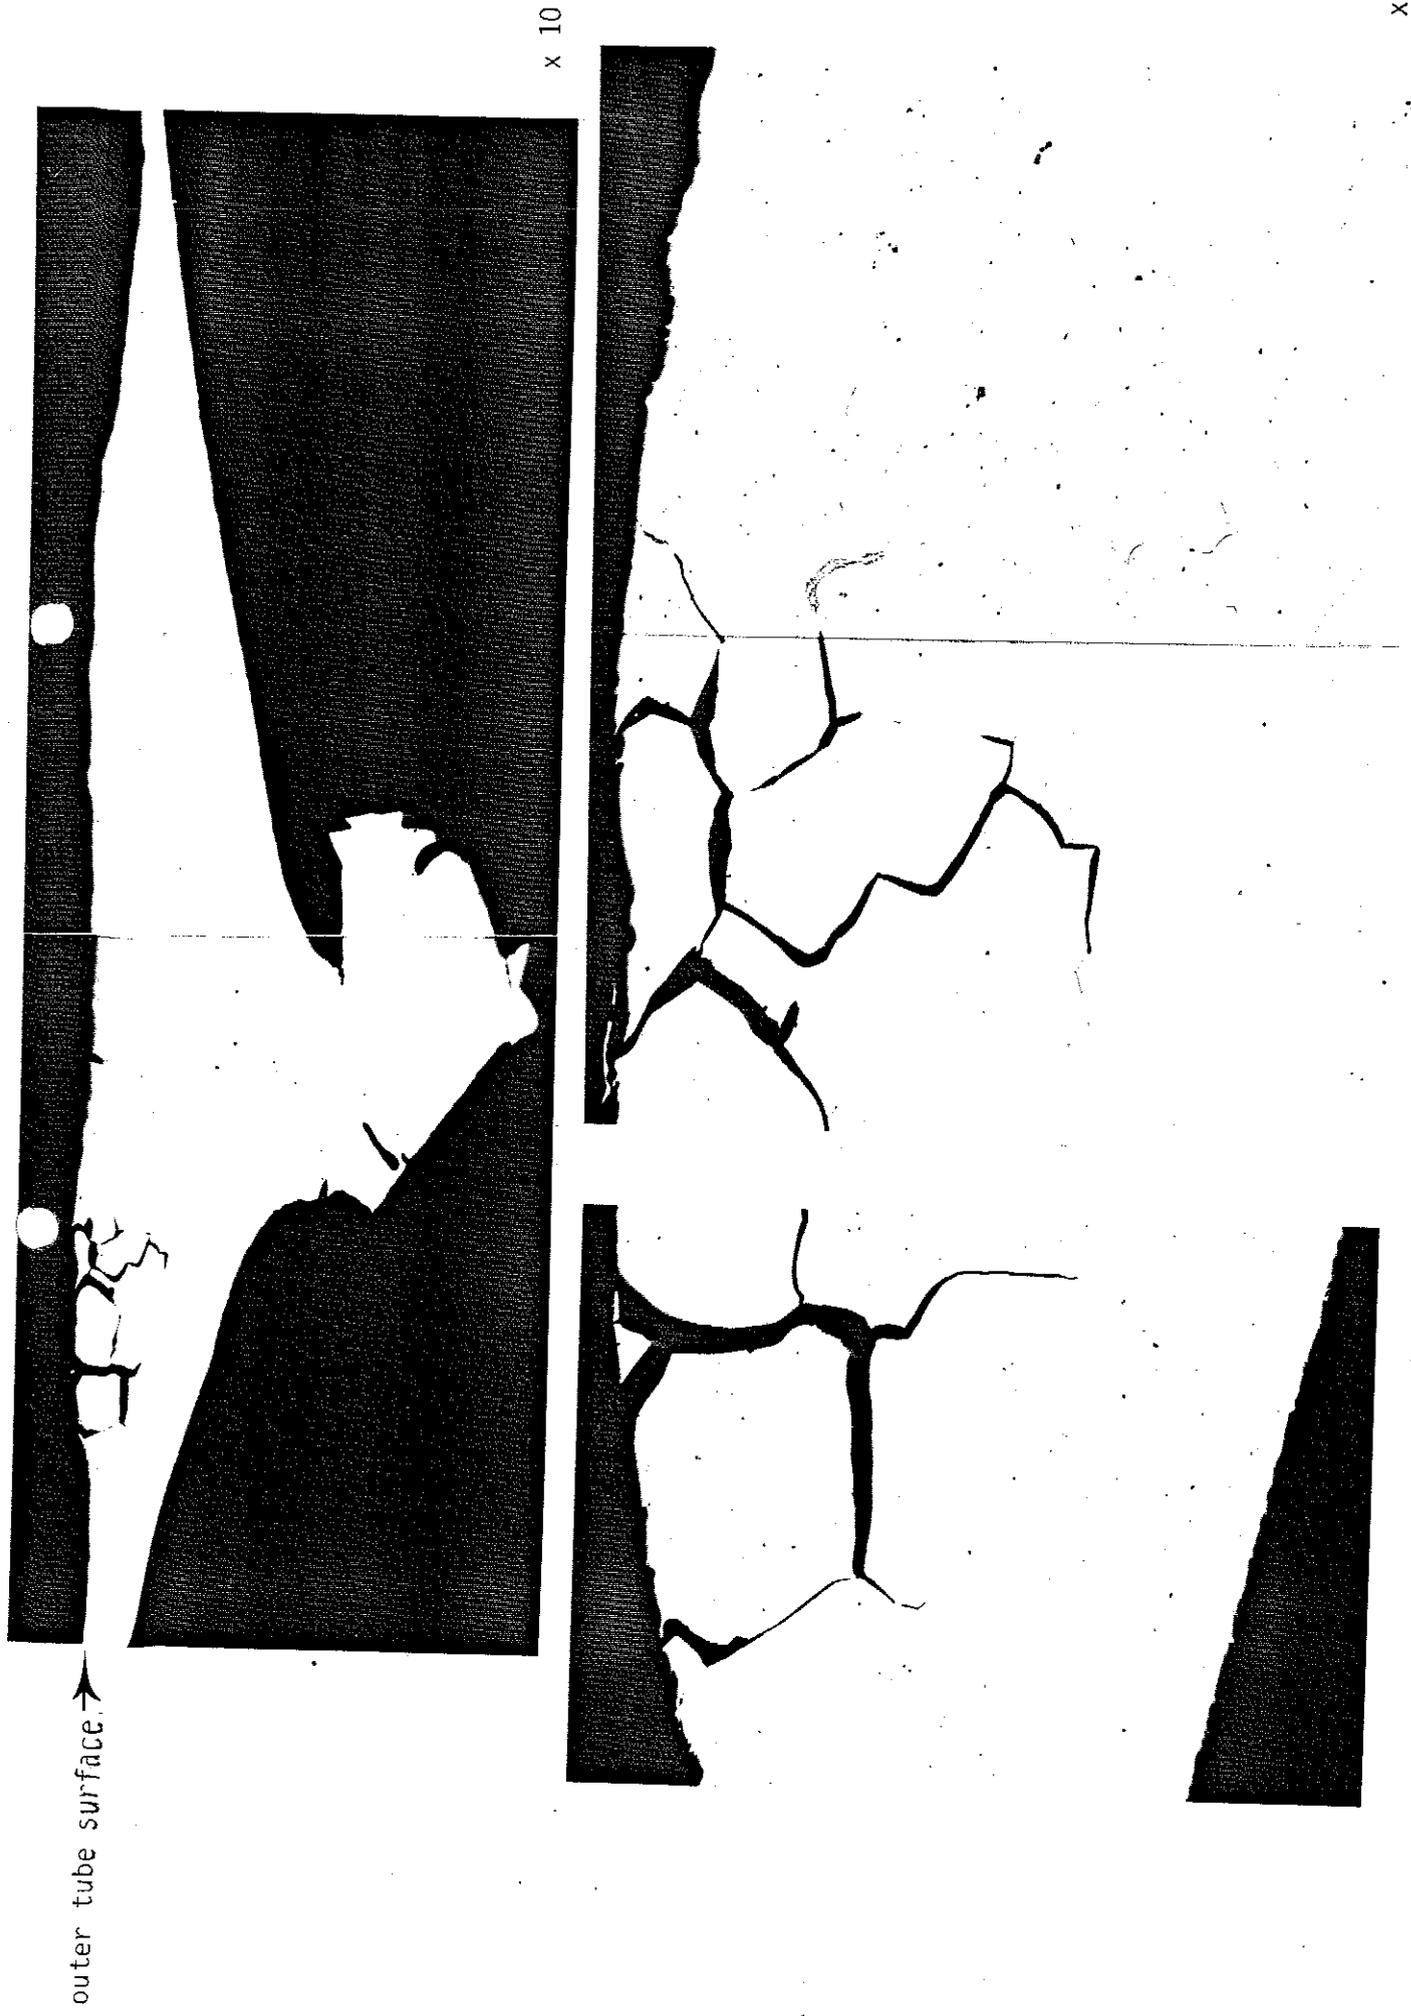
Examinations revealed an extensive intergranular network of cracks, showing equiaxed microstructure with a very large grain size and numerous recrystallisation twins and glide bands.

The material used for the safe-end ring was definitely AISI 316 in the fully-annealed condition; this material can very easily be sensitized, probably during welding of the ring to the reactor vessel in the cold leg duct.

Residual stresses combined with service stresses may have promoted the initiation and extension of the damage.

Aggressive chemical substances necessary to cause the damage of the sensitized material could not be revealed; damage in pre-service aggressive environment cannot be ruled-out.

Fig.12. Section M2 normal to the tube surface. Crack pattern at the outer tube surface.

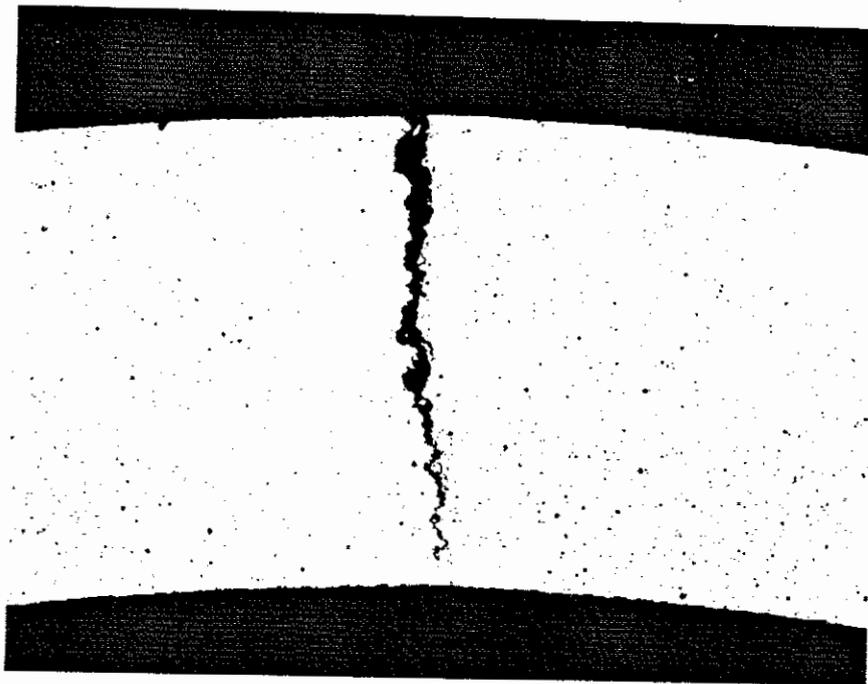
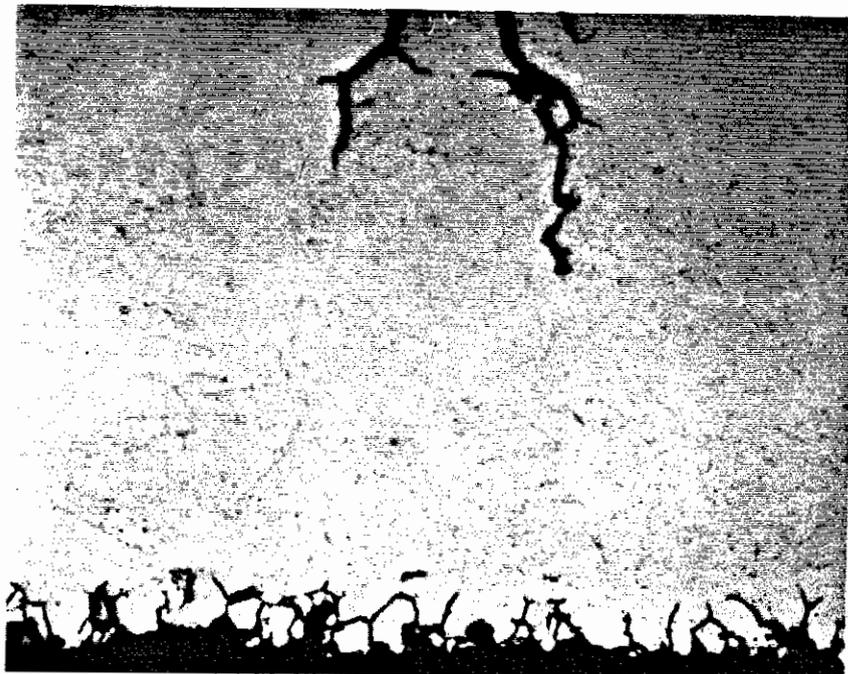
- microstructure and grain size, i.e. tube processing temperature, has an important influence; this confirms the effect of the annealing temperature range on the susceptibility to IGSCC;
- secondary side cracking, however, seems to be determined by the crevice chemistry and associated formation of particular surface layers, rather than by the material microstructure;

Fig.13. Secondary side longitudinal crack
Top : general view
Bottom : detail of crack tip and inner tube surface

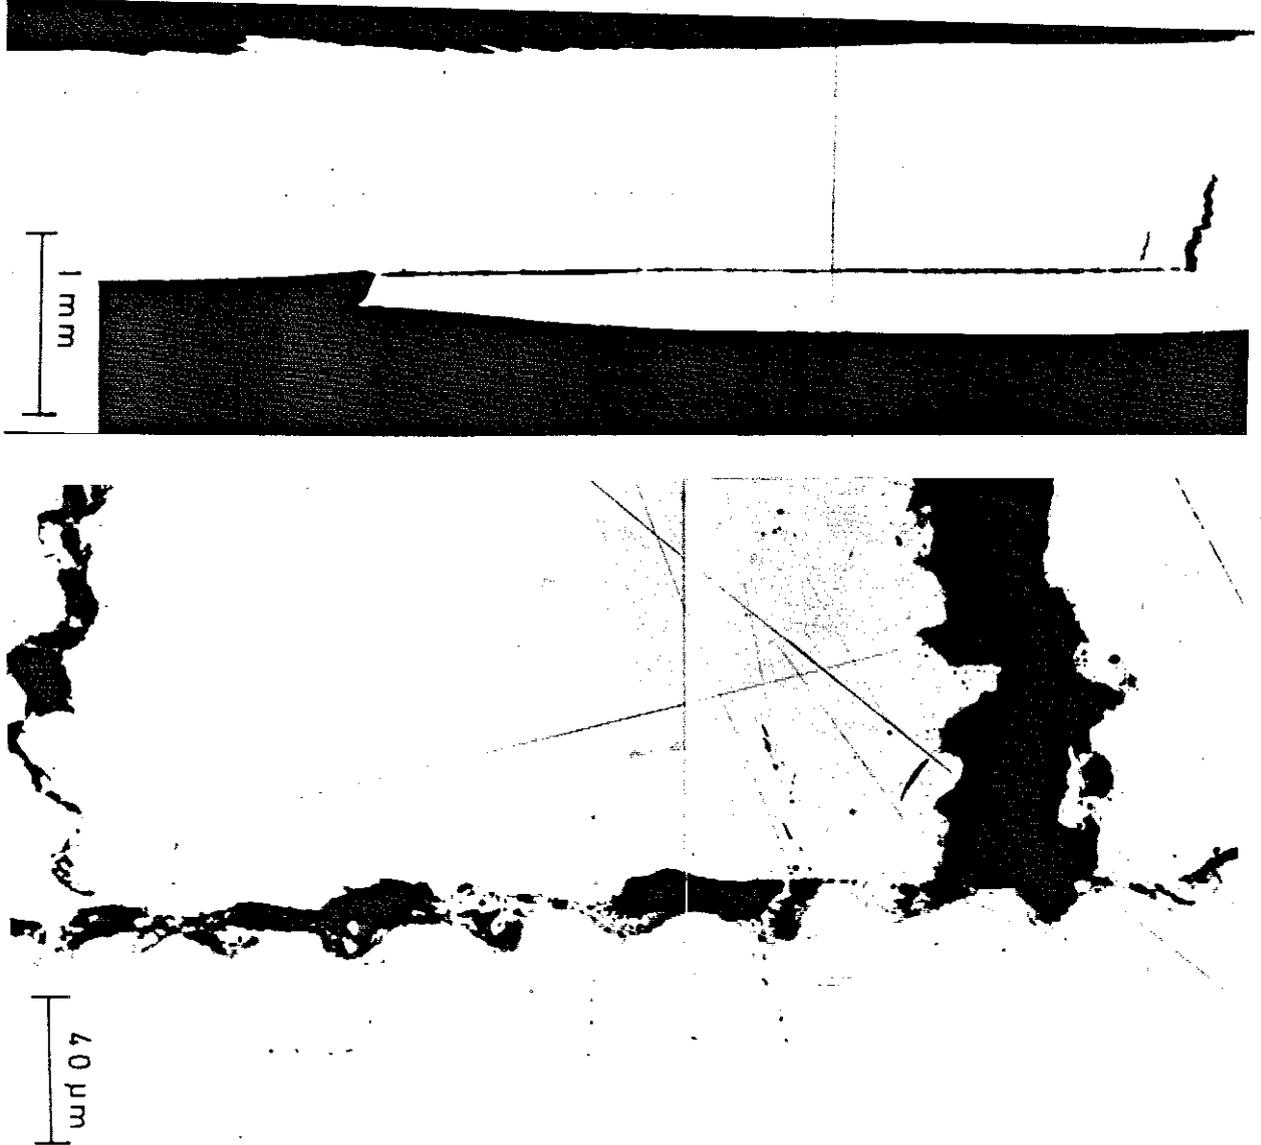
Fig.14a.

- the role of Si, Al, S and oxygen found as major elements in the outer tube surface layers is not very clear in relation to the secondary side stress corrosion cracking process;
- extensive circumferential cracking was observed in the case of an improperly applied sleeve. Limited circumferential cracking has also been seen under the lower unwelded sleeve end. Metallography and the overall geometry of these defects seem to indicate that these have been mechanically induced during the sleeving operation.
- a substantial hardness increase of the tube material and the development of small circumferential cracks at the lower-sleeve end appear to be the two major phenomena resulting from the mini-sleeve application.

Circumferential cracks initiated at lower sleeve end of tube

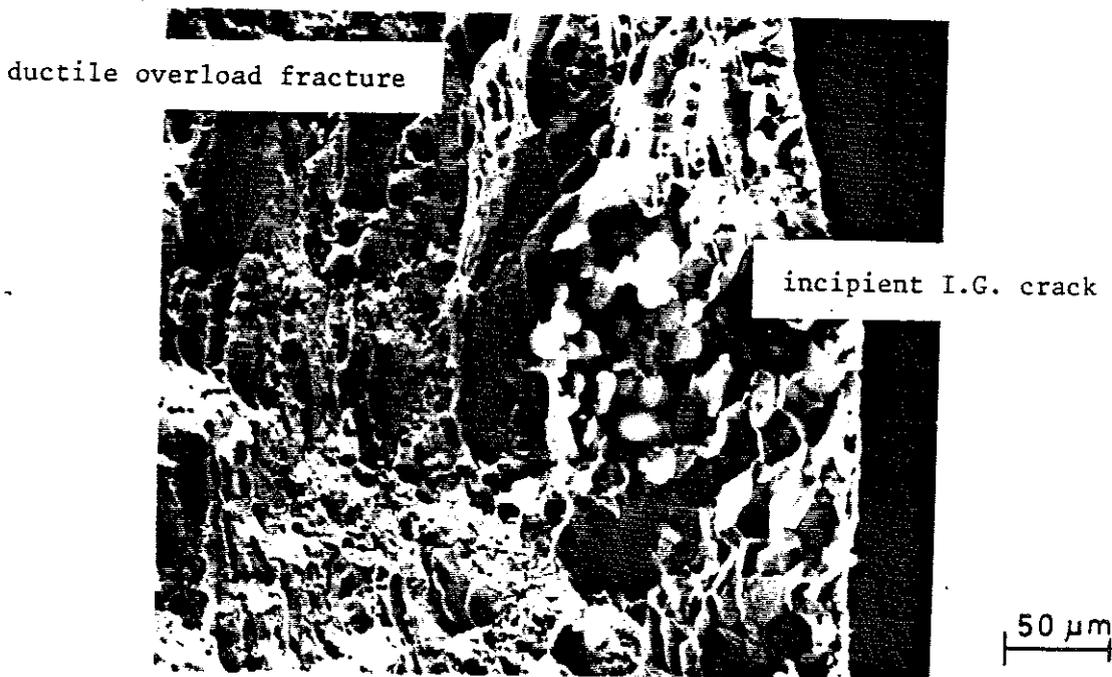
Fig.14b.

Tensile rupture of tube
The overload fracture meets semi-circular I.G. cracks at the outer tube surface. At higher magnification loose particles can be seen in these areas.

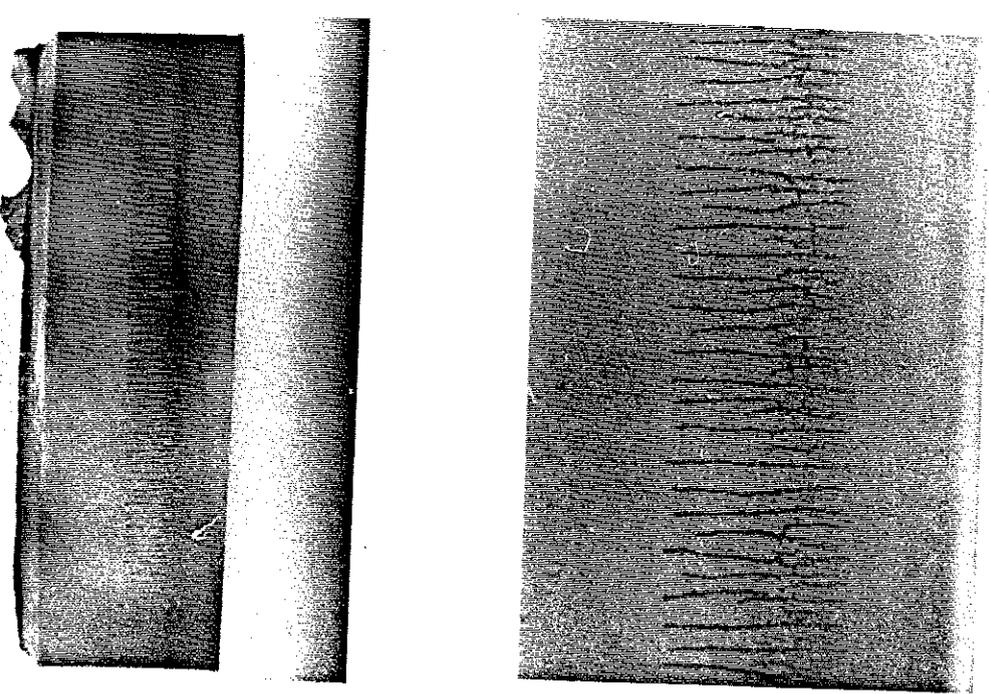
Die penetrant control revealed a lot of cracks of about 20 mm length, almost impossible to see with the naked eye, and all axially oriented at equidistance from each other. See Fig. 15a.

Fig.15a. Die penetrant revealed axial cracks.
