EXAMINATION OF IRRADIATED CONTROL RODS AT MAGNOX ELECTRIC

**Presentation to the European Working Group
Hot Laboratories & Remote Handling**

Prepared by Magnox Electric Staff

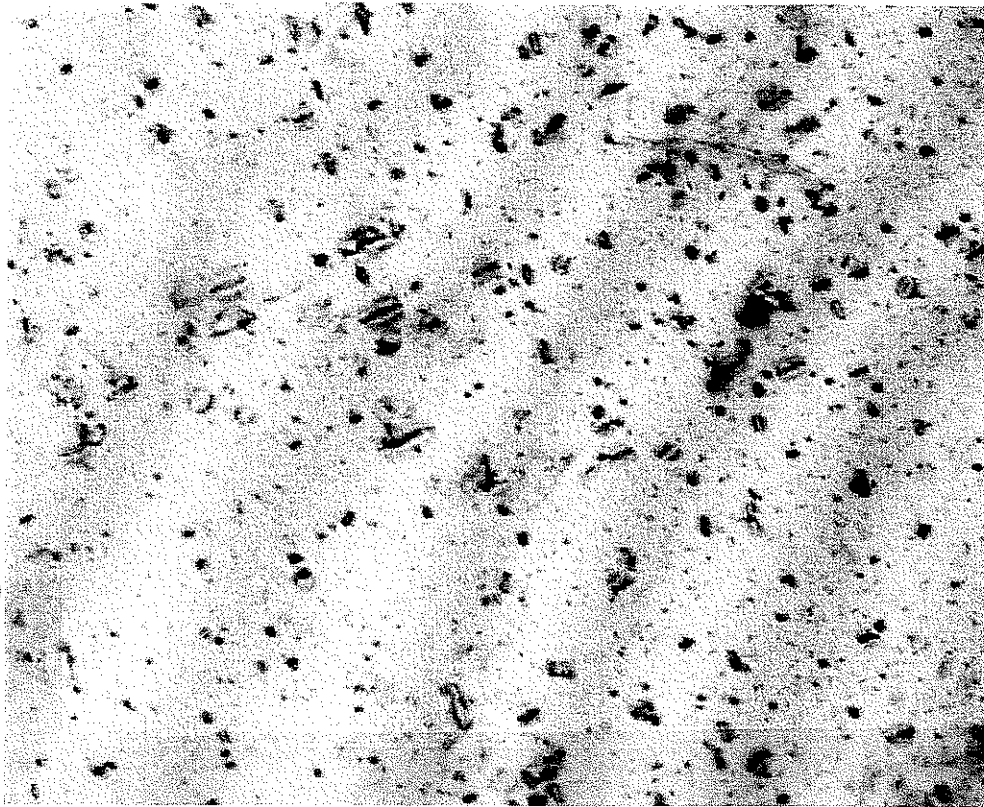
The Joel 3010 TEM has an operating voltage of 300 KeV and provides high quality imaging of microstructural features in magnetic materials. The general microstructure of the failed material was comparatively uniform and clean. A few small areas of pearlite were observed. Stringers of manganese silicate were present, the largest of which crossed several grain boundaries. The "non-loop" dislocation density within grains was low. Figure 5 (top) shows a typical area. There is a size-distribution of dislocation loops, from several tens of nanometres down to a few nanometres. At the bottom of the size range the dislocation loops are virtually indistinguishable from copper precipitates. The electron beam is close to a $\langle 100 \rangle$ direction in the grain being examined so that contrast is due to diffraction from two (100) sets of planes that are aligned nearly edge-on. Diffraction contrast is somewhat away from the Bragg condition for the two sets of planes, so fine-scale microstructural features can be seen with good resolution in the image. Dislocation loops in irradiated ferritic steel are known to lie predominantly on $\{100\}$ planes, so that for orientation of Figure 2, 2/3 of loops are expected to be viewed edge-on and 1/3 to lie in the plane of the foil.

In order to confirm the identification of copper precipitates the sample was examined in the FEGSTEM. Over forty precipitates were examined by EDS. The great majority of these were identified as copper, by the presence of copper and iron in the spectra obtained. There is always a strong iron signal as the electron beam must pass through matrix above and below each precipitate. The copper precipitates are typically a few nanometres in diameter while the sample thickness in the region being examined would typically be several tens of nanometres. Some copper sulphides were also present, as expected in this type of material, along with one or two aluminium-rich particles.

Measurements were made of 20 loops and precipitates in an area from the field of Figure 5, directly from the negative of a dark-field image, using a standard 10x Lupe. In the case of non-circular dislocation loops and precipitates, the longest dimension was measured. Average diameters derived for loops and precipitates were $\sim 4\text{nm}$ and $\sim 12\text{nm}$, respectively.

The control rod was known to have had an operating life of 25 years ($t_{\text{CR}} \sim 130,000$ hours). The mean copper precipitate diameter measured for the damaged rod material gives an operating temperature estimate of $285^\circ \pm 15^\circ\text{C}$, using the expression

The confirmation of an operating temperature at the failure region of the control rod of $\sim 285^{\circ}\text{C}$ as a primary contributory factor in the loss of sheath ductility enabled a clear safety case to be established for the operation of all other rods at the normal temperature of $\sim 330^{\circ}\text{C}$.

Damaged sheath material, operating temperature 285C.

Figure 5: The damaged rod operating at an abnormally low temperature. Small copper particles and crystal defects have a strong embrittling effect and the sheath cannot absorb swelling of the boron steel insert without cracking. With fewer and larger microscopic features, the undamaged sheath material deforms without cracking. Measurement of copper particle size combined with a good theoretical understanding of their growth allows the operating temperature to be calculated.

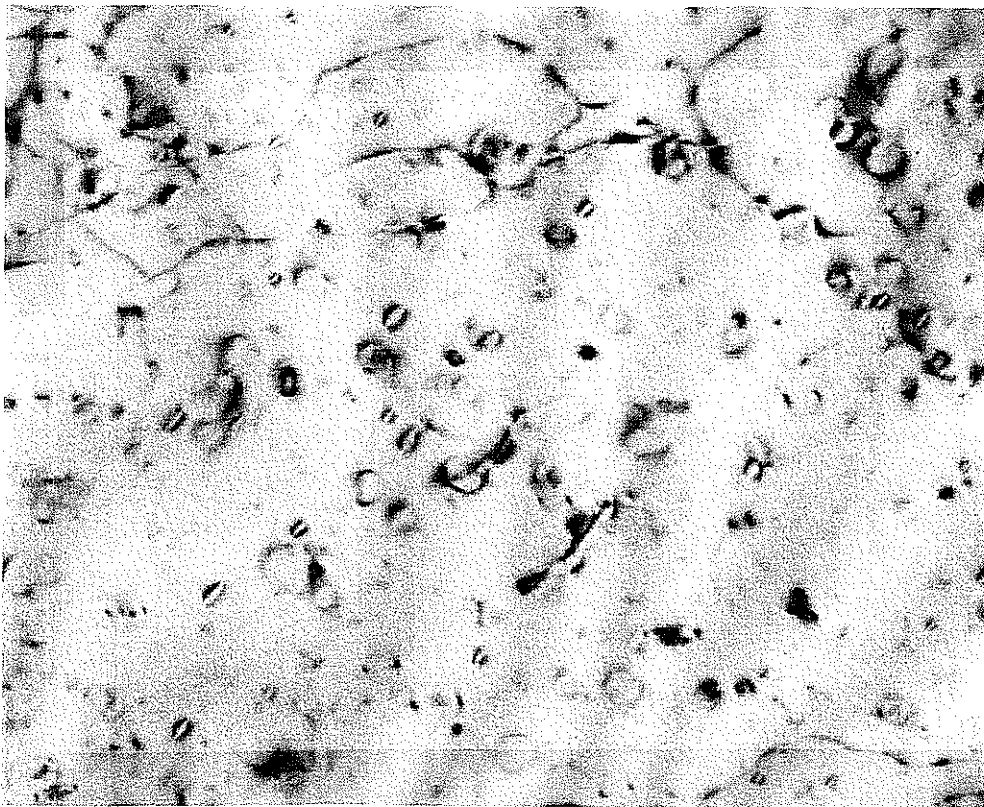
TEM examination revealed a microstructure that was consistent with known composition and assumed operating conditions. Non-loop dislocation density was variable within the material but generally higher than had been observed in the failed material. Both dislocation loop and precipitate densities were considerably lower. In areas with a significant density of line dislocations, loops were smaller and there was definite evidence of interaction between the two dislocation types, Figure 5 (bottom).

Undamaged sheath material, operating temperature 350C.

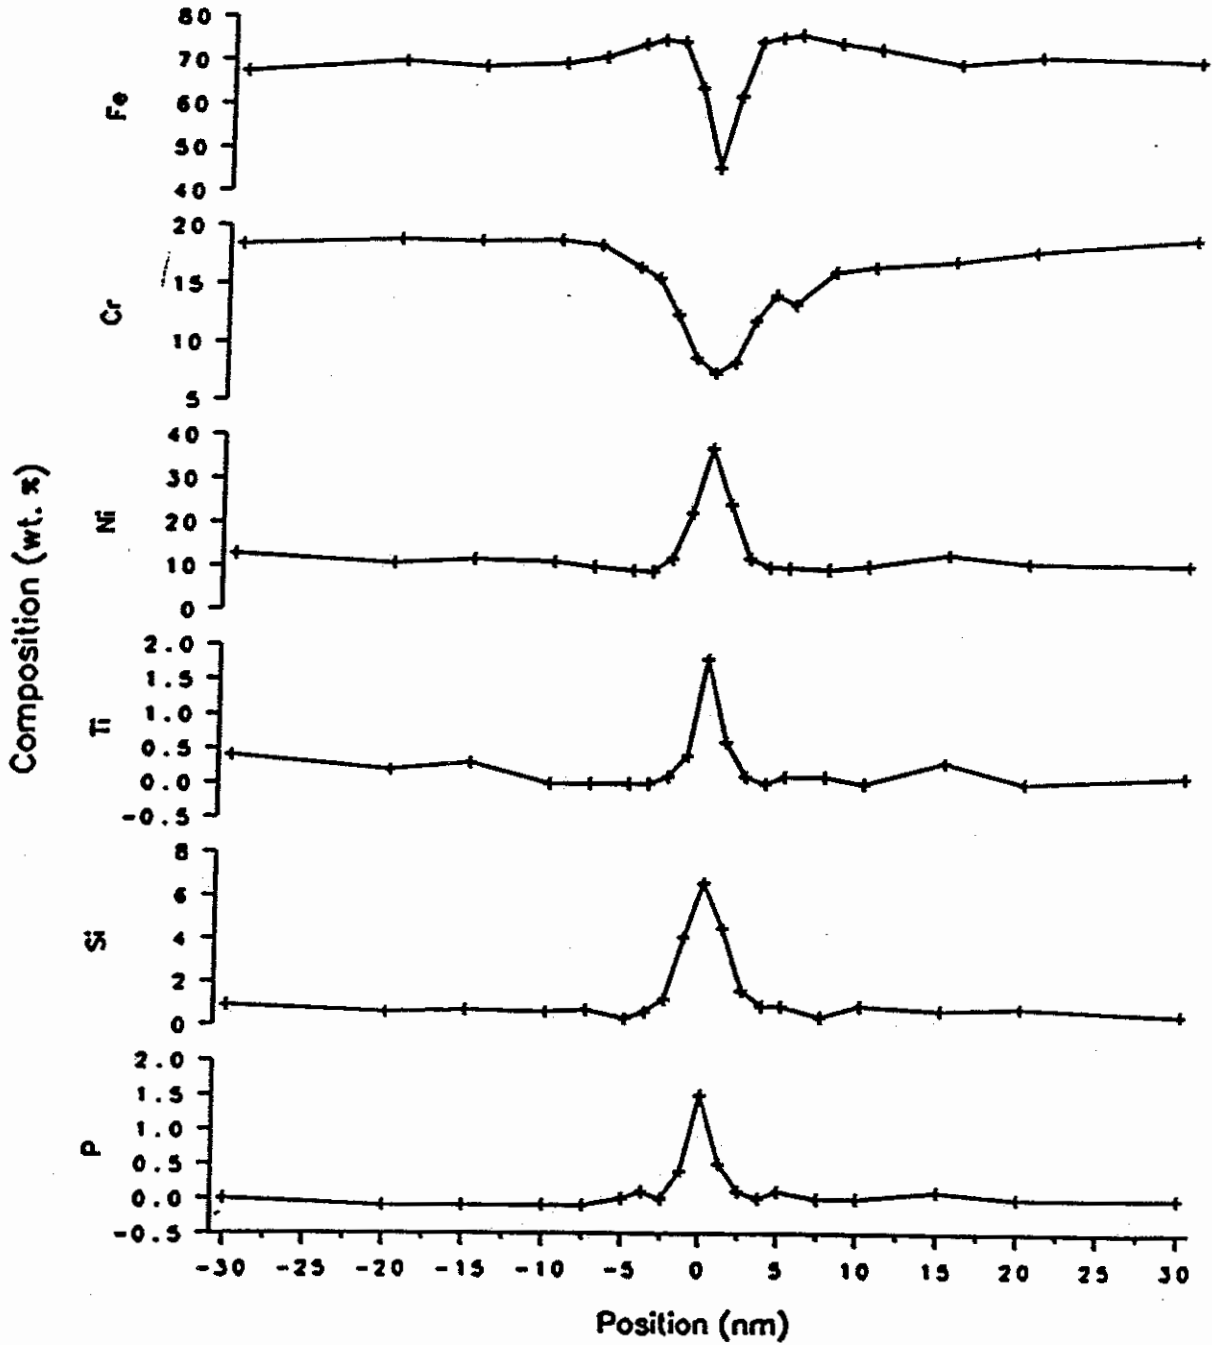
Figures 6 and 7 illustrate a composition profiles taken from different control rods. Whilst the results from Station 1 clearly indicate significant chromium depletion, this effect in the sample shown in Figure 7 is much less severe. Investigations at Berkeley Centre have indicated a strong relationship between chromium migration and the presence of molybdenum which appears to serve as an inhibitor to this process.

Figure 6: Grain boundary composition profiles from FEGSTEM analysis

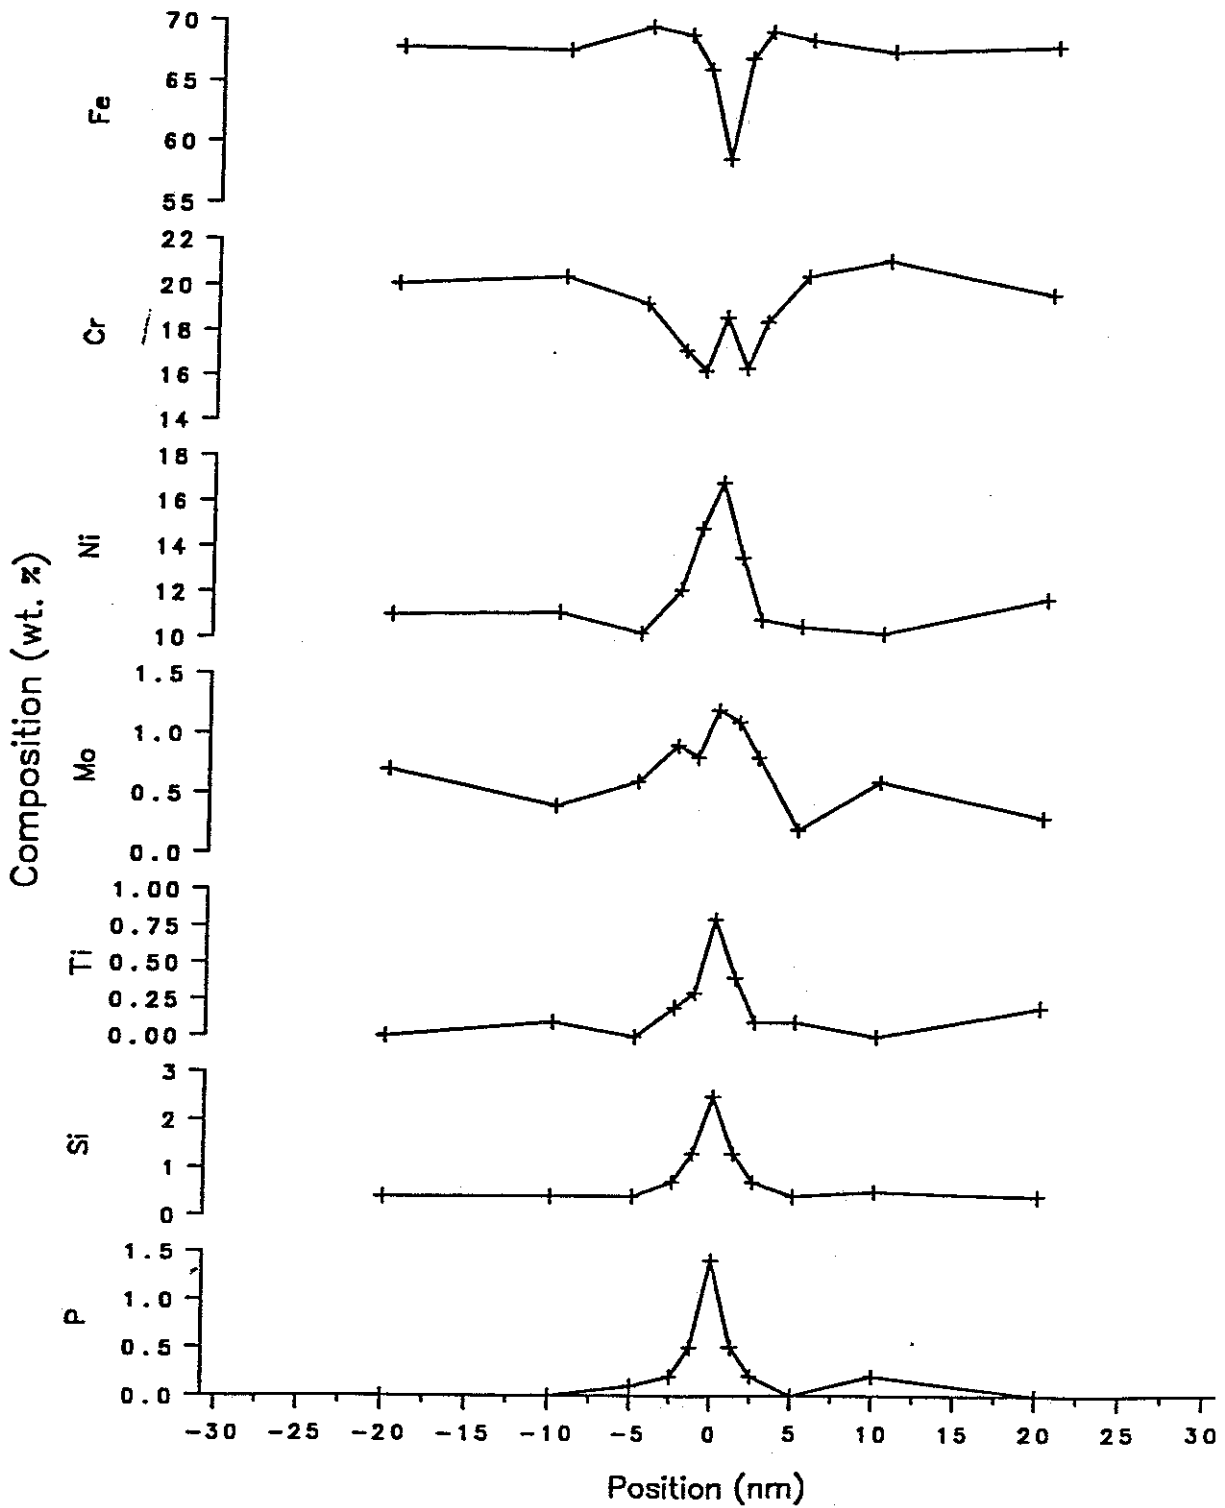
Station 2

Figure 7: Grain boundary composition profiles from FEGSTEM analysis

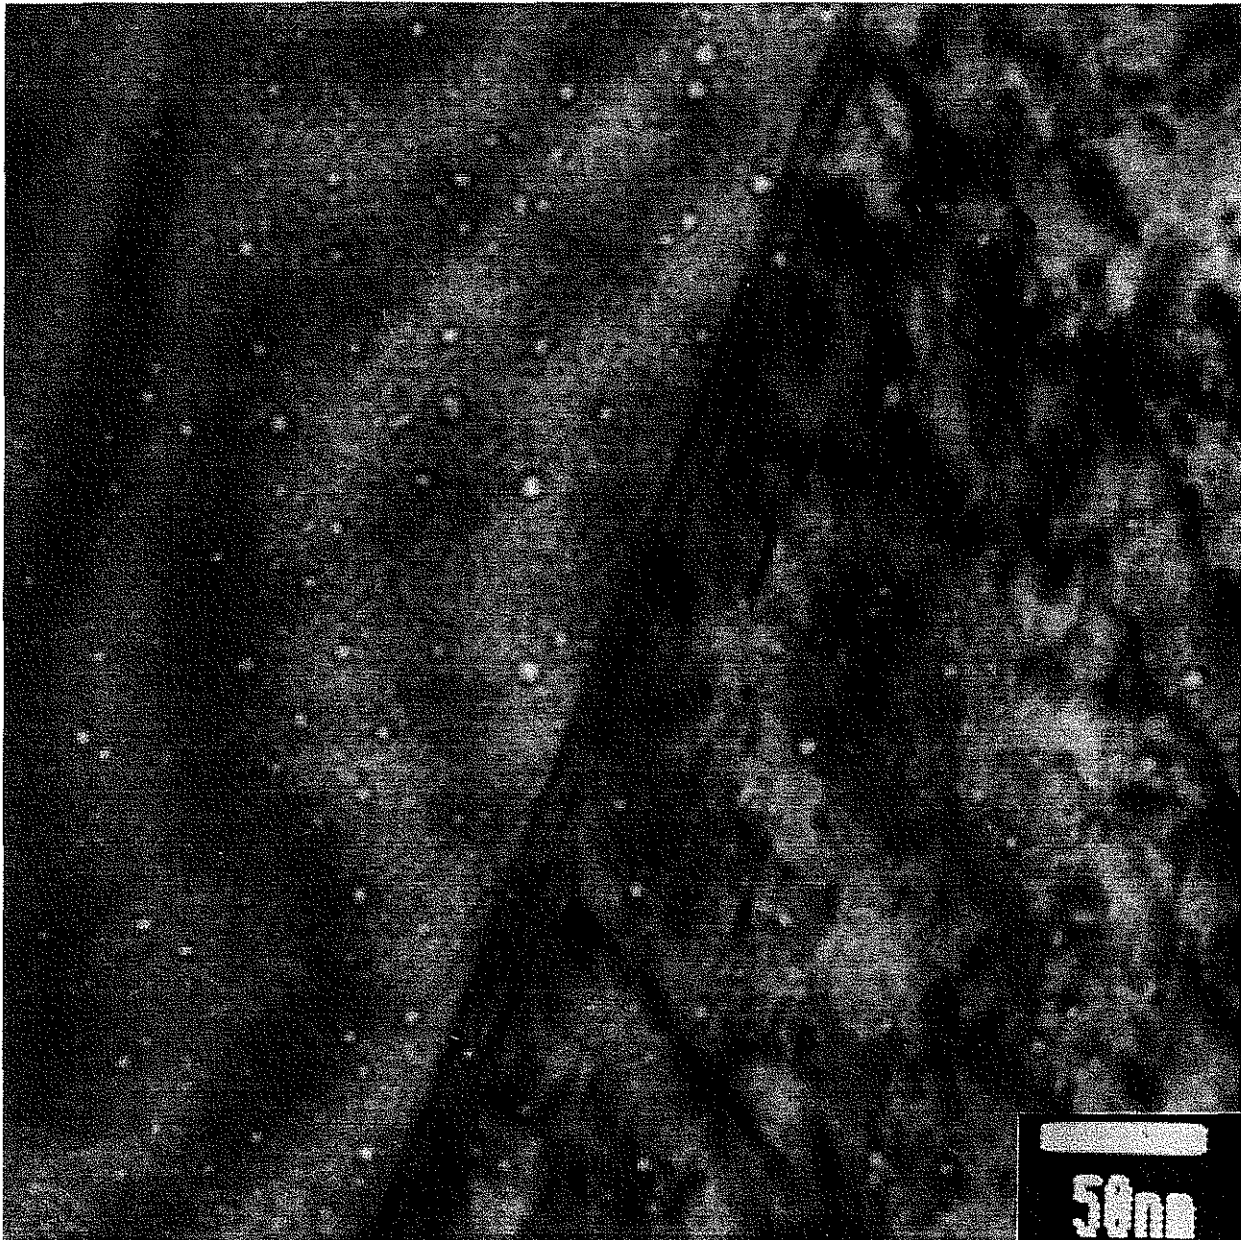
Station 1

TEM observations also enable the voidage volume fraction to be calculated, which may typically be around 0.03% (Figure 8). This value is fully acceptable for Magnox reactors where available clearances for control rod movement are generally much larger than those in water reactors. Composition of 'void' inclusions can be interrogated using the EELS (Electron Energy Loss Spectroscopy) facility on the FEGSTEM.

voids
size 2-6nm number density $9 \times 10^{21} \text{m}^{-3}$
volume fraction 0.03%

Figure 8: TEM Examination of Irradiated Stainless Steel Sheath Material
