# POST IRRADIATION EXAMINATION OF THE FUEL RODS OPERATED IN WWER-1000 MIXED CORES

IAEA Technical Meeting on “HOT CELL POST-IRRADIATION EXAMINATION AND POOL-SIDE  
INSPECTION OF NUCLEAR FUEL” (Smolenice, Slovakia, 23-27 May 2011)

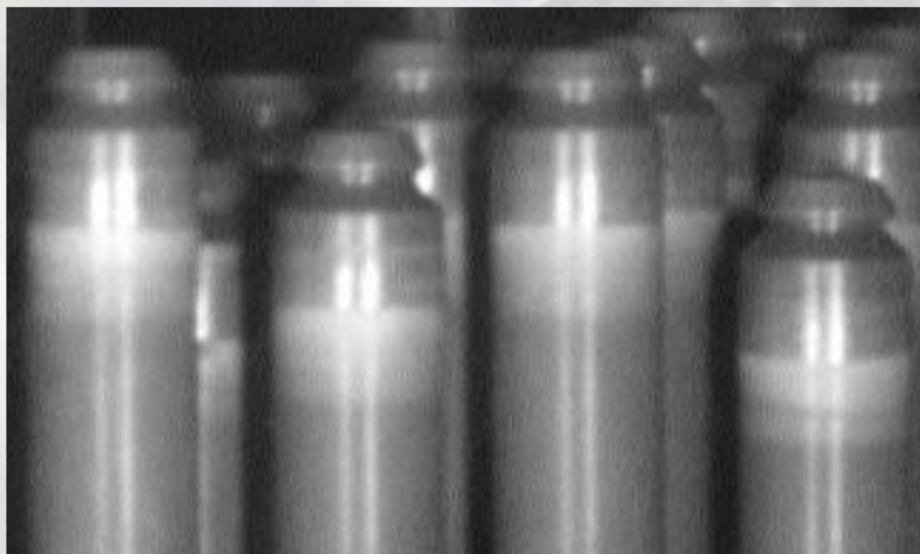
- The weld joints of the fuel rod top and bottom end plugs were uniformly light-grey.
- Some fuel rods, however, were observed to have cladding dimness in the weld joint area of the top/bottom end plug.

*Weld Joints of Top End Plugs after 4 cycles*

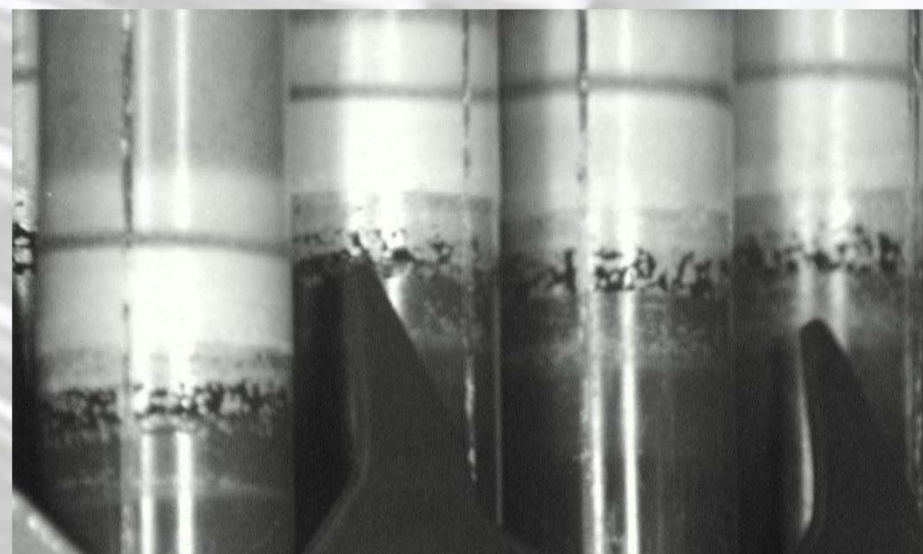
*Weld Joints of Bottom End Plugs*

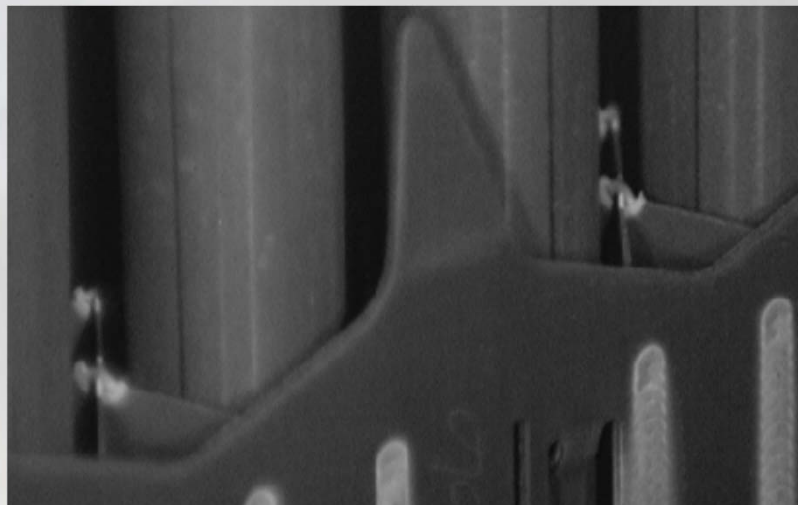
*Zr1%Nb Grid 14 Weld Joints after 2 cycles*

During visual inspection were not observed any visible defects such as corrosion plaques, pittings or cracks in the area of weld joints.

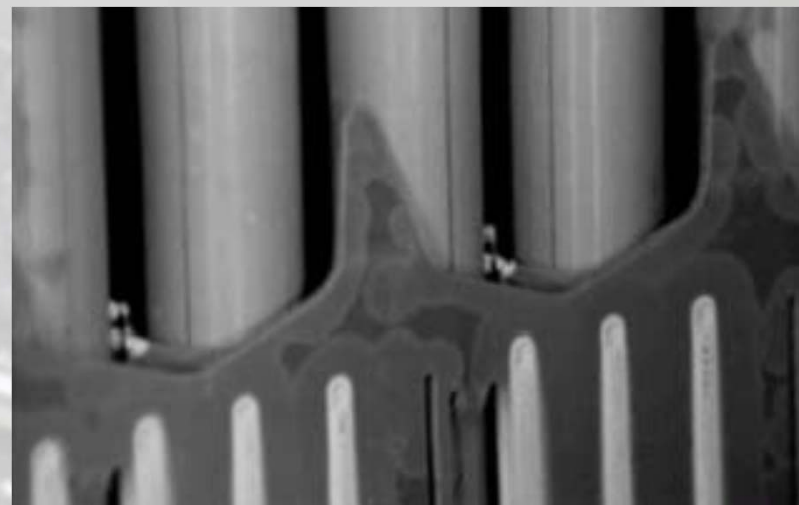
*Zr1%Nb Grid 14 Weld Joints after 3 cycles*

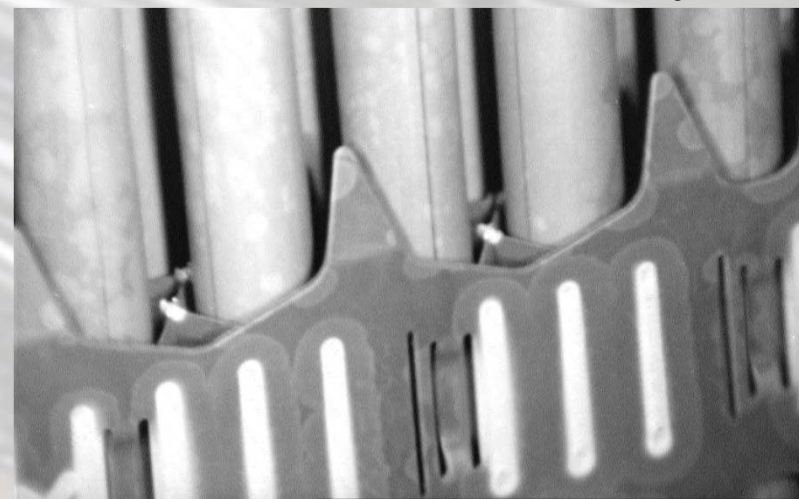
It gives the opportunity to state that this type of weld joint is operational in WWER-1000 conditions.

*Zr1%Nb Grid 14 Weld Joints after 4 cycles*

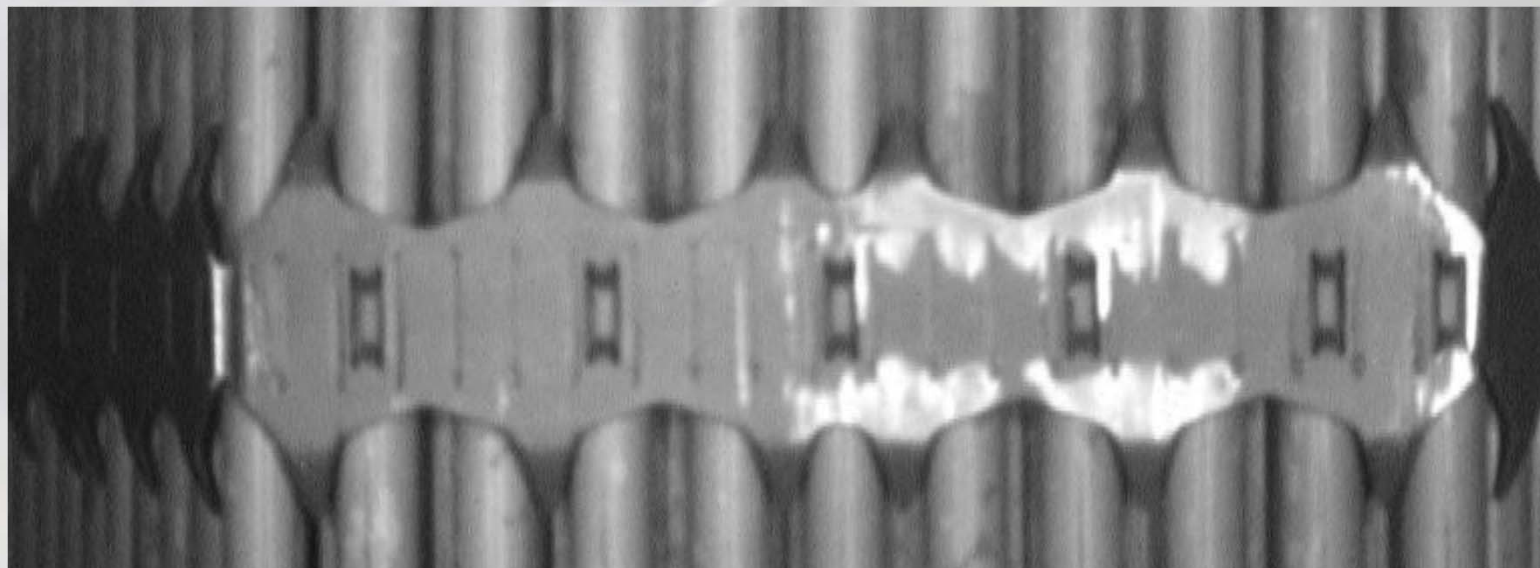
Some grids on WLTAs had burnishes resulting from friction against the adjacent FAs during FA installation into and withdrawal from the core.

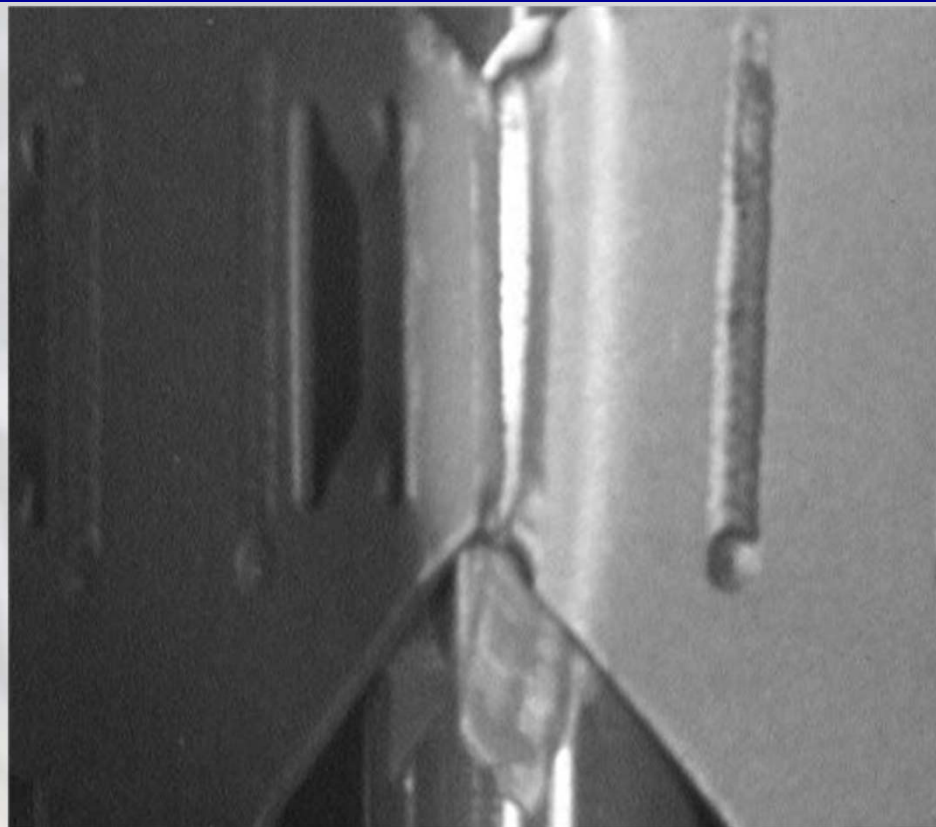
The bottom end plug of the corner rod between WLTA AA02-03 Faces 4 and 5 showed marks visually resembling wear signs or a foreign particle

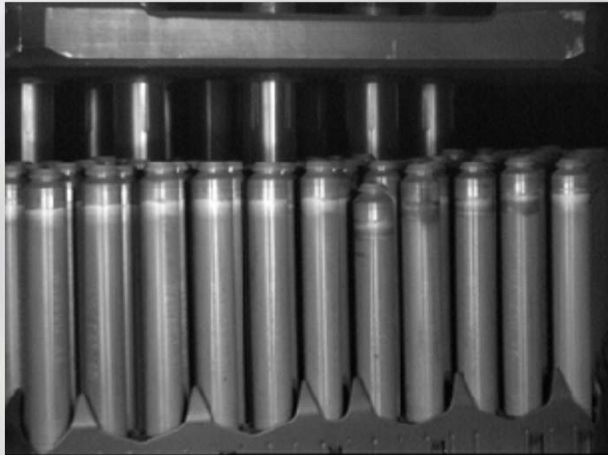
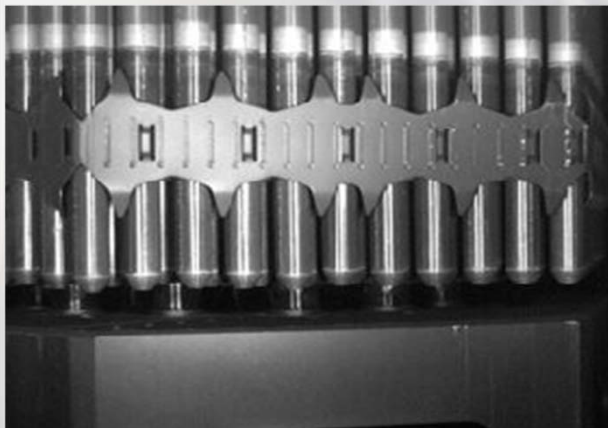
*inspection 2007*

- Fuel rod displacement resulted in making contact between some bottom end plugs and the bottom nozzle plate. No fuel rod was observed, however, to have been displaced towards immediate proximity with the WLTA top nozzle.
- Fuel rod downward displacement until making contact between the bottom end plugs and the WLTA bottom nozzle is a design feature and does not adversely affect nuclear, mechanical, and thermal hydraulic core parameters and does not result in violation of fuel rod and FA operability criteria.

Visual inspection: Fuel Rod Displacement, WLTA AA02-03, Face 4<sup>16</sup>
