Blister Defect Analysis of U_3Si_2/Al Nuclear Fuel Cladding by Ultrasonic Test

Helmi Fauzi Rahmatullah, Mohammed Fauzi, Roziq Himawan, and Setia Permana

Center for Nuclear Fuel Technology (BATAN), Banten, Indonesia

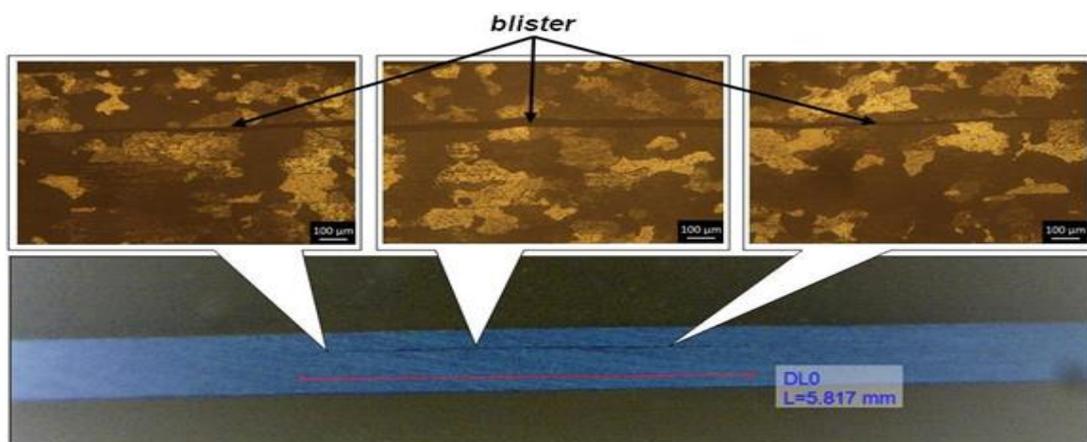
Figure 24: Microstructure blister defect from U_3Si_2/Al Nuclear Fuel Cladding
