The Pool-Side Inspection of Post-Irradiation Fuel Assembly in QINSHAN NPP

S. Wang^a

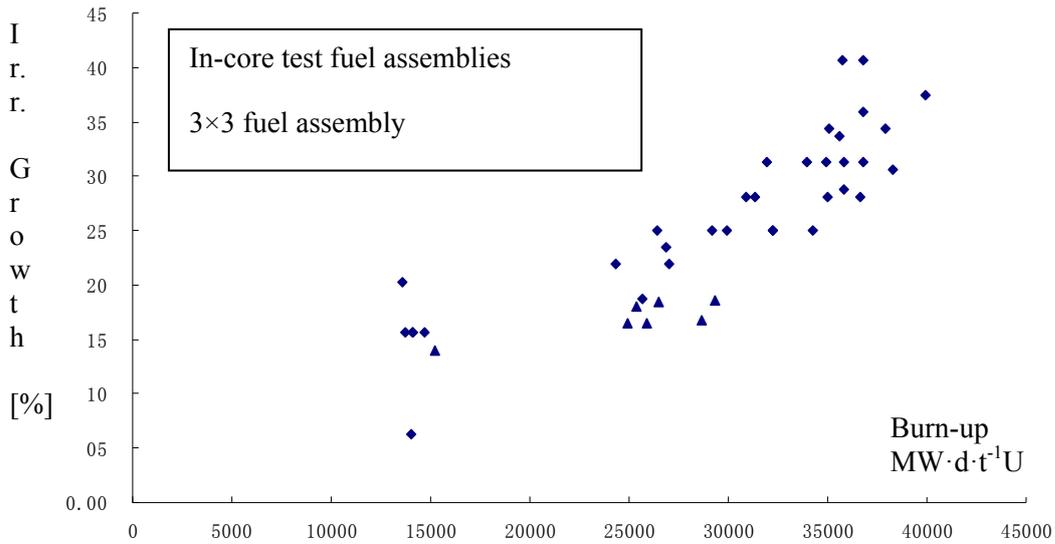
Irradiative growth: no irradiative growth of FAs is occurring. Nevertheless irradiative growth of fuel rods was observed. The distribution of irradiative growth value versus burn-up is shown in Fig. 2.1. The relevant results of 3×3 FA during the design verification test are also shown in Fig. 2.1.

FIG. 2.1. Irradiative growth effects in fuel rods.

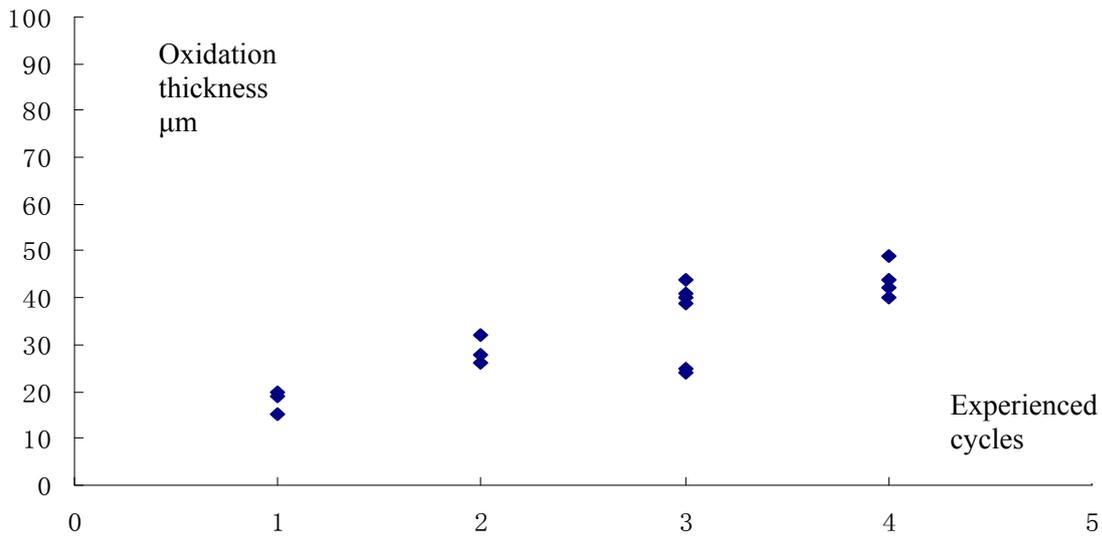
Measurement of oxidation film of rod: Max-thickness of oxidation film is $49 \mu\text{m}$ much lower than the requirements of regulation and guideline [3–4] that corrosion thickness at the end of life should be less than 10% (0.7 mm) of cladding wall. That means the anti-corrosion performance of fuel cladding is sufficient in the range of burn-up test, and the fuel rod is safe.

As shown in Fig. 2.2, it is obvious that the oxidation film thickness of rod is linearity with its endured cycle number. That is corresponding with the results of relevant compute code.

FIG. 2.2. The effect of oxidation film in fuel rod.
