INVESTIGATION OF FAILURE OF HIGH BURN UP CARBIDE FUEL PIN OF FBTR THROUGH POST-IRRADIATION EXAMINATION

ABSTRACT

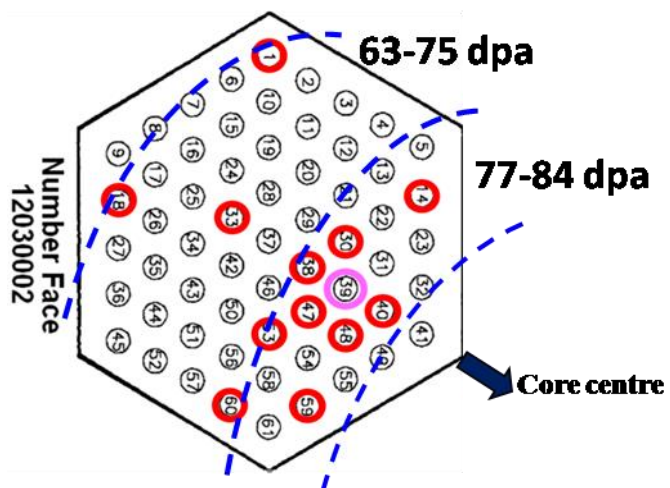
In addition to the failed pin, twelve intact pins were selected for comprehensive examinations based on their proximity to the failed pin and the extent of displacement damage seen by them (Fig. 2). Investigations were planned to assess the condition of the fuel and clad for signatures of impending failure, if any. Non-destructive examination techniques performed to characterise the intact pins and failed pin included neutron radiography, axial gamma scanning, and profilometry. Based on the results obtained, a few fuel pins were selected for further examination through fission gas analysis, metallography, high-temperature tensile testing of cladding and clad swelling measurements. The failed location of the pin was subjected to fractography, metallography and microhardness measurements. The results obtained were compared with that obtained for a Ist ring FSA and another IIIrd ring FSA that had reached a burn-up of 155 GWd/t without failure. The experimental details of the various PIE techniques employed in this study are described elsewhere [3, 4]. The salient results of the investigations are presented in the following section.

Fig 2. Schematic showing the fuel pins selected (encircled) for detailed examinations. Pin 39 is the failed pin location

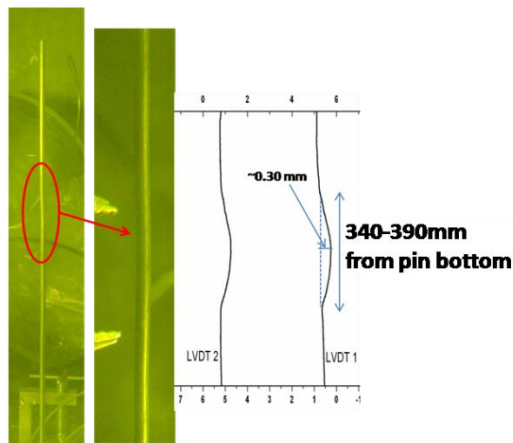
fuel pins of FFSA. It was seen that the increase in length and diameter of the fuel pins of FFSA were in general higher than the pins of FSA_{I ring-155 GWd/t} of similar peak displacement damages. The failed fuel pin and surrounding pins show localised bending at the same axial locations as that of failure (Fig. 3). Fuel pins of higher diametral strains exhibited asymmetrical deformation (in two perpendicular orientations), in addition to bending.

Fig 3. Photograph of typical fuel pin and its LVDT trace showing localized bending

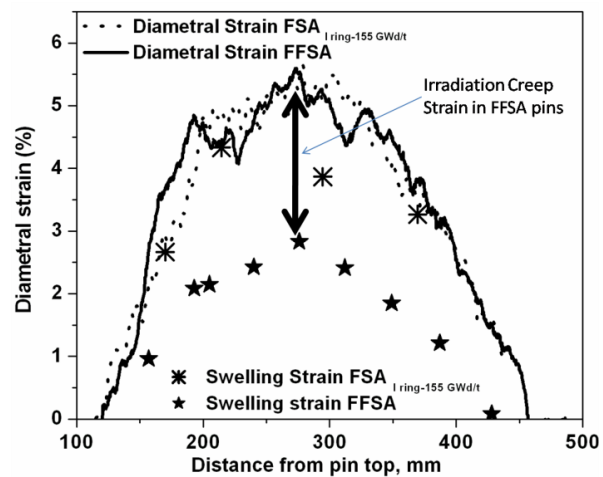
The swelling and creep components of the diametral strain of cladding were decoupled by estimating swelling strain ($\frac{1}{3}\Delta V/V$) from density measurements [5]. For the pins of FFSA, the swelling component was low (Fig. 4) as compared to the pins of FSA_{I ring-155 GWd/t}. The higher creep contribution to the diametral strain suggests high clad stresses due to Fuel Clad Mechanical Interaction (FCMI) in the pins of FFSA.

Fig 4. Relative contribution of swelling and irradiation creep components to the total diametral strain

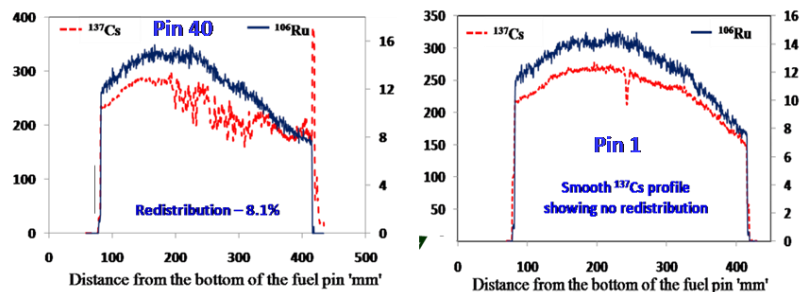
Extensive perturbation in the profile of Cesium isotope (^{137}Cs) at axial locations starting near the peak power location was observed in the failed pin. Similar perturbations in Cs profile was observed in fuel pins adjacent to the failed pin while fuel pins located away from the failed pin did not indicate any such perturbations (Fig. 5). The extent of migration and redistribution was severe in fuel pins surrounding the failed fuel pin pointing to the possibility of higher fuel temperatures in the fuel pins in the region of failure.

Fig 5. Axial distribution of ^{137}Cs and ^{106}Ru for fuels pins around the failed pin (refer Fig. 2 for location of the pins indicated)

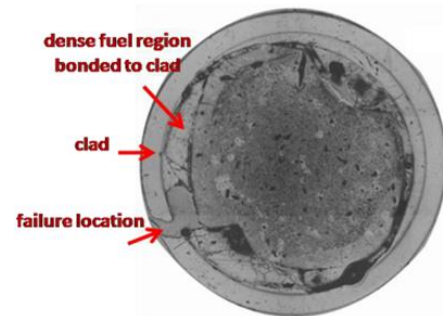
The optical micrographs at the failed location revealed fuel adhering to the clad and the fuel between the circumferential crack and the clad inner diameter is seen to be highly densified. The photomicrographs at the peak power and top locations of the fuel column of the failed and adjacent intact pins show an asymmetric circumferential crack pattern indicative of non-uniform temperature around the pin (Fig. 6).

Fig. 6 Photomicrograph of the cross-sections of bottom end of failure location (240 mm from top)

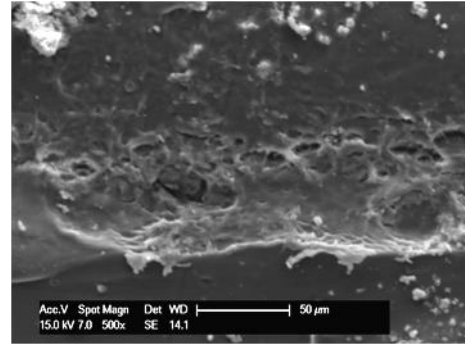
The microhardness measurements of the cladding at locations of failure and other axial locations did not reveal any indications of clad carburization, consistent with clad microstructure. The fractographic analysis of the failed region of the clad carried out using SEM indicated mixed mode of fracture showing both brittle and ductile features in the failure region (Fig. 7).

Fig. 7 SEM images of replica showing the ductile and brittle features of the failed fuel pin fracture surface indicating mixed mode failure
