## Failure Analysis on AFA 3G Gd Rod from Nuclear Power Plant

*China Institute of Atomic Energy, Beijing, China*

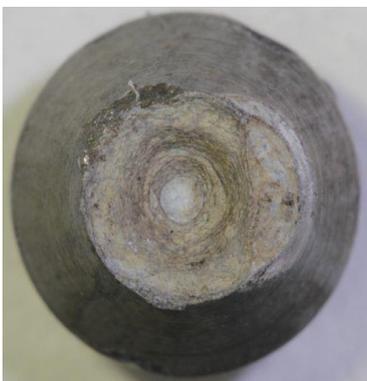
The high resolution visual inspection confirmed two failure on the rod, one was the hole welding, and the other one was lower plug welding, show as Figures 21 and 22, respectively. The whole hole welding part was missing, and there was a “H-type” cracking at the lower plug welding.

Figure 21: Hole welding failure

Due to the visual inspection result and the hydrogen content measurement, the failure at lower plug welding was a secondary failure, and the upper failure was primary. The failure root cause of Gd rod was hole welding defect.

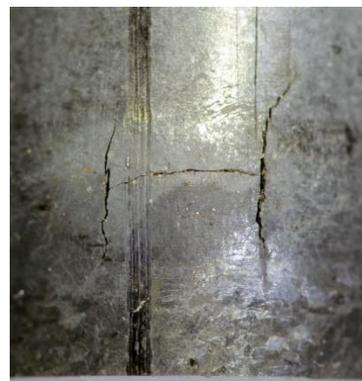
Figure 22: Lower plug welding failure

Hydrogen content analysis showed that the hydrogen content at the position of lower plug welding was 1720 µg/g, while that was only 133 µg/g at the position nearby the upper plug hole welding, the result showed at Table 1.
