Destructive Examination of Experimental CANDU Type Nuclear Fuel Tested in TRIGA Reactor

Institute for Nuclear Research – RATEN - ICN
Pitești, Romania - <madalin.savu@nuclear.ro>

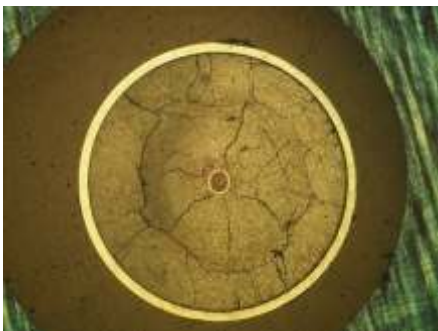
Figure 1. Experimental fuel instrumented with thermocouple

The sample longitudinal and cross-section macrographs (figure 1 and figure 5) show connected radial and circular fissures which are normal for CANDU UO_2 pellets and the cladding (figure 4) does not present nonconformities, having a uniform thickness.

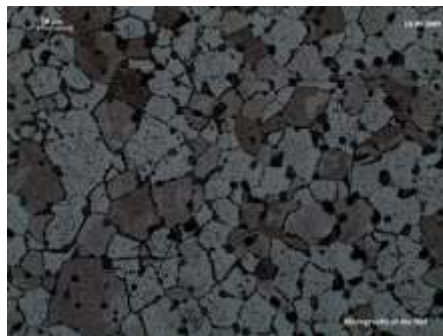
Figure 2. Fuel grains aspect in the middle of the pellet

The pellet microstructure was analyzed using a magnification of 200x. The examination showed that the fuel pellet consists of unaffected grains and equiaxed grains. (figure 2)

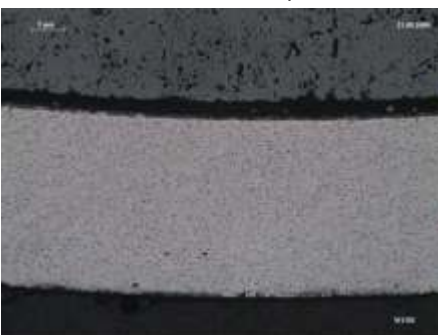
Figure 3. Cladding aspect of the fuel

Hydride precipitates dimension and orientation were analyzed using 500x magnification and no major precipitates were observed (figure 3), which represent the expected result due to the short irradiation time.

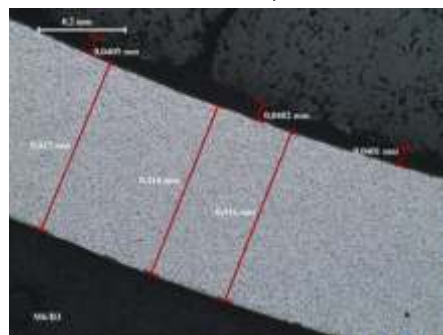
Figure 4. Cladding and gap thickness measurement

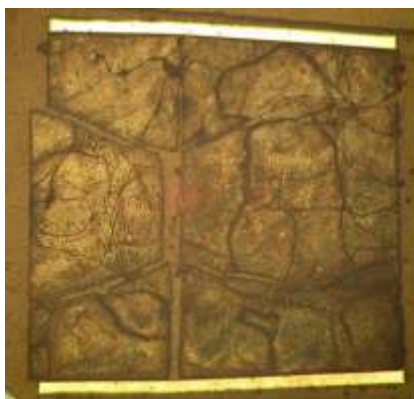
Figure 5. Macrograph of longitudinal cross-section
