Eddy Current Detection of Cladding Defects Due to Fuel Pellet Imperfections

D. Papaioannou^a, R. Nasyrow^b, N. Niagolova^c, V.V. Rondinella^d, W. Goll^e

Abstract. An eddy current device has been used to localise cladding defects on irradiated fuel rods. The system has been initially tested with cold specimens, providing very good results and is now in regular operation in a hot cell at the Institute for Transuranium Elements (ITU). In this paper we demonstrate the system's performance and present recent results on a series of irradiated fuel rods with PCI-failures and partly long splits (secondary failures). The rods were delivered in tight capsules and only gamma scans could be done in the β -, γ -reception cell. Big defects were well visible through distortions in the gamma profile, whereas the smaller ones were very hardly detectable. They could be precisely localised later on, as soon as we cut the fuel rod and examined the individual segments with the eddy current device in an α -cell. Careful sampling around the defect location, specimen preparation and detailed microscopic analysis confirmed cladding cracks driven by fuel pellet imperfections or, more specifically, by miss

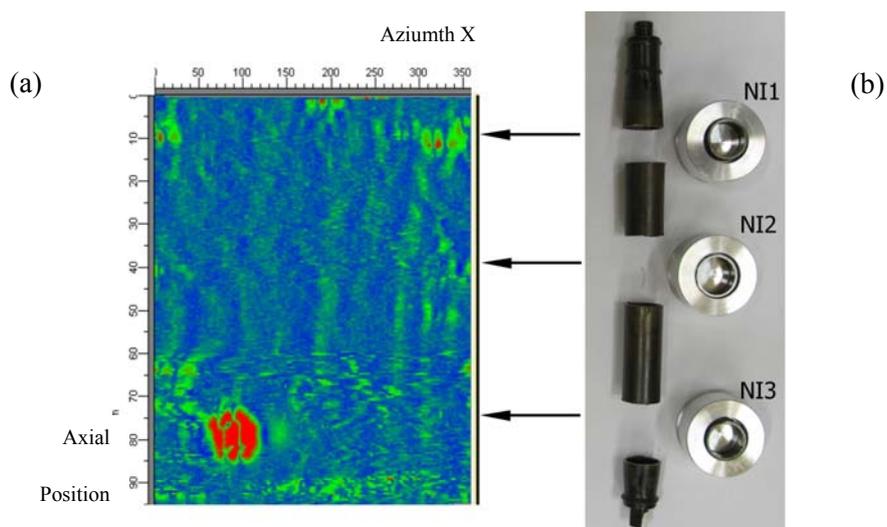
FIG. 2.2. (a). Eddy current hologram of a non-irradiated creep test cladding specimen (b). The green colour on the hologram represents small, and the red colour bigger defects.

The hologram in Fig. 2.2 has been recorded on the surface of a cladding tube after creep test. In this graph the X-abcissa-axis gives the azimuth and the Y-ordinate-axis the axial position of the sensor. The colour variation from the blue background (corresponding to surface level) denotes presence of small (green colour) or bigger (red colour) cladding defects. In order to confirm this, three small pieces of the tube specimen were cut at the positions of interest, embedded in proper holders, polished and observed with an optical microscope (Fig. 2.2(b)). In all cases the observed defects are in very good agreement with the hologram result.

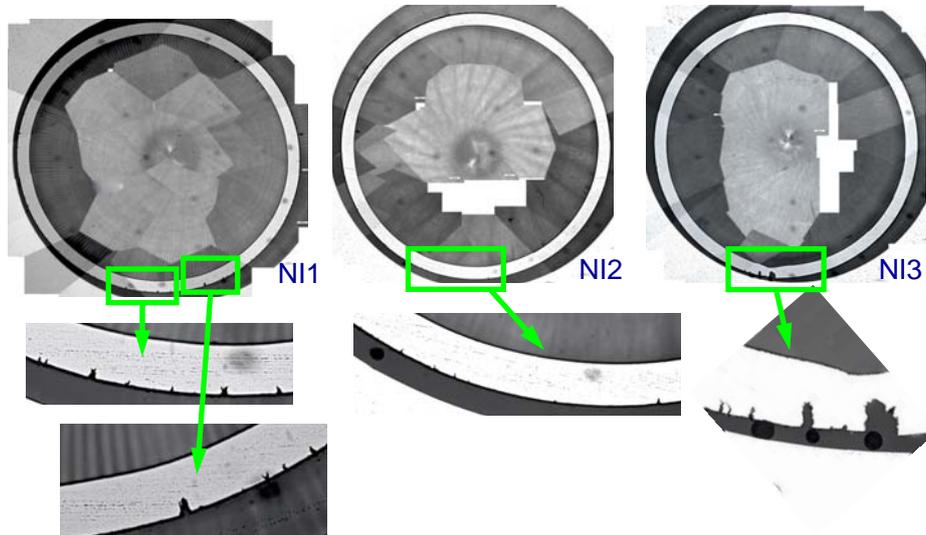
FIG. 2.3. Macrographs and detailed cladding photographs of the cross sections of the three specimens cut as shown in Fig. 2.2.

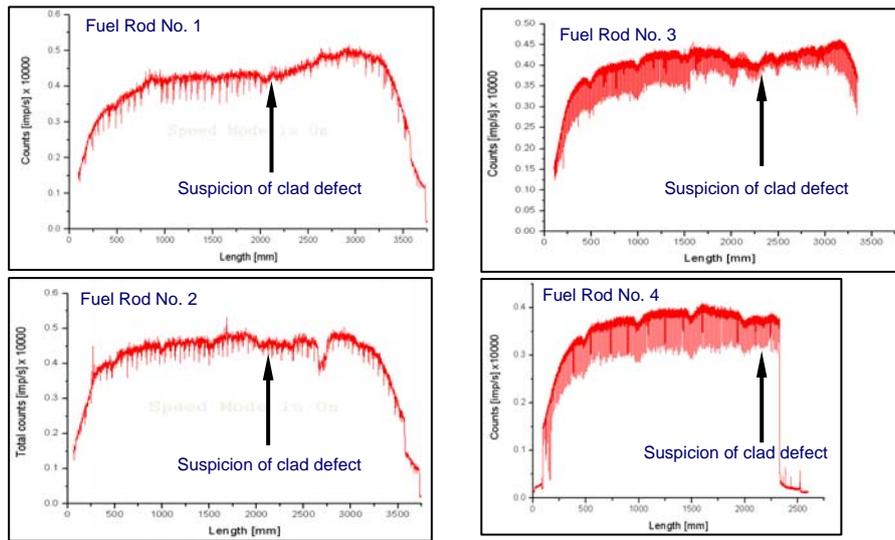
The obtained spectra, shown in Fig. 3.1, did not provide unequivocal information about the suspected positions of cladding failures. The fuel rods were then cut in 480 mm long segments and the segment eddy current device was used to identify and precisely localise the defects. The obtained EC-hologram around the interesting rod axial region helped successfully to identify and localise the cladding defect, as can be seen in Fig. 3.2.

FIG. 3.1 The γ -spectra of the 4 irradiated fuel rods; the suspected position of cladding defects are indicated.

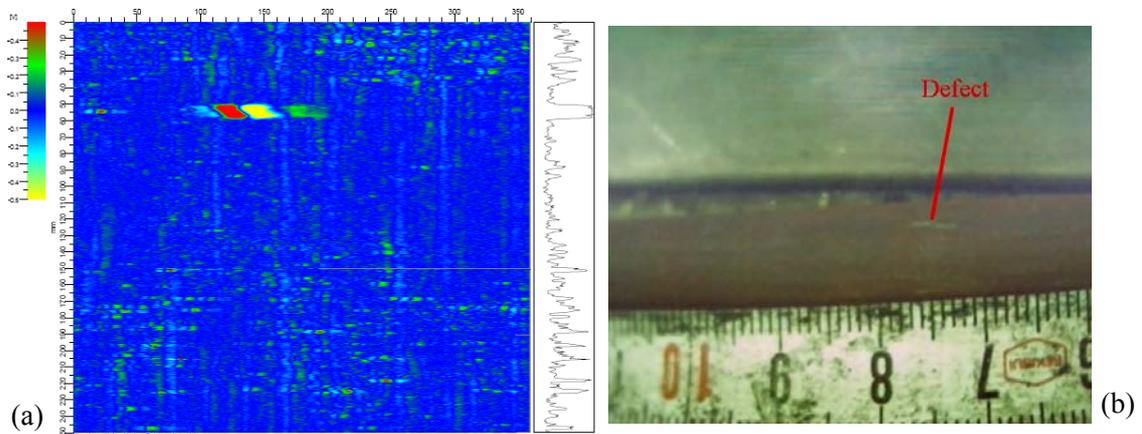
FIG. 3.2. The EC-hologram (a) and the cladding defect visually identified (b).

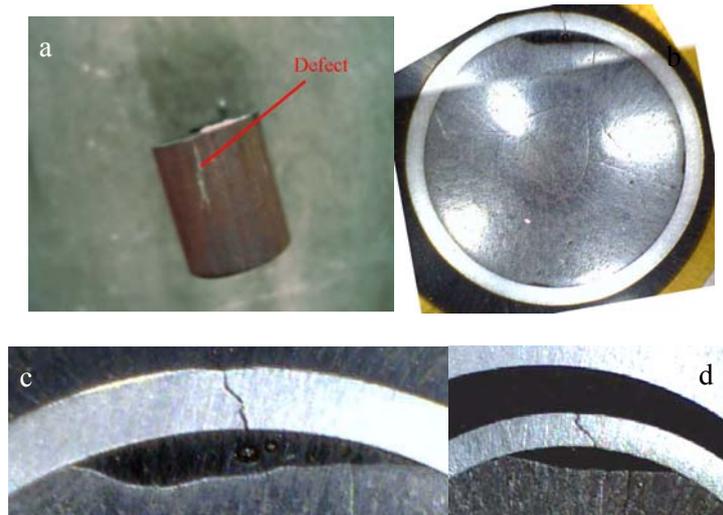
The assumption of the power plant experts was that the defects could be due to pellet imperfections, such as missing chips from the pellet edge, usually called MPS [1,2]. In such a case, stress-corrosion cracking caused by iodine (ZrI_4 is brittle) can take place in the cladding.

It was expected therefore that the tips of the initiating cladding defects in the delivered fuel rods would be close to a pellet-pellet interface. For this purpose, cuts were implemented just before the corresponding pellet of interest, whose position had been located by finding a dishing position at the beginning of the segment and counting the pellets up to the desired position. Such a cut from fuel rod No. 4, as well as the prepared specimen and photographs of the identified cladding defects are presented in Fig. 3.3, whereas Fig. 3.4 shows photographs of the MPS areas with the cracked cladding from all examined fuel rods.

FIG. 3.3. a) Sections from which the metallographic sample was prepared; b) Overview of the metallographic sample with the MPS defect; c) Close up of the defect area at the beginning of the fuel pellet; d) Defect area at an axial location ca. 0.8 deeper (after grinding) than in c.

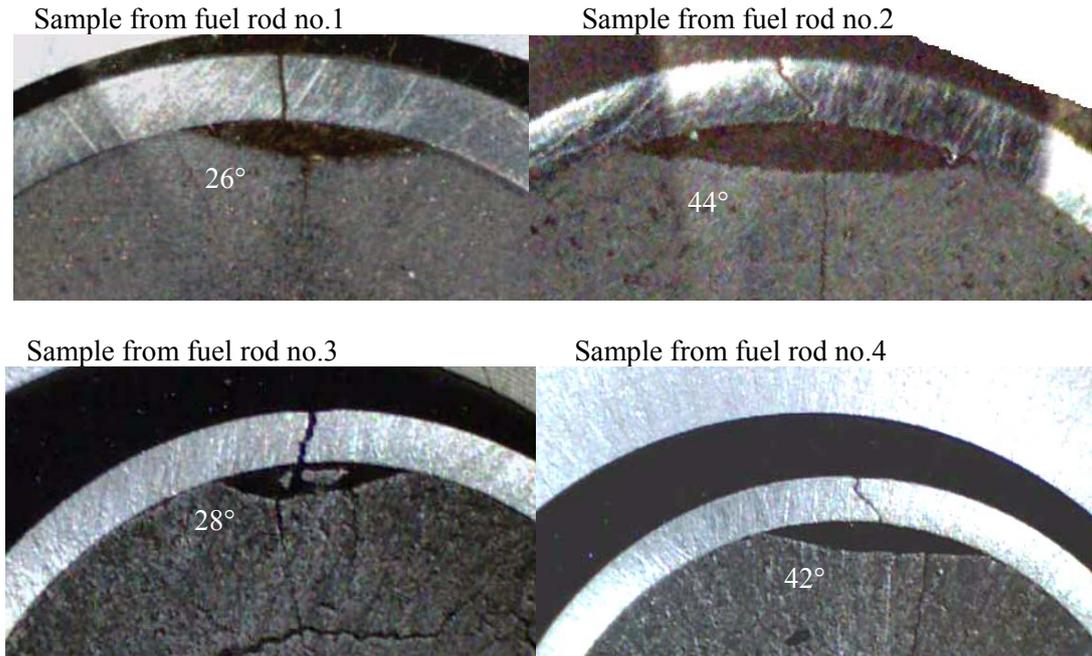
FIG. 3.4. Photographs of all confirmed MPS and corresponding cladding defects in the four rods analysed.

Using a small EC device assembled and installed at ITU, cladding material defects due to pellet imperfections (MPS) could be successfully identified and precisely localised. MPS areas are endangering the cladding integrity because of the local strains that can be generated in these areas. The holograms of the data obtained on a series of spent fuel rods confirmed the expectations of clad failures and permitted the preparation of exact and proper specimens to study cladding crack growth and MPS meniscus sizes.
