Pool-Side Inspection of Post-Irradiation Fuel Assembly in QINSHAN NPP

2011.5

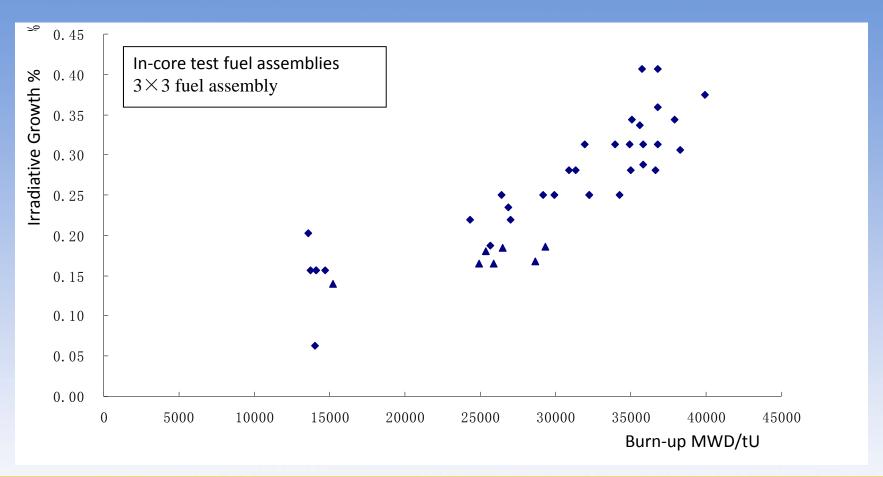
Irradiative Growth

- No irradiative growth of FAs is occurring.
- Nevertheless irradiative growth of fuel rod is observed.
- The distribution of irradiative growth value versus burn-up is shown as follows.
- The relevant results of 3×3 FAs during the design verification test are also shown.

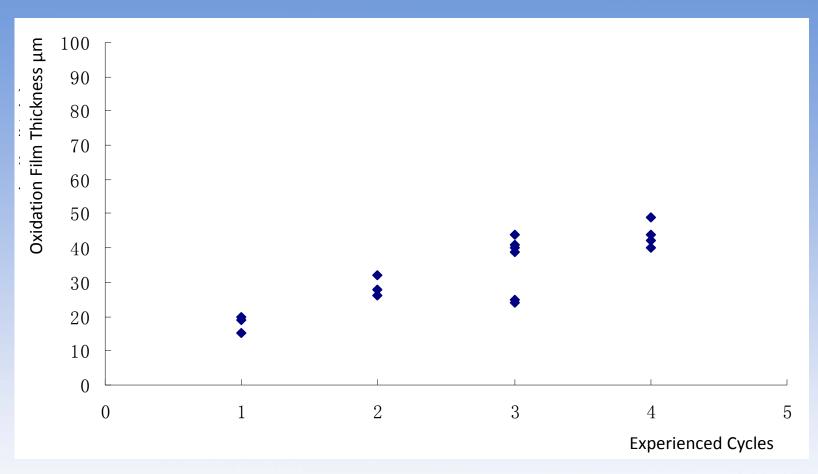
Thickness of Oxidation Film

- Max-thickness of oxidation film is 49µm much lower than the requirement of regulation and guideline that corrosion thickness at the end of life should less than 10% (0.7mm) of cladding wall.
- That means the anti-corrosion performance of fuel cladding is sufficient in the range of burn-up test, and the fuel rod is safe.
