# **Post Irradiation Examination of Thoria-Plutonia Mixed Oxide Fuel in Indian Hot Cells**

Post Irradiation Examination Division  
Nuclear Fuels Group  
Bhabha Atomic Research Centre  
Trombay, Mumbai, India

# AC-6 Cluster

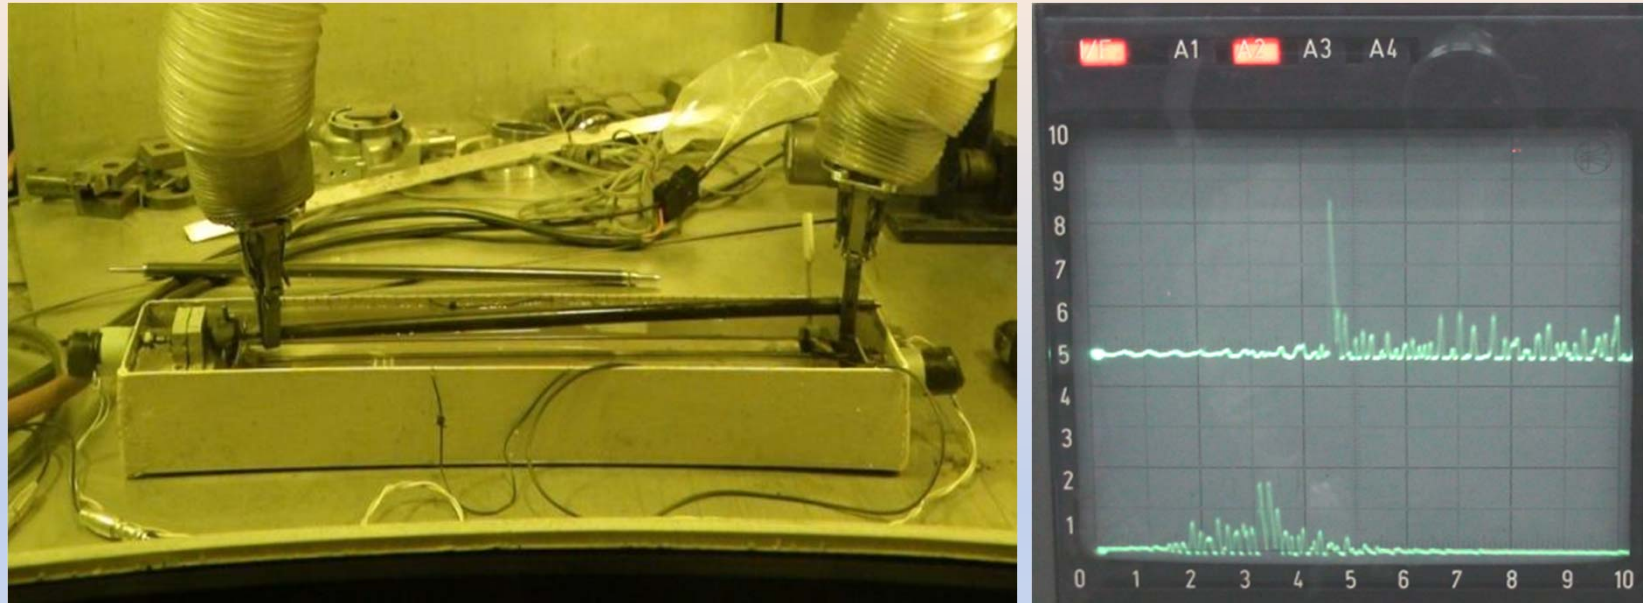
Surface roughness signals are seen, defect signal difficult to discern.

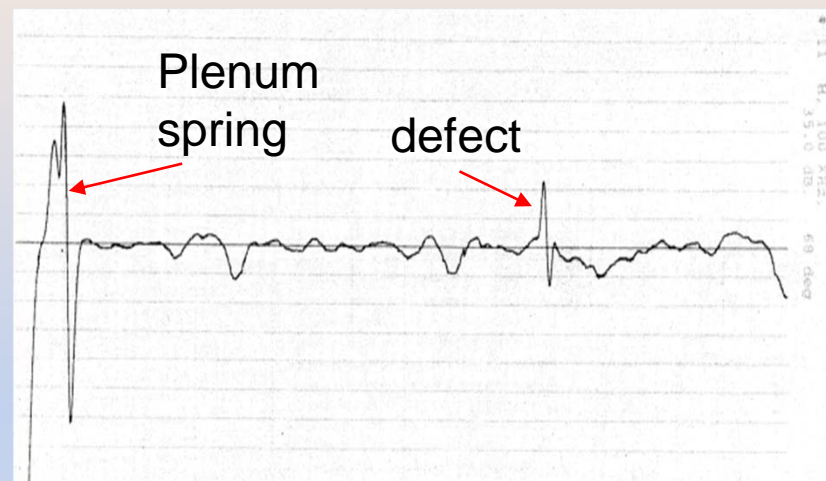
Length of the fuel pin TH-2

Eddy current signal

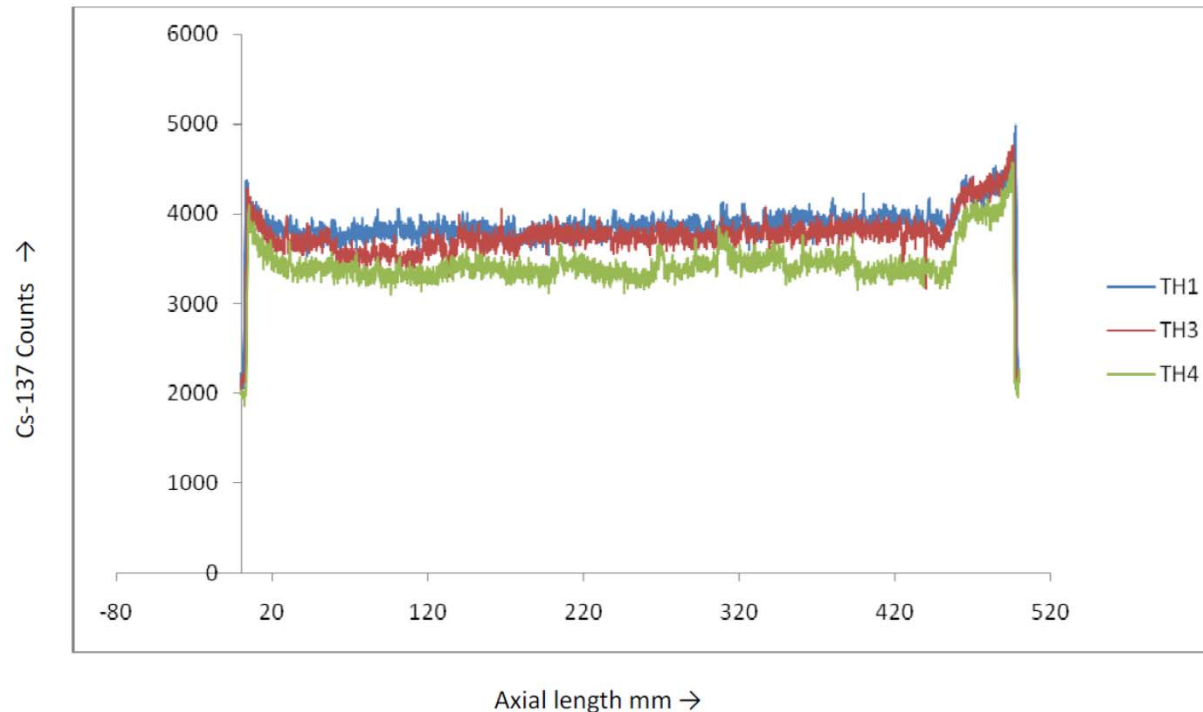
The scans showed higher counts of Cs-137 near the top and bottom portion of the elements. This can be attributed to the fact that some caesium might have migrated in these regions which are relatively cooler. The scans showed nearly flat response along the rest of the elements.

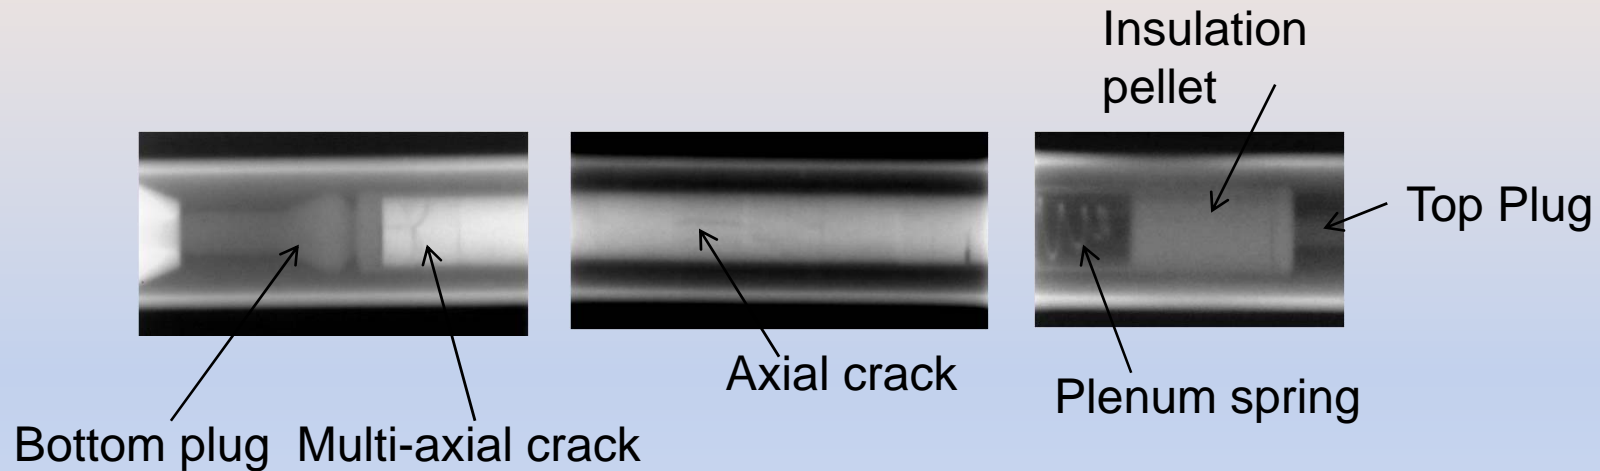
AC-6 cluster, Pin Th-4

**No abnormality was found in the appendages**

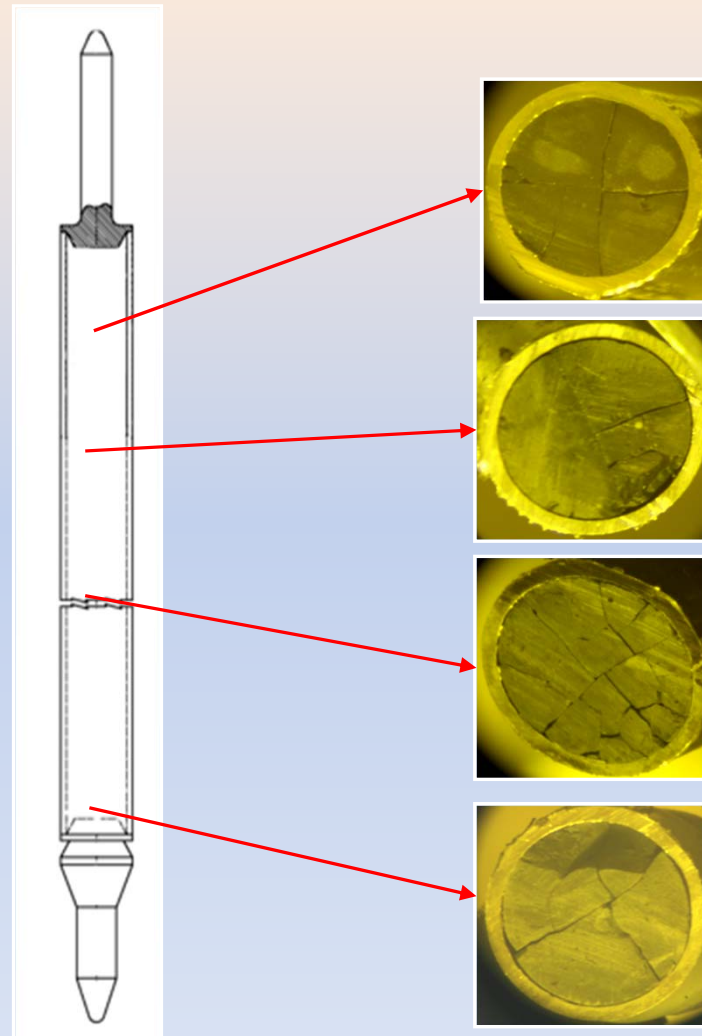
**Periscopic view of the cut surfaces of the fuel pin, TH-5 at different axial locations, cracks also seen in Neutron Radiograph**

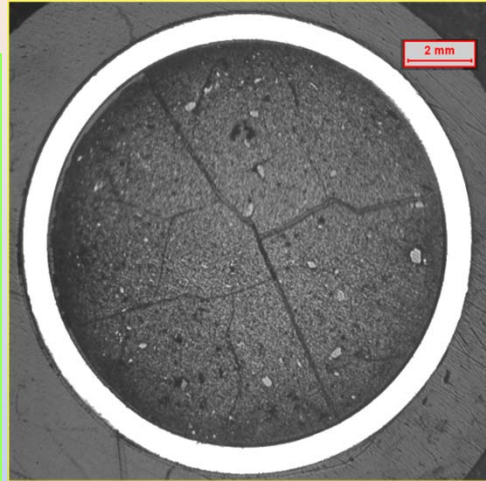
**Section at  
285 mm  
from the  
top end  
plug weld**

**Photomacrograph**

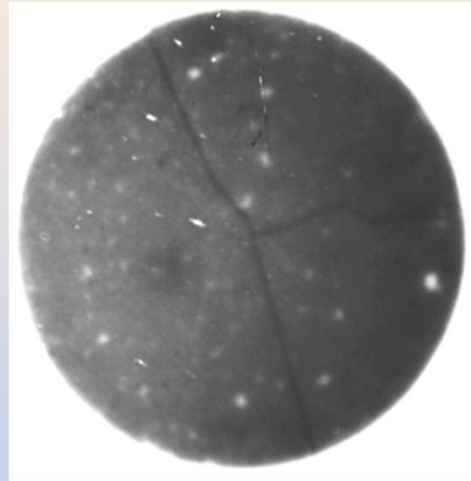
**β-γ autoradiograph**

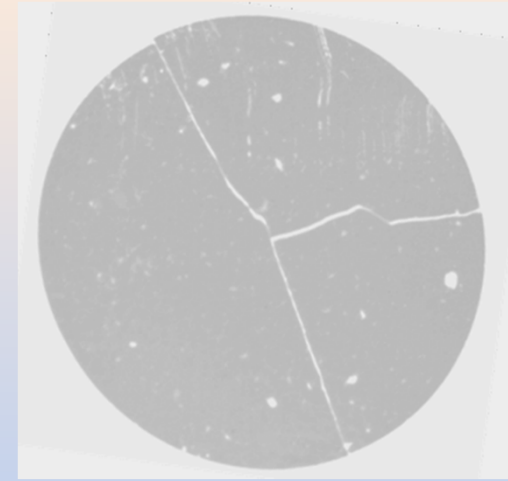
**α-autoradiograph**

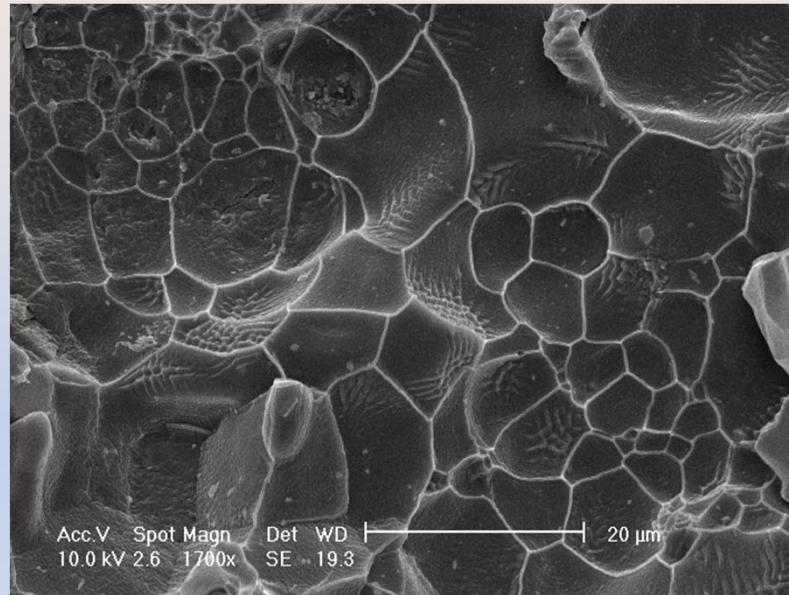
**Combination of small & large grains**

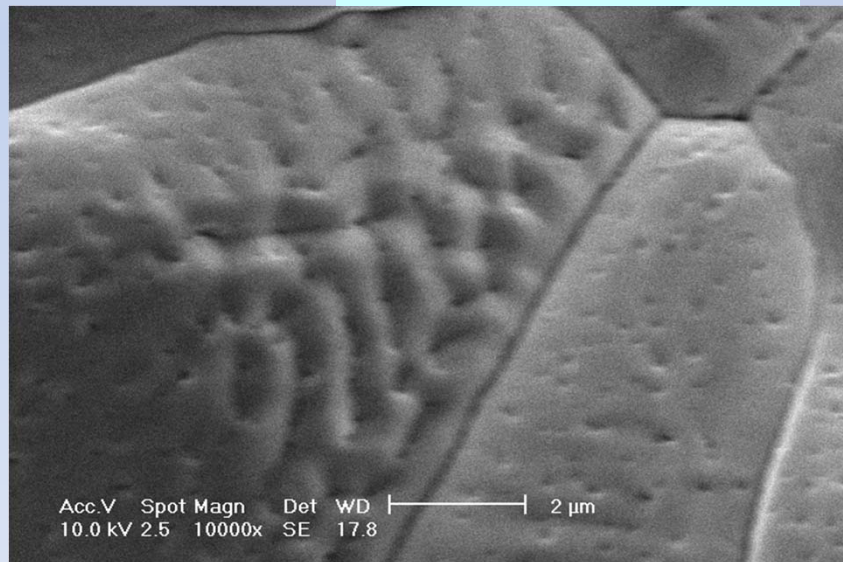
**Fission gas bubbles on fuel grain faces**

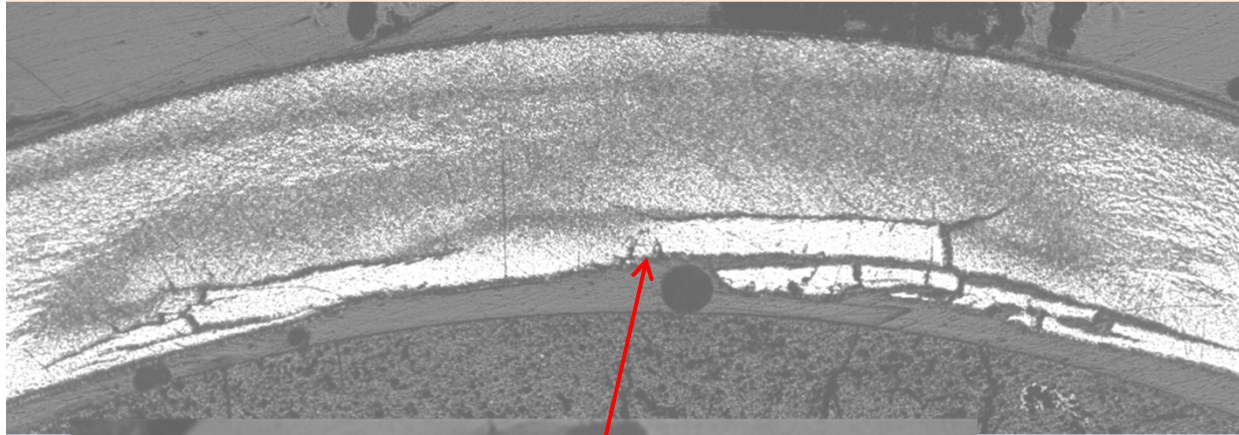
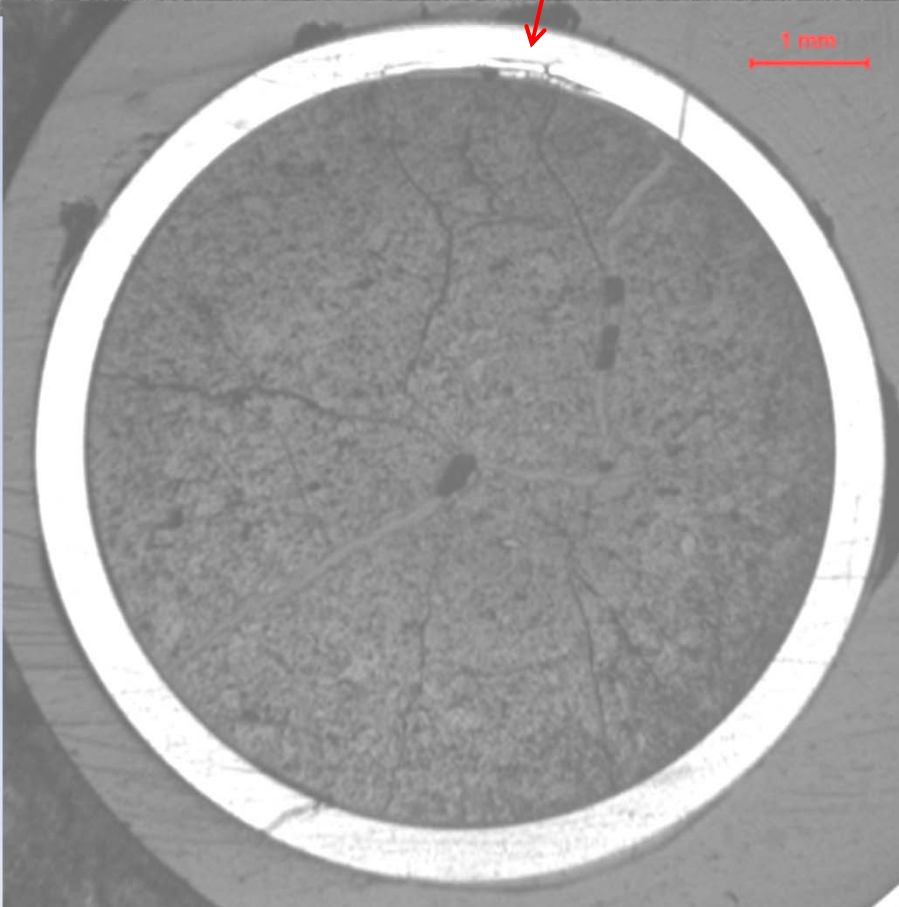
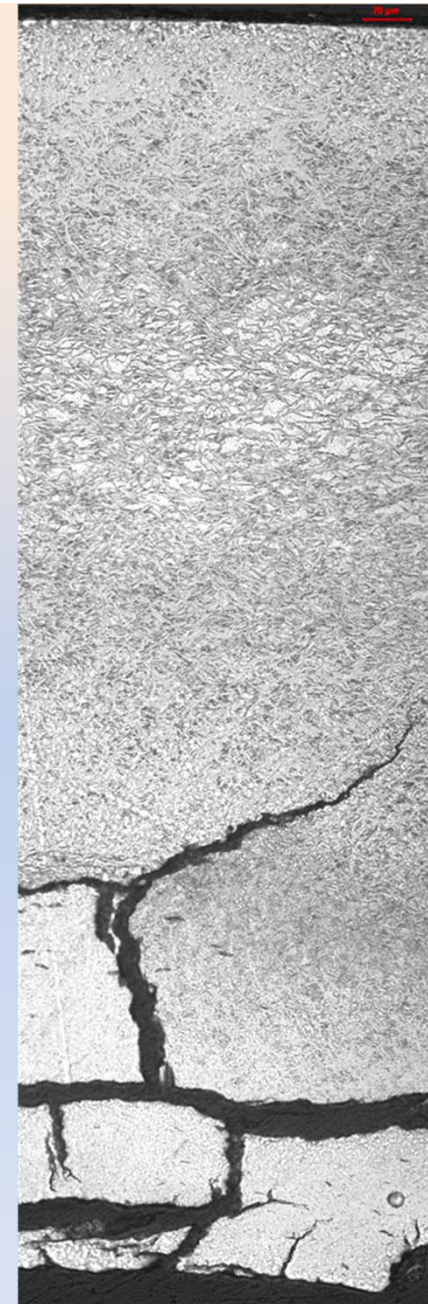
## ECT marked region metallography on Fuel Pin TH-2

Cracked  
hydride blister  
due to internal  
moisture

- Pin TH-2 had failed during due to internal hydriding.
- Pin TH-1 and TH-3 have been qualified by non destructive examinations for further irradiation.
  - Presence of radial cracks in the fuel
  - Visible grain growth or columnar grain formation were absent
  - The grain size and grain morphology was similar to that of the as-fabricated fuel; average grain size of 14  $\mu\text{m}$
  - Non uniform grain size with a few grains up to 30  $\mu\text{m}$  and at some locations clusters of fine grains of 2-3  $\mu\text{m}$
  - Bimodal grain size distribution in some regions of the fuel
  - Reduction in porosity in the central portion of the fuel
  - Appearance of submicron size fission gas bubbles on the fuel grain surfaces in the central region and evidence of inter-linking of bubbles
  - Almost uniform distribution of Pu activity in the fuel section
