Non-destructive examination on the spent fuel rods

Abstract: In order to investigate the behavior of PWR fuel rods, eight fuel rods removed from 3 assemblies of Qinshan nuclear power plant (QNPP) were examined at the hot cell facility of China Institute of Atomic Energy (CIAE) in Beijing. The maximum burnup was about 40 GWd/tU. This paper presents the results of non-destructive examination. The results included: 1) Status of cladding surface, 2) cladding integrity, 3) distribution of oxide film on the outer surface of claddings, 4) dimensional change on axial and circumferential, 5) distribution of fission products in the fuel column, 6) defects, uniformity and structural integrity of the fuel and cladding. The obtained data can be used to evaluate the fuel performance after irradiation.

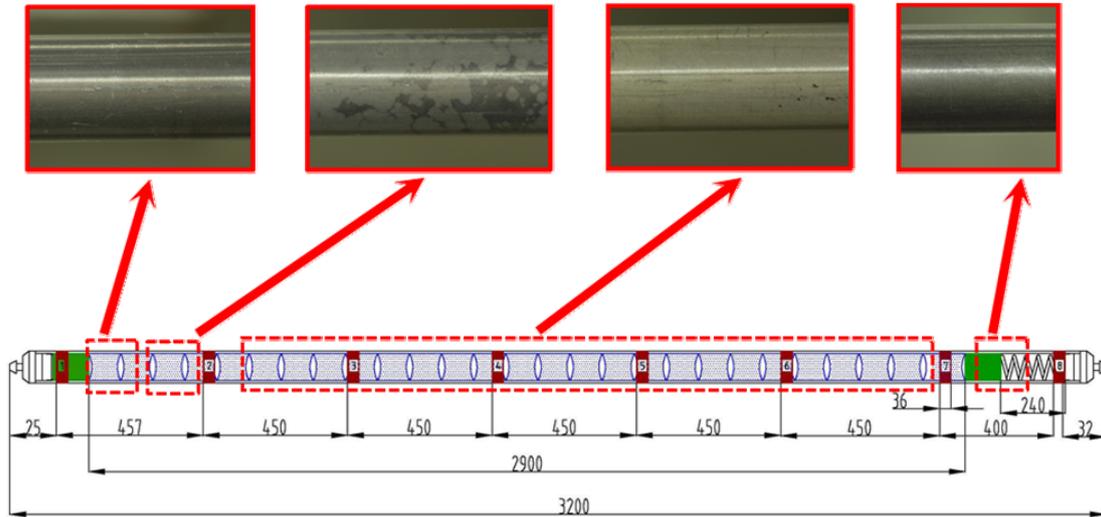
Fig. 2 Typical appearance of fuel rod

At the lower part from 1st to 2nd grid, the appearance was lustrous black at the very start and gradually to the mottled. At the center part from 2nd to 7th grid, the color was changed into gray continuously. The upper part of the fuel rod was transformed into black. The typical appearance of fuel rod is shown in Fig. 2.

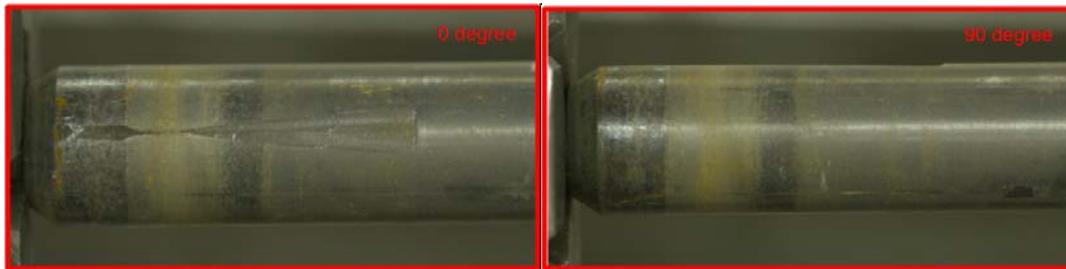
Fig. 3 Fretting Mark for YQ-005U-N04 fuel rod

visual examination to all eight fuel rods. Especially for the fuel rod of YQ-005U-N04, the bottom part had obvious Fretting mark(Fig. 3). No unusual bending and twisting, remarkable corrosion, unusual deformation and defects were observed in visual examination except for YQ-005U-N04.

(1) No unusual bending and twisting, significant corrosion, remarkable deformation and defect were observed in the visual examinations for the fuel rods. The difference in appearance among cladding was not clear from the results of visual examination. Except for YQ-005U-N04 fuel rod, with big fretting mark was observed.

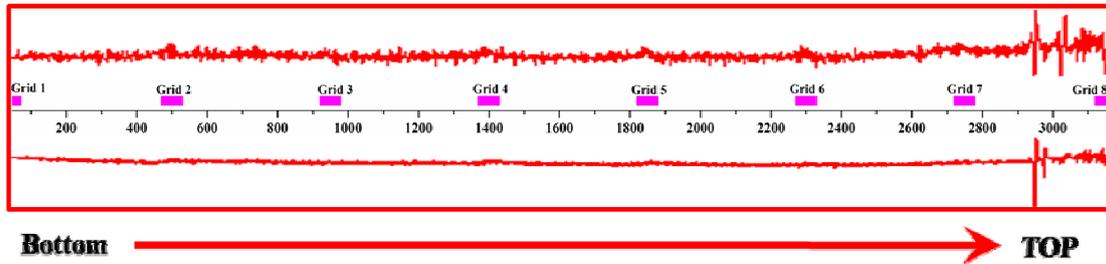
Fig. 4 Typical results of eddy current inspection

Typical measured traces are shown in Fig.4. It was confirmed that the cladding integrity had been maintained during irradiation. No through-wall defects were found, however, several small indications were noted for outside wear marks. It is very obvious for the spacer grid.

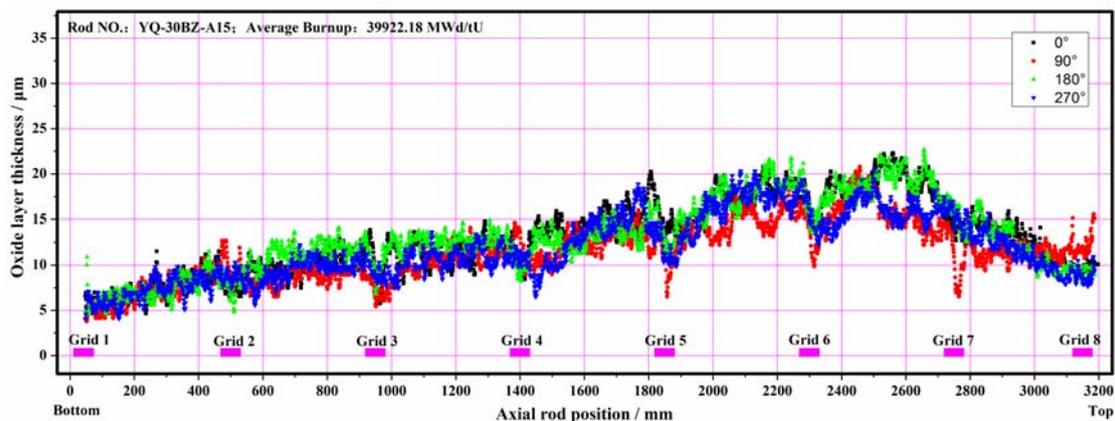
Fig. 5 Typical oxide profiles of rod YQ-30BZ-A15 at four orientations

Typical oxide thickness profiles are shown in Fig. 5. Span-average oxide thickness for these rods is listed in table 2. The profiles show oxide thickness increasing from the bottom to the top of the rod, with reductions occurring in the areas of the intermediate spacer grids. The maximum of oxide film thickness was observed in the region from

the fifth to sixth span, and the axial profile of oxide layer thickness was depressed at seventh span. The maximum value of the oxide thickness was less than 25 μm . The oxide film was thinner in the grid region than in the middle of the span. This phenomenon was caused by two factors [3], first, the spacer grids are made of Inconel-718, which is a neutron absorber and decreases the power. Second, these grids increase the coolant mixing which causes the local cooling of fuel rod surface. However, the oxide thickness profile of two fuel rods from assembly YQ-005U was abnormal. Typical measured traces are shown in Fig. 6. This phenomenon can be explained from the out diameter profiles in section 2.6.

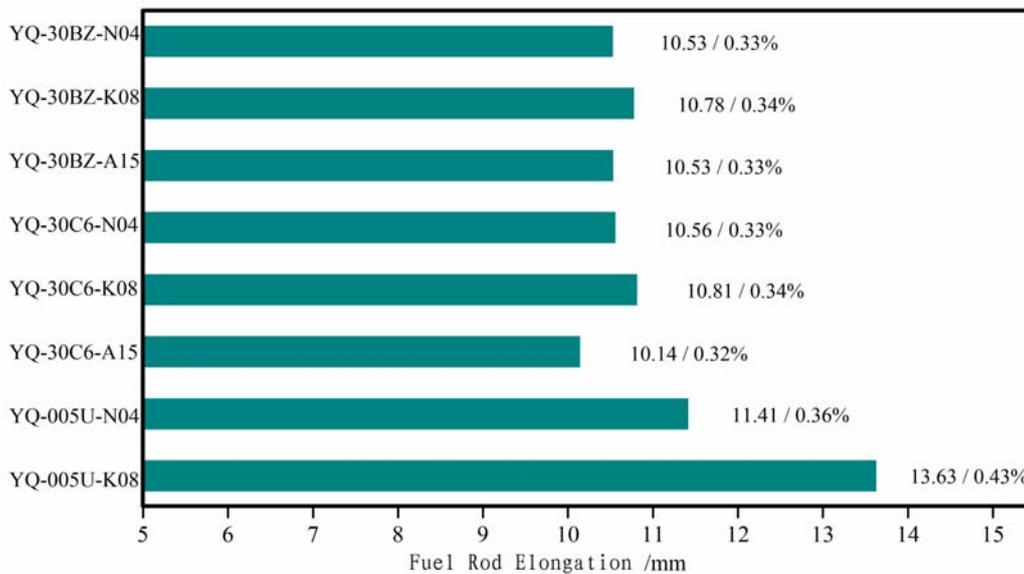
Fig. 7 Chart of eight fuel rods elongation

The total length of eight fuel rods was determined by measuring the difference in elevation between a standard rod of known length and the fuel rod. The estimated uncertainty in the measured growth of the rods is $\pm 0.5\text{mm}$. Elongation data for all fuel rods are shown in Fig. 7. The minimum elongation was 10.14mm (0.32%) and the maximum one was 13.63mm (0.43%). The eight fuel rod elongation was within the range of the design criteria (35mm)^[2]

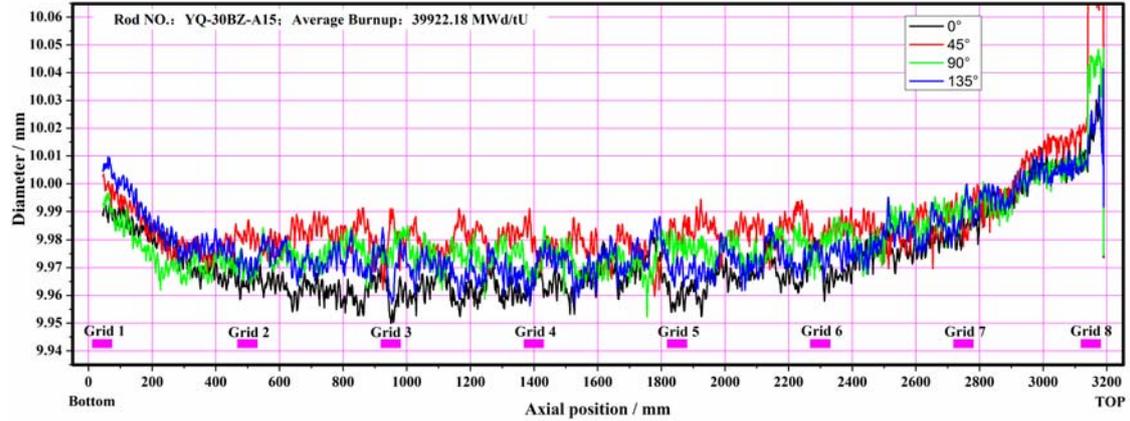
Fig. 7 Distribution of diameter value along fuel rod(YQ-30BZ-A15)

value. The maximum creep down of at the all eight fuel rods was from 51.1 μm to 83.6 μm . The maximum ovality was 28.1 μm ~82.9 μm . Fig. 7 is the distribution of diameter value along fuel rod(YQ-30BZ-A15). Fig. 8 is the diameter diagram for YQ-005U-N04 with maximum creep down and ovality value.

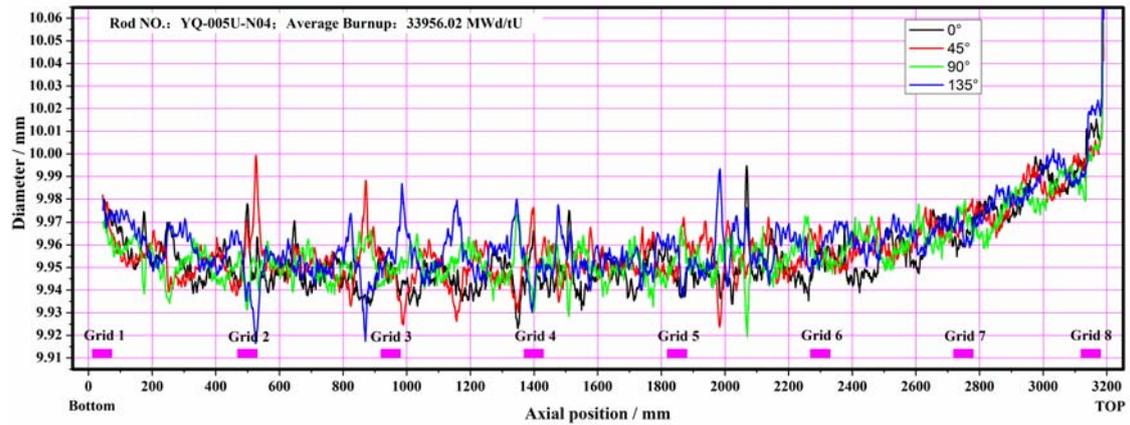
Fig. 8 Distribution of diameter value along fuel rod

(4) The maximum axial elongation of the fuel rod was 0.43% to the as-fabricated, which was within the design criteria. The rod diameter was much decreased in the fuel region in contrast to the gas plenum. Fuel rod of YQ-005U-N04 has the maximum ovality.

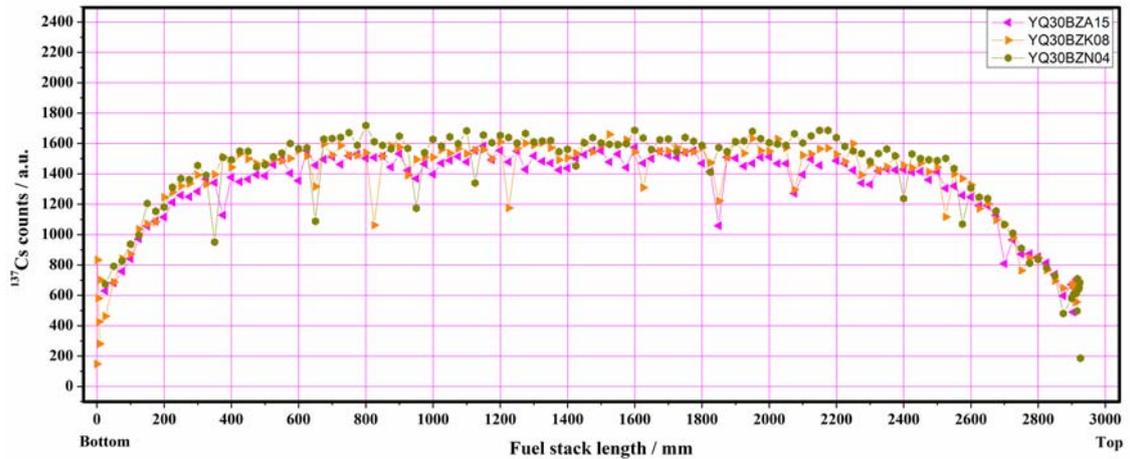
Fig. 9 Typical profiles of gamma-ray intensity

Gamma acquisition along the fuel rod was performed at regular intervals of 25mm, each measurement had the duration of 30s of live time. Typical profiles of gamma-ray intensity are shown in Fig. 9. A prominent depression of count rate at fuel pellet interfaces is observed, which means there is no interaction between the pellets. This gamma activity profile highlights practically a symmetric loading of the fuel rod.

This figure also shows that the axial burnup profile was nearly flat at the center region.
