REPLACEMENT TECHNIQUE FOR FRONT ACRYLIC PANELS OF A LARGE SIZE GLOVE BOX USING BAG-IN / BAG-OUT METHOD

*Department of Hot laboratories and Facilities,
Nuclear Science Research Institute,
Tokai Research and Development Center
Japan Atomic Energy Agency*

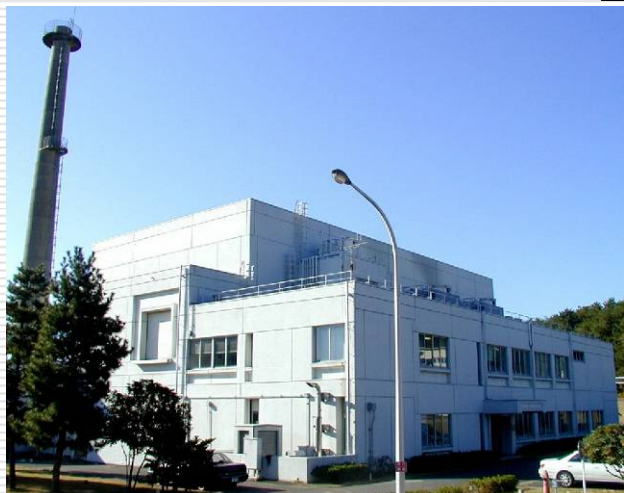
WASTEF : Waste Safety Testing Facility

WASTEF was established in 1982 for examining safety storage and disposal of high-level waste from reprocessing of spent fuel.

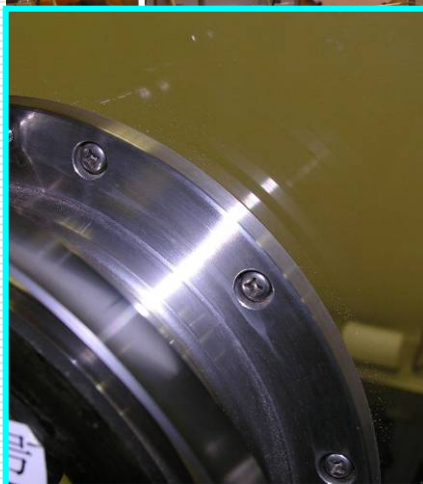
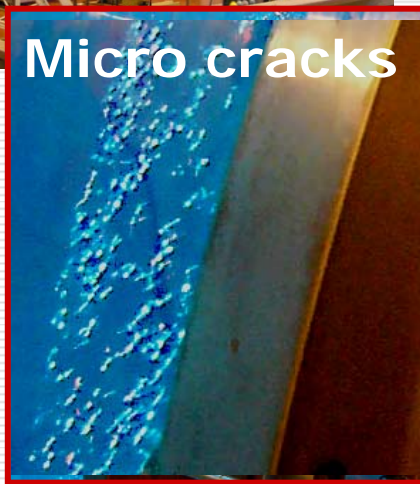
Micro cracks were found in the acrylic panels caused by degradation.

For safety operation

Degraded panels must be replaced by new panels.

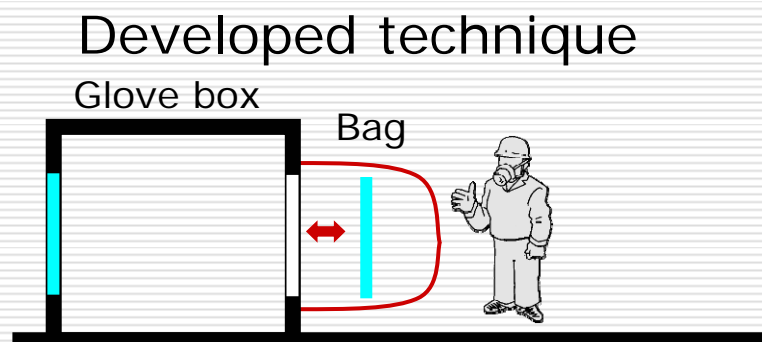
Comparison of replacement technique

Developed	Conventional
Airtight condition	Hold	Break
Decontamination	Degraded panel only	The whole of the glove box
ALS work in the isolation tent	not necessary	Required

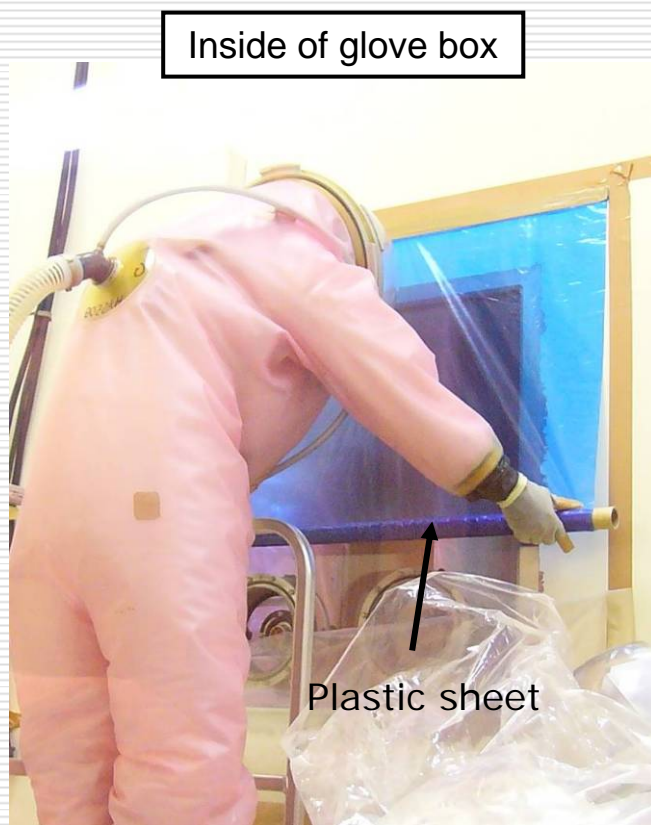
1. Decontamination of degraded panel

Degraded panel:
1.0 X 1.0 m

Contamination level

before $\beta \gamma$: 1.2 Bq /cm²
 $\alpha \gamma$: 33.6 Bq /cm²

after $\beta \gamma$: Back ground
 $\alpha \gamma$: Back ground

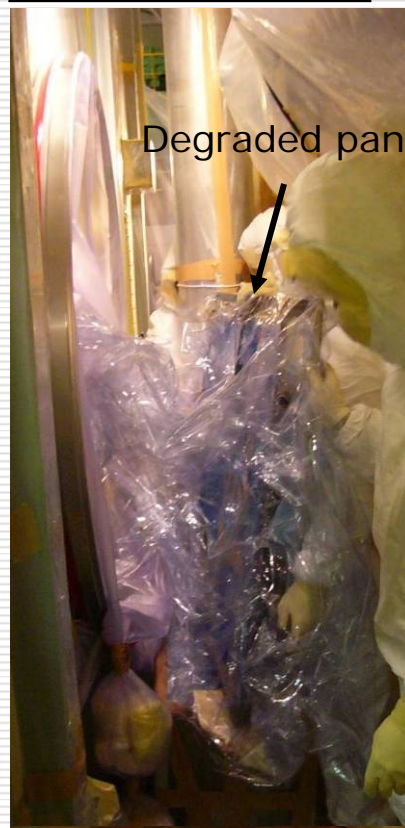
3.Replacement of the acrylic panels(1/2)

Outside of glove box

1. Bag-in / bag-out port was screwed on the outside of the glove box.
2. The degraded panel was covered with the 1st bag.
3. The degraded panel was removed from the glove box.
4. The 1st large bag containing the degraded panel was sealed and separated from the glove box.

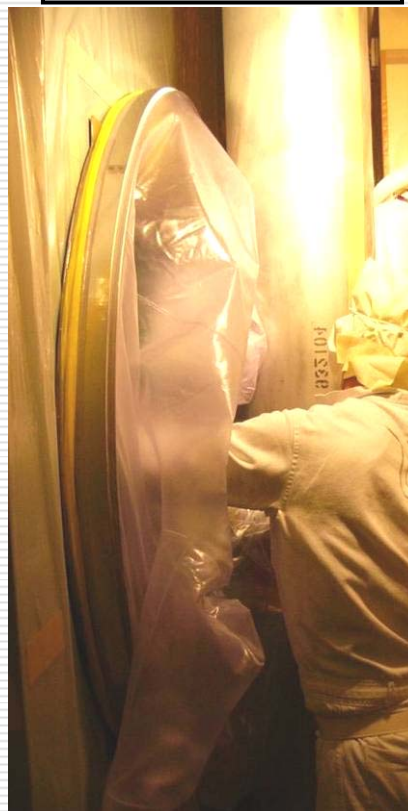
3.Replacement of the acrylic panels(2/2)

Outside of glove box

1. The 2nd large bag containing the new panel was set over the rest of the 1st bag.
2. The rest of the 1st bag was removed, the 1st bag was sealed in the 2nd bag.
3. The new panel was screwed on the glove box.
4. The 2nd large bag and airtight panel were removed from the bag-in /bag-out port.
