## Status and Activities of PIEs on Nuclear Fuel in NPIC

**Abstract.** Development and status of hot laboratory in Nuclear Power Institute of China was presented. Main activities of post irradiation examination on nuclear fuels, including testing fuel bundles for PWRs and dispersion fuels for research reactors were also generally described.

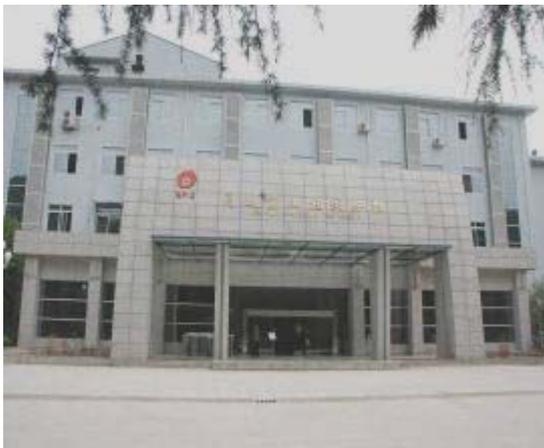
*FIG. 1.1. Main building of HFETR.*

Nuclear Power Institute of China (NPIC) was a research center for PWRs in China. Two research reactors were operated by NPIC, one of which, was the High Flux Engineering Test Reactor (HFETR, Figs 1.1–1.2). Since 1980, HFETR was in operation for more than 30 years. Various kinds of testing fuel assemblies have been irradiated, and, then examined in hot laboratory. An overview of activities and an status of those post-irradiation examinations (PIEs) is briefly presented in this paper.

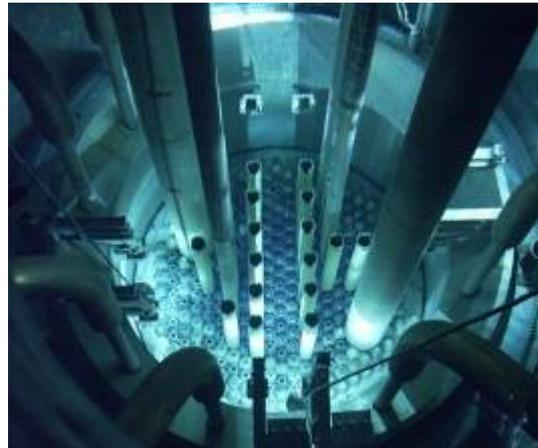
*FIG. 1.2. Reactor core of HFETR.*

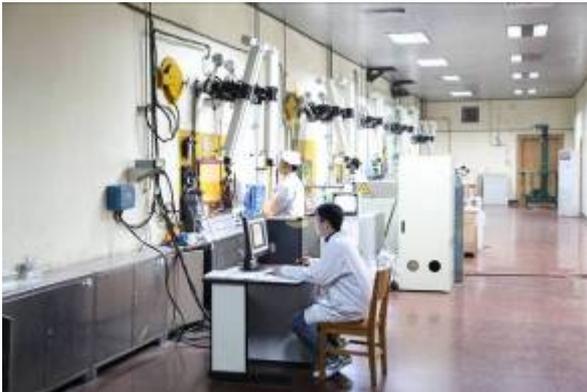
FIG. 2.1 Hot cells for dismantling and NDT. FIG. 2.2. Semi hot cells for mechanical testing.

A complex of hot cells was built just aside the HFETR during same period of construction. Two lines on the second floor were used for PIE of fuels (Fig. 2.1), which is connected with the spent fuel pool of HFETR by an underwater transfer channel. A line of semi hot cell on the first floor (Fig. 2.2) was used for mechanical testing of reactor structure material. From 2006–2011, two rounds of refurbishments and upgrading of hot cell facilities were performed. The main capacity of the hot laboratory is listed in Table 2.1.

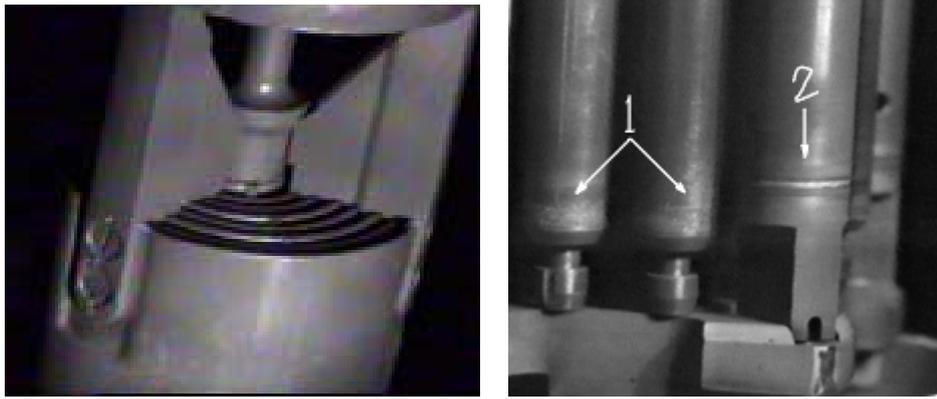
FIG. 3.1. Underwater visual inspection of fuel element (left: top end of HFETR fuel element; right: bottom end of a testing PWR fuel bundle).

Visual examination was performed in the spent fuel pool and hot cell respectively. Surface conditions, such as obvious deformation, defects, damage could be determined (Fig 3.1). Water-proof and radiation resistance cameras were used in most occasions.

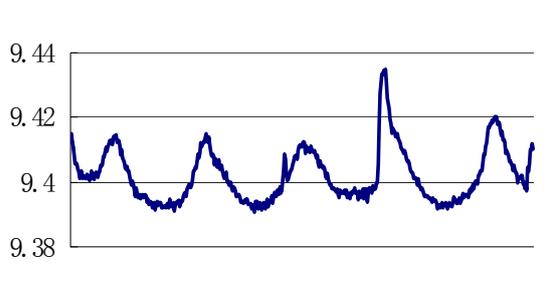
FIG. 3.2. Fuel rod diameter variation (mm).

Deformation and curvature of fuel elements were measured in hot cell with a remote controlled 3-D coordinator machine. Also a LVDT apparatus and a laser beam device were used to measure the variation of fuel rod diameter (Fig. 3.2).

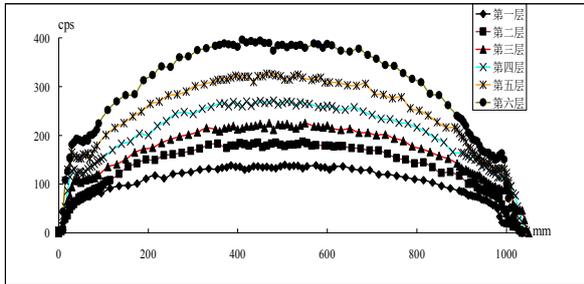
FIG. 3.4.  $\gamma$ -profilometry of fuel tubes.

Relative burn-up distribution of fuel elements was measured by  $\gamma$  profilometry scanning.  $^{137}\text{Cs}$  was used as the monitoring isotope for counting. Axial distribution of burn-up of a HFETR fuel elements is shown in Fig 3.4. Due to tubular structure and core loading of HFETR, the outer fuel tube reached high burn-up, and lowest burn-up corresponding to 3<sup>rd</sup> tube which was in the middle layer.

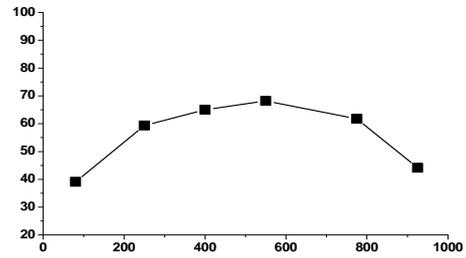
FIG. 3.5. Burn-up distribution of fuel tube (axial position (mm) vs. burn-up (at%)).

Fuel elements could be dismantled and sampled to absolute burn-up determination. The uranium isotope was separated and measured by mass spectrometer. Averaged burn-up of HFETR fuel tube and axial distribution were in good accordance with the  $\gamma$  profilometry results (Fig. 3.5).

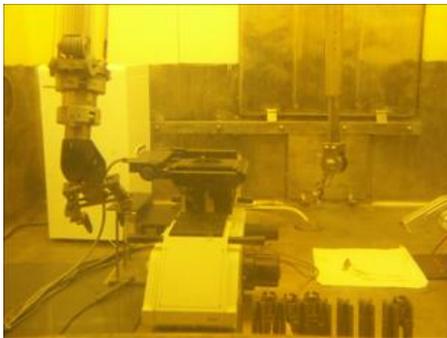
FIG. 3.6. OM in hot cell.

The evolution of microstructure was a big concern during irradiation. Microstructure was examined by a remote controlled optical microscopy (OM, LeikaMef4A, Fig. 3.6) in hot cell. Conjunction between cladding and fuel meat (Fig 3.7), cracks and microvoids in pellets can be examined.

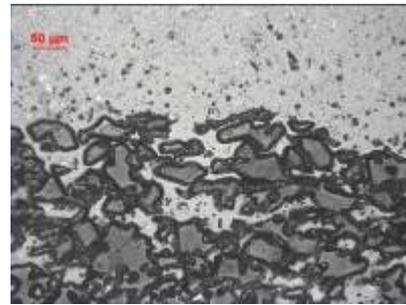
FIG. 3.7. Conjunction of fuel meat and cladding.

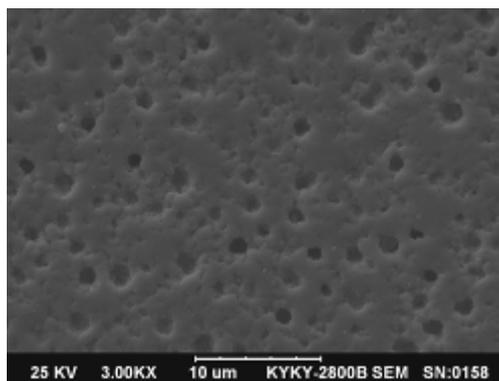
FIG. 3.8. SEM of irradiated  $UO_2$ .

Further more, a customized scanning electron microscopy (SEM) was used for fractography of irradiated materials. Fig. 3.8 shows microvoids and porosity of a PWR fuel pellet.

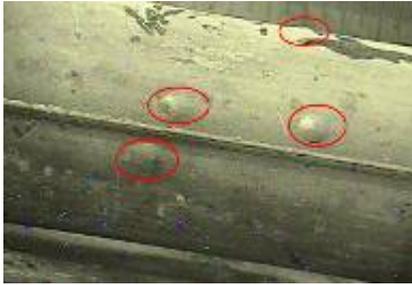
FIG. 3.9. 12 Blistering of fuel tube.

was installed in hot cell to perform blistering testing for fuel tubes in full length. A blistering test for a HFETR fuel tube showed that threshold temperature was more than 500 °C. Results are shown in Figs 3.9–3.10.

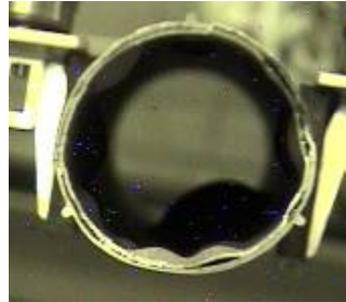
FIG. 3.10. 13 Separation of cladding and fuel matrix.

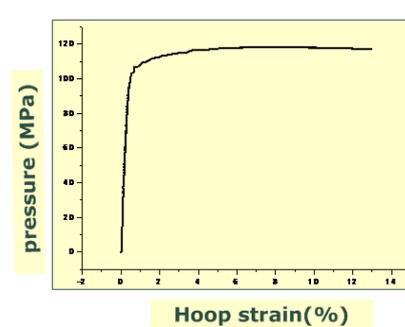
FIG. 3.11. Strain vs. inner pressure relationship.

Burst testing of cladding tube for PWR fuel, could be performed in hot laboratory, both at ambient temperature and 350 °C. A failed tube and strain vs. inner pressure relationship of burst testing is shown in Figs 3.10–3.11.
