Experience in maintenance and decommissioning of in-cell equipment of an operating alpha, beta, gamma hot cell facility.

T.Johny, Shaji Kurien, T.Ulaganathan, Jojo Joseph, S.Venugopal & T.Jayakumar

Metallurgy & Materias Group,
Indira Gandhi Centre for Atomic Research, Kalpakkam, Tamil Nadu – 603102, India
johnny@igcar.gov.in Ph +91 44 27480500 extn 26446

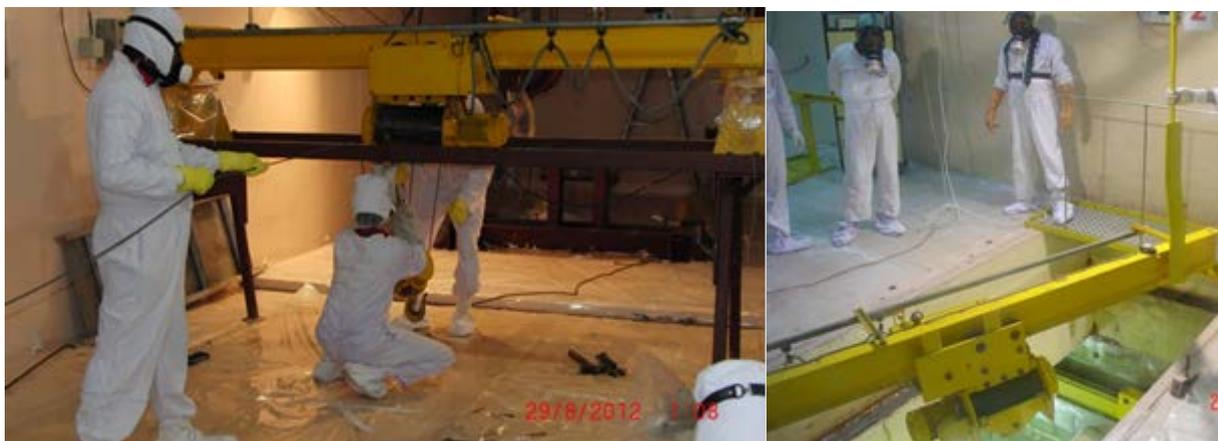
3.2 Cell-1 in-cell crane: In case of hot cell #1, the in-cell crane rope came out of the drum while operating the crane due the excessive wear and tear of the rope guide. After converting the hot cell #1 environment from nitrogen to air the repair crew wearing Personal Protective Equipment (PPE) entered the Upper Isolation Area (UIA) and removed the roof plug. Using the UIA crane, the Cross travel (CT) carriage was lifted to the UIA. The rope guide in the crane was repaired. The crane was tested by arranging temporary power supply. Subsequently the CT carriage was put back and the roof opening was closed. After ensuring that the crane is working satisfactorily, the hot cell was brought to normalcy.

Fig 2: Repair campaign of hot cell #1 crane

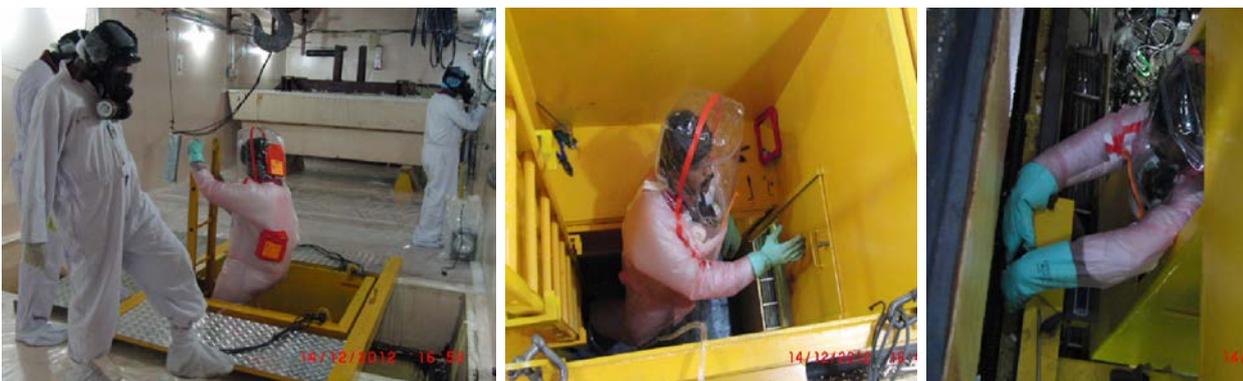
3.4 Cell-2 in-cell crane: The problem with the hot cell #2 in-cell crane was the stoppage of motion during its long travel motion. Visual inspection using video camera through roof opening showed that one of the lateral guide bearing of gantry had failed.

Fig 3. Photographs showing various stages of cell #2 crane repair

The bearing had the function of preventing the skewing of the crane trolley.

3.4.1 A detailed study revealed that the crane can be repaired only by man entry into the hot cell. The MES-I made earlier which does not offer any radiation protection to the repair crew member, was not useful for this job. The floor of the hot cell was highly contaminated and had higher dose levels. Therefore a shielded Man Entry system-II (MES-II) was developed for the repair of hot cell #2 in-cell crane. It was provided with 10 mm thick mild steel shielding at sides and bottom, and an additional shielding of 6 mm lead at the bottom.

3.4.2 A member of repair crew climbed down to the bottom of the MES. He found that the trolley was in skewed condition necessitating correction. Using a C-clamp summoned immediately, he corrected it before replacing the damaged bearing. After he moved up, the MES was taken out. The operators stationed at the operating area tested the crane & ensured that all systems are functioning normally. Subsequently repair crew put back roof plug and brought back hot cell to normalcy.

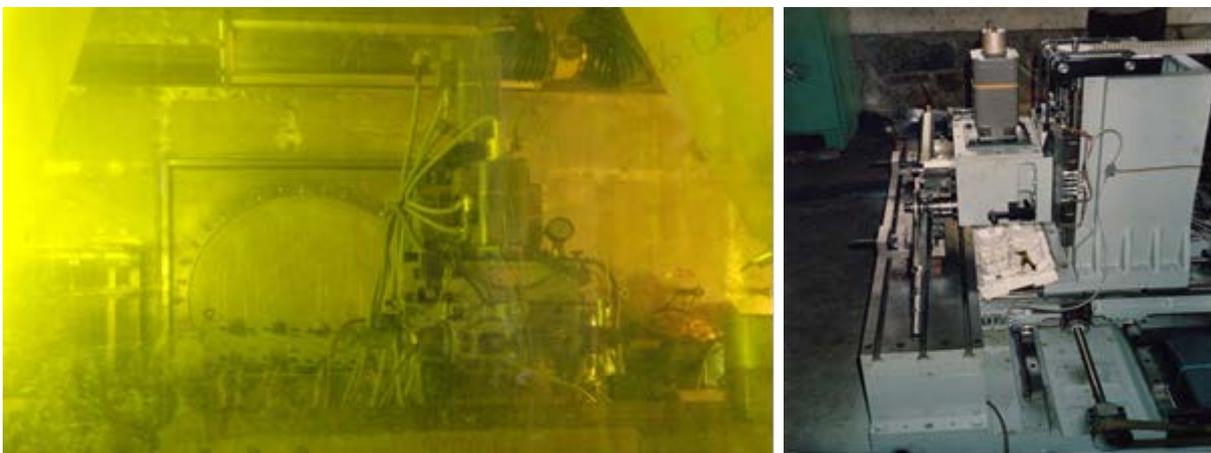
3.5 Decommissioning of hot cell #2 CNC milling machine: The CNC milling machine was extensively used for the metrological inspections, diamond wheel based dismantling of irradiated subassemblies, and preparation of tensile specimen from the hexagonal wrappers of dismantled subassemblies. When the integral rotary encoders of servo motors of the Y and Z axis failed after a few years, it was initially solved successfully by installing and operating identical dummy motors with rotary encoders outside the hot cell. The dummy motors derived identical power input from the motion control system and the output of its encoders was used as the feedback to control the in-cell motors and to maintain the positional accuracy of the Y and Z axes. After about fifteen years of total service, further failures including that of the bellow coupling between the Z stage lead screw and motor necessitated complete replacement of the machine. After installing and commissioning newly developed compact machines like Dimensional Measurement-cum-

Fig 4 a: CNC milling machine inside the hot cell 4 b) CNC machine before commissioning

3.5.1 The CNC machine was installed over a base plate bolted to the hot cell floor on which an XYZ stage and a work bench were assembled. It occupied space of 1578 mm x 1025 mm x 1118 mm (L x B x H). A detailed study of the machine was carried out to decide the manner in which the dismantling has to be carried out. After considering factors such as the shape, size and weight of the various components, and the ease with which these components can be disassembled remotely or manually, it was decided to dismantle the machine into three major parts and transport them to waste management facility in three separate leak tight SS 304 boxes. The three parts are the work bench, vertical column (Z-stage) including the machining head, and the base plate with XY stage.

Laser Dismantling machine (DMLD) and Tensile specimen Preparation Machine (TSPM), it was decided to decommission the old CNC milling machine to clear up prime space in the hot cell. This machine was designed for repair and maintenance through replaceable parts but it did not have enough design features suitable for easy decommissioning. All preparatory dismantling activities were done remotely.

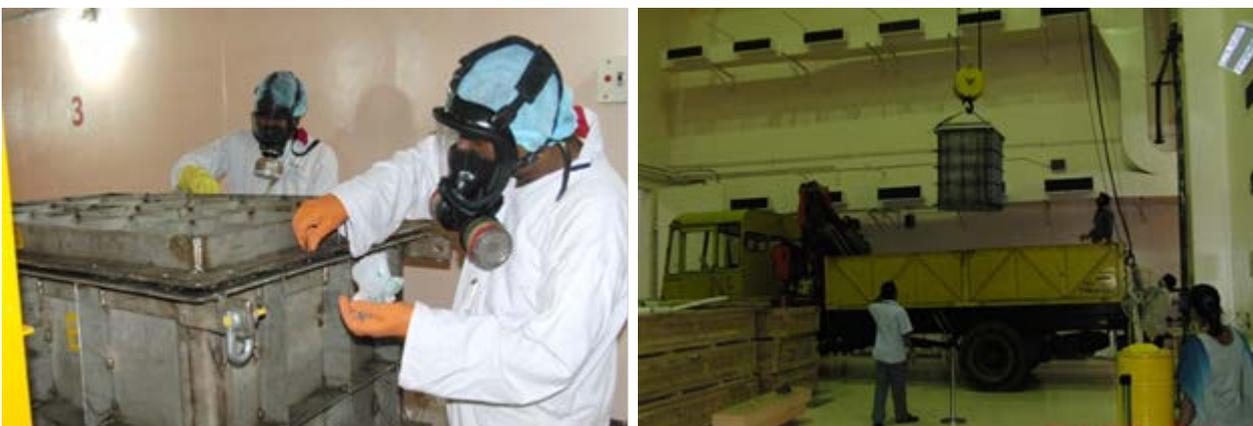
3.5.2 The work bench was bolted to the base plate with six numbers of M12 bolts. These bolts were loosened and removed using the in-cell power manipulator. Special tools were used for this operation. The hot cell environment was then converted to air. After getting safety clearance, the dismantling crew wearing personal protective gadgets entered upper isolation area (UIA) and the roof shielding door of cell #2 was opened. The work bench was then lifted to the UIA using the UIA crane and it was transferred to the 1840 mm x 540 mm x 680 mm (L x B x H) size stainless steel box. Its lid was closed and tightened with gasket in place using bolts and nuts.

Fig 5 Disposal of CNC machine in leak tight containers and its transport.

3.5.4 After completing the initial preparations for hot cell man entry, dismantling crew assembled MES-I at the UIA, climbed down into hot cell with necessary tools through MES-1, made the working platform horizontal, cut and removed most of the remaining screws, shielded cables and copper hydraulic lines from the vertical column using special tools. After the completion of the work, the MES-I was disassembled and removed from the roof plug opening. The vertical column was lifted to the UIA using the crane, and was transferred to the 1340 mm x 900 mm x 1240 mm (L x B x H) stainless box. Subsequently the roof plug was put back and the hot cell was brought back to normalcy. The box was then shifted out and transported for disposal.

3.5.7 The side pockets at the back vertical face of the base plate were not visible from the operating area through the shielded glass viewing windows. The inspection of the location using cameras revealed that the location cannot be accessed from top using MES-I with extended tools for the removal of epoxy resin and nuts from side pockets. Therefore, it was decided to access the location by opening the hot cell rear-access-door and to carry out the work manually. It was carried out by persons in ventilated suits, standing in front of the opened door, from LIA, using extended tools. Subsequently, hot cell roof plug was opened and the base plate with XY stage was lifted to UIA using UIA crane, packed in SS container and disposed.
