Management of JMTR hot laboratory without operation of system of air supply and exhaust

¹Japan Atomic Energy Agency, Oarai-machi, Ibaraki-ken 311-1393, Japan

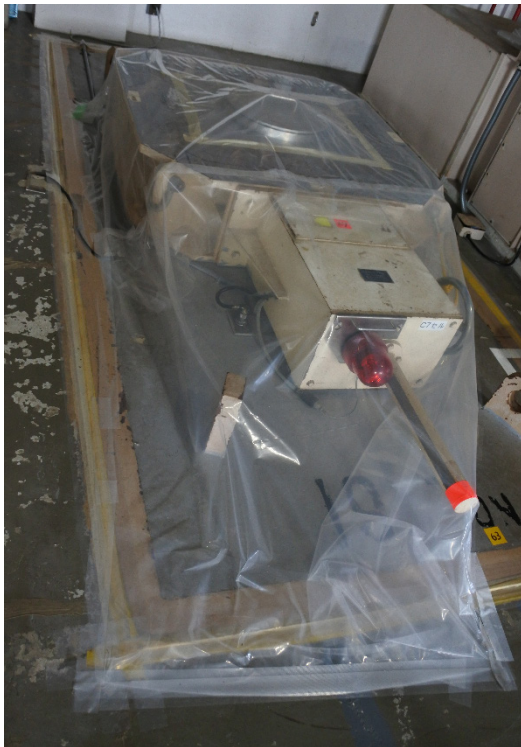
Fig.2-2 Sealing by tape and vinyl acetate sheet

When the area of sealing was too large to seal by tape, the area was covered by vinyl acetate sheets and the around of sheets was sealed. Figure 2-1 and 2-2 show the pictures of the sealing. Figure 2-1 shows the sealing using tape and Figure 2-2 shows the sealing using tape and vinyl acetate sheets. The electric power of entrance doors of radiation controlled area was shut down to prevent opening carelessly. Temporary isolation rooms made of vinyl acetate sheets and plastic pipes were settled to separate radiation controlled area and non-controlled area. Figure 2-3 shows one of the isolation room and the seals. The doors and the isolation rooms must not be opened at the same time. The seals are checked every day by visual checking and the results are recorded.
