Hot Fuel Examination Facility 1st Hot Cell Window Replacement

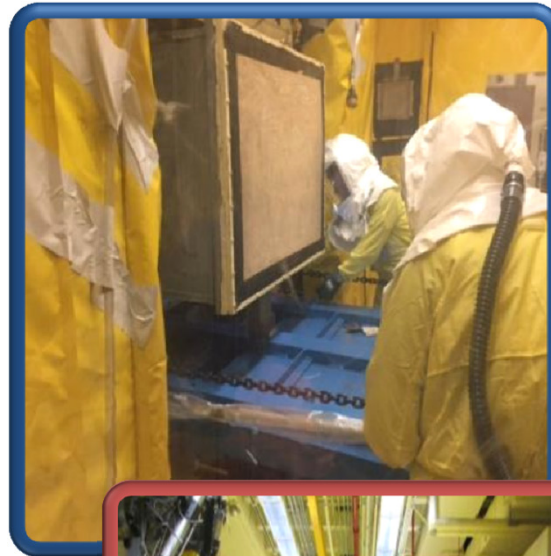
- HFEF began operations 1975
- Window replacement design began 2014
- Window unit replaced in 4 days
- Tank unit: 5 slabs of glass with mineral oil

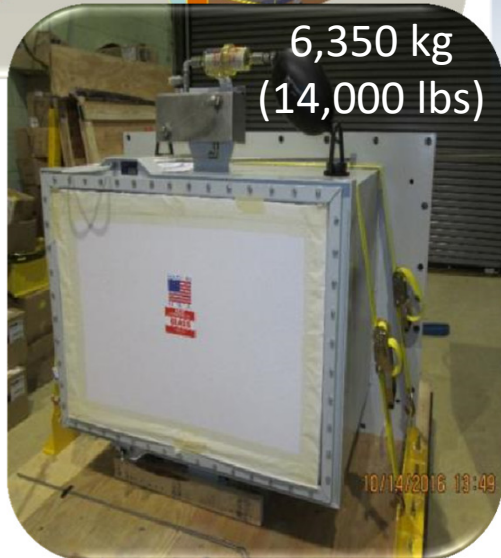
6,350 kg
(14,000 lbs)
