BLISTER DEFECT ANALYSIS OF U_3Si_2/Al NUCLEAR FUEL CLADDING BY ULTRASONIC TEST

HELMI FAUZI R

Center For Nuclear Fuel Technology
BATAN (Indonesia)

September 16 – 21, 2018
Helsinki, Finland

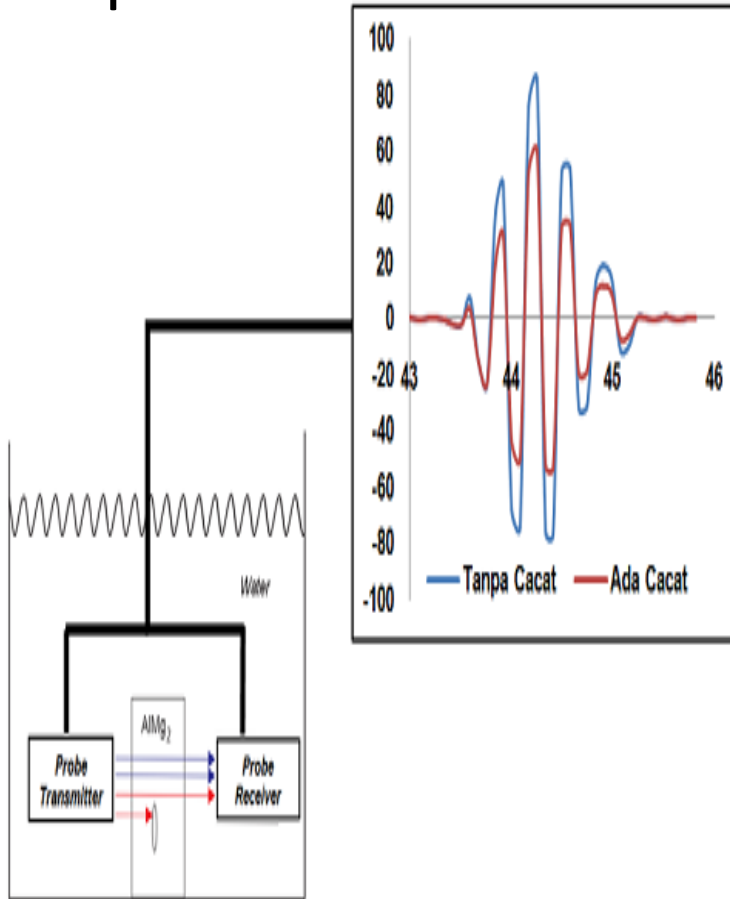
Through transmission technique

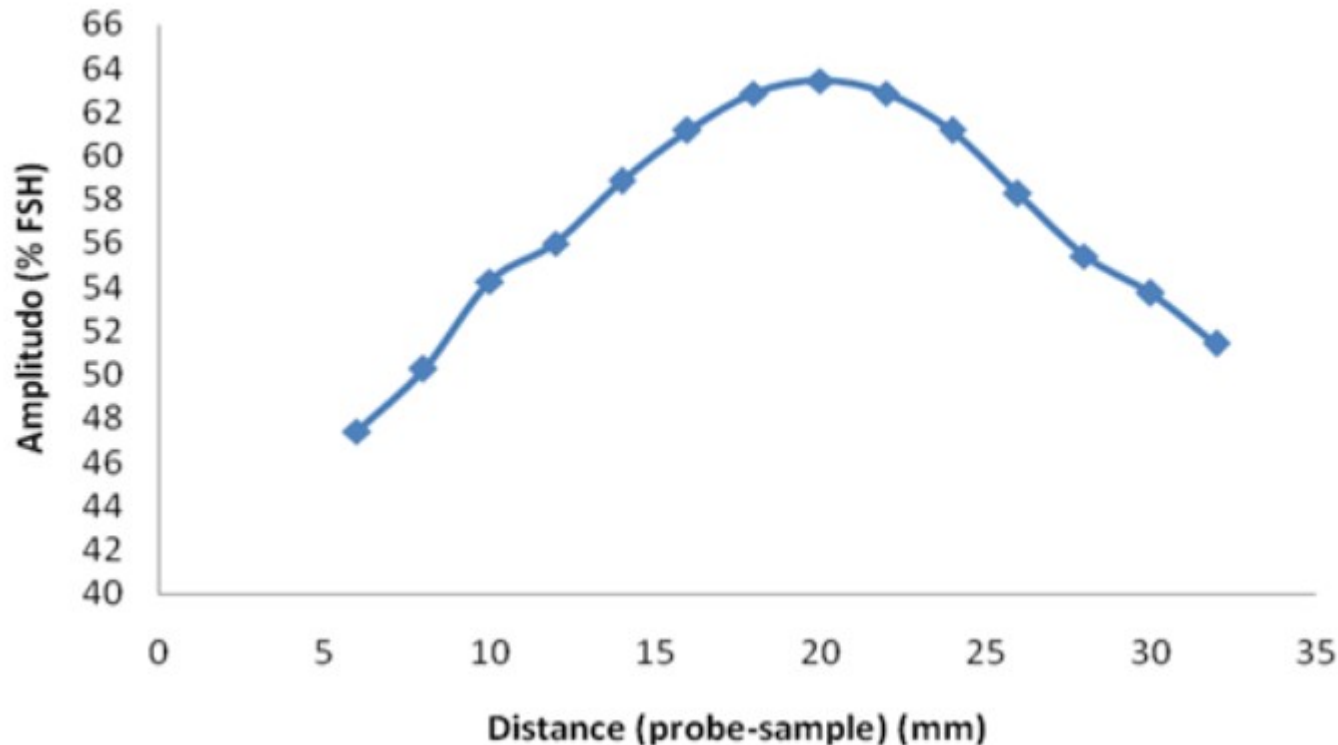
Determination of Optimal Probe Distance with Pulse-Echo Technique

The distance probe-test specimens to amplitude with pulse-echo technique

Non-destructive tests using ultrasonic tests can detect blister defects in the U3Si2 / Al fuel cladding successfully. Wave propagation in the water medium (Velocity) is optimally obtained at 1545 m/s, the optimal distance between the probe - test object with pulse-echo technique is 20 mm and the optimal distance between the two probes with the through transmission technique is 40 mm. Blister testing of AlMg2 cladding with through transmission technique decreased output signal by 80% FSH, whereas in pulse-echo technique there was only 19% decrease of signal. Interpretation of signals to detect blister defects in fuel cladding with through transmission techniques is easier to do than pulse-echo techniques.

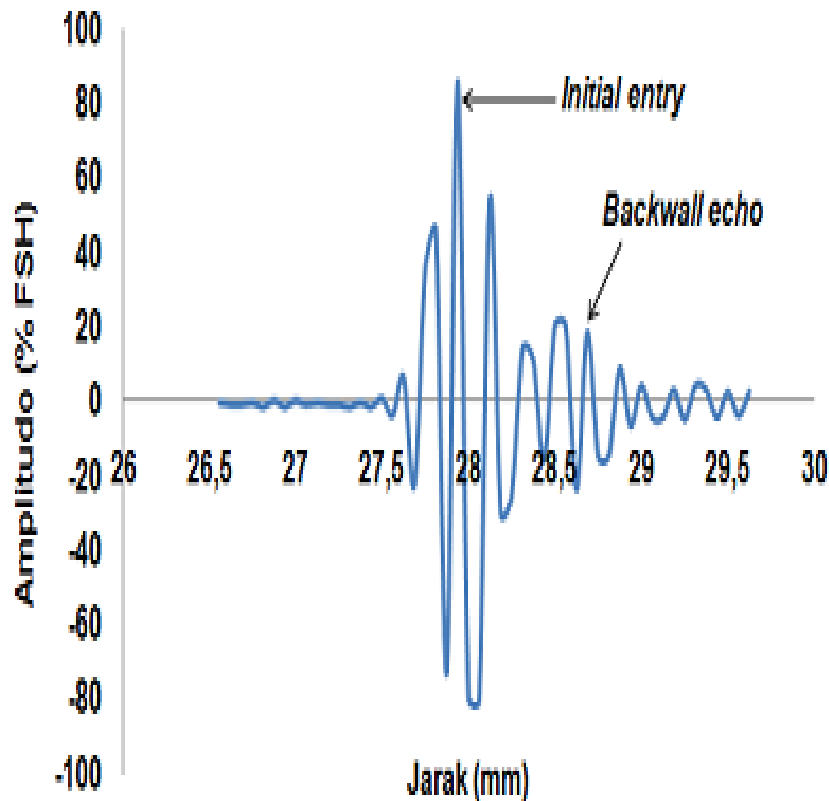
Output Signal of Cladding Sample Testing with Pulse-Echo Technique

Normal Section

Pulse-echo Technique	Through transmission Technique
The resulting output signal is difficult to interpret in detecting blisters	The output signal is easier to interpret when detecting blisters
In the blister defect there is a signal decrease of 19% FSH	In the blister defect there is a signal decrease of 80% FSH
Probes must focus on identifying signals for Initial Entry (IE) and Backwall Echo (BE)	The probe is sufficiently focused on the difference in signal reduction that occurs between normal and anomalous (defective) parts

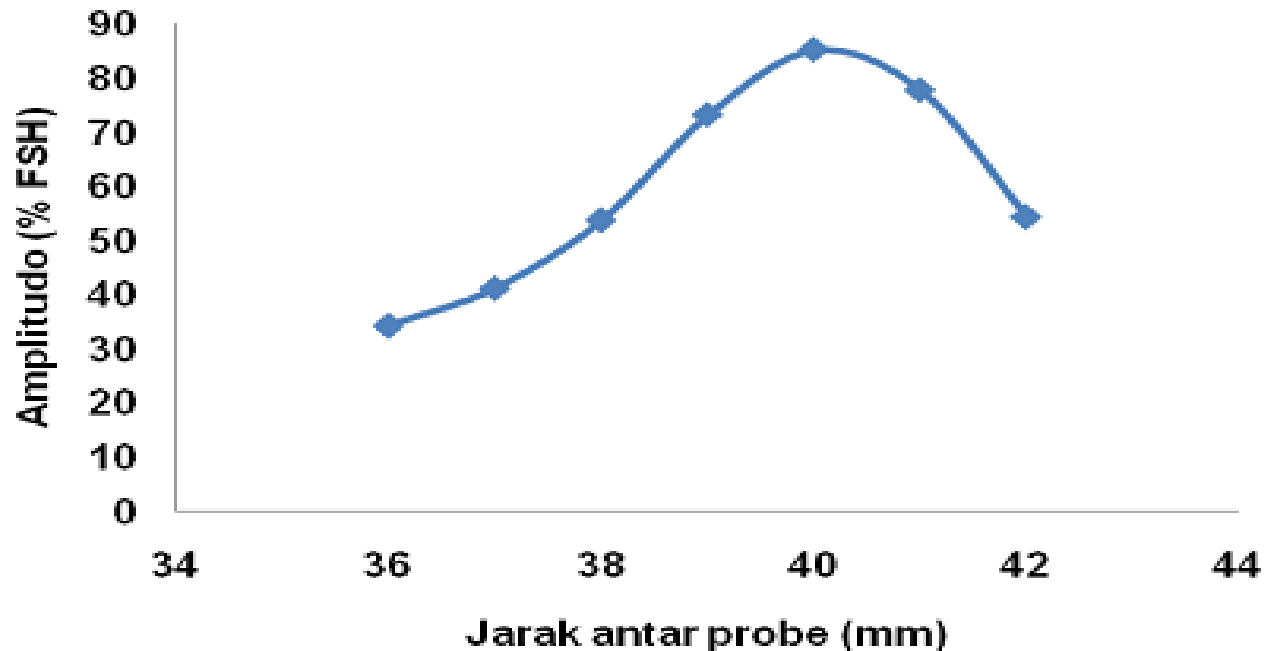
Determination of Optimal Probe Distance with Through Transmission

The distance probe-test specimens to amplitude with through transmission technique

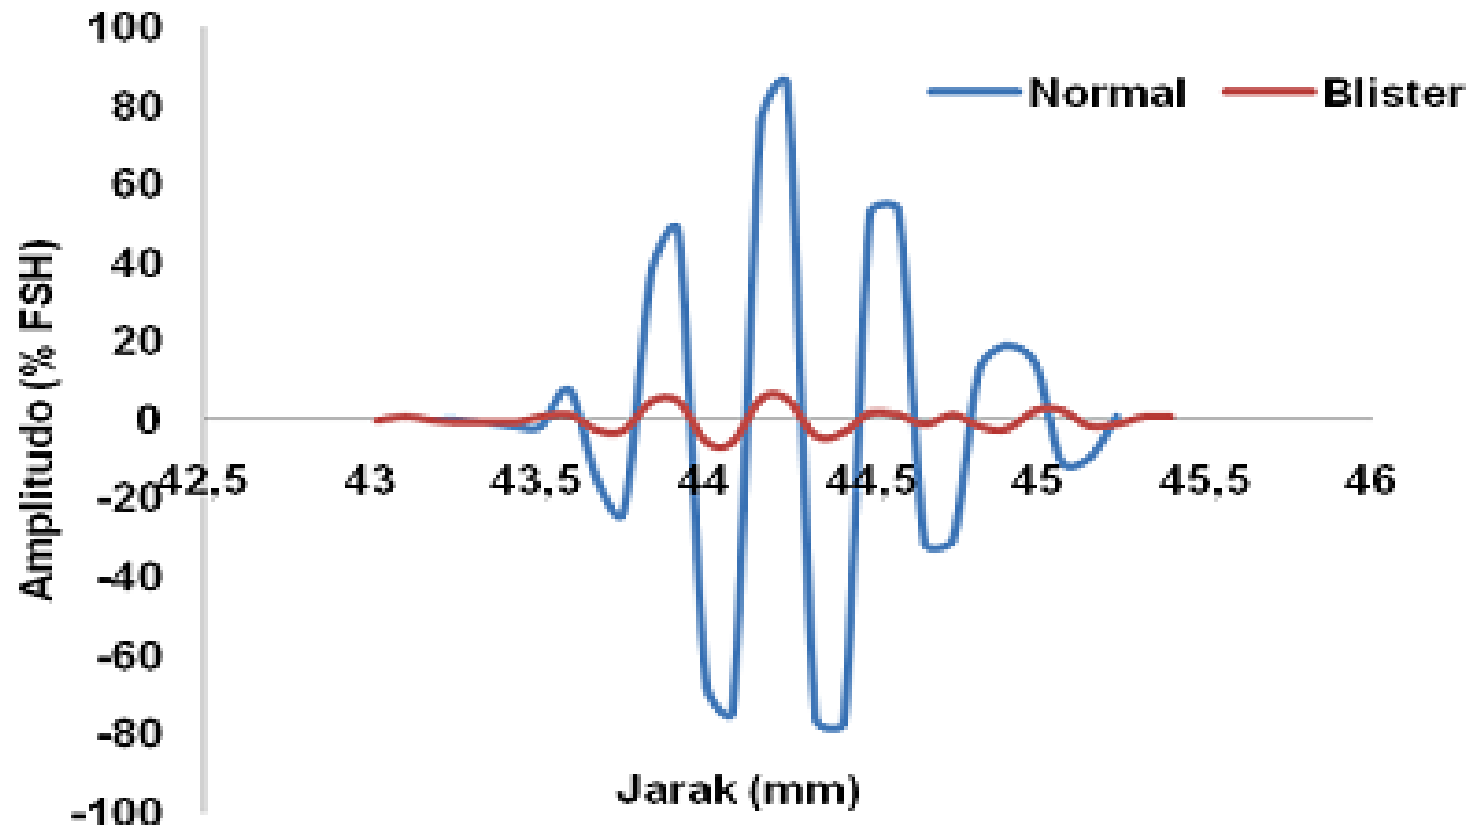
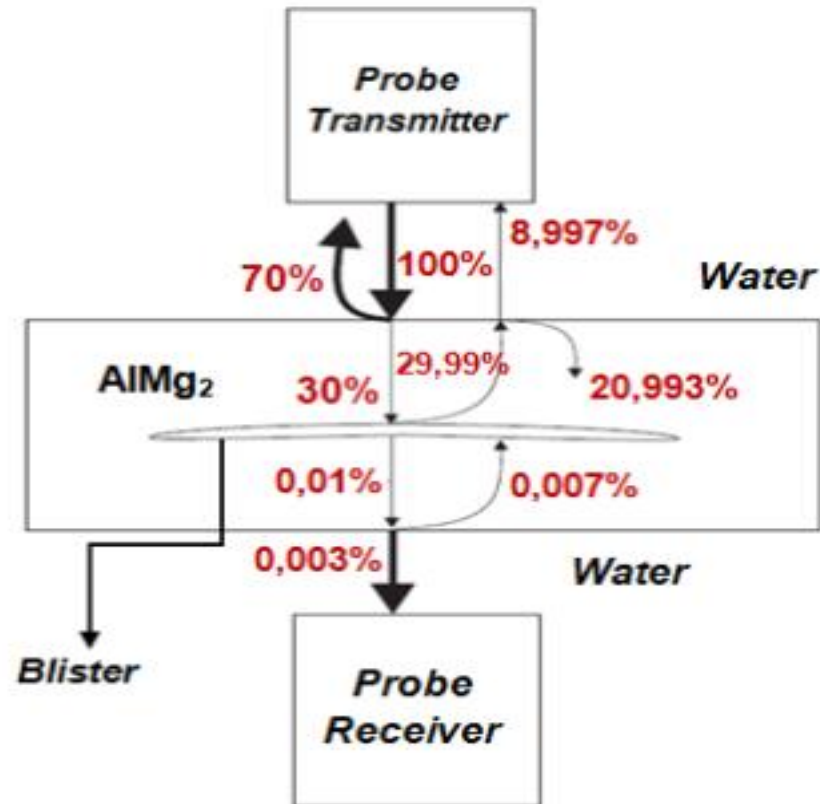
Output Signal of Cladding Sample Testing with Through Transmission Technique

Reflexivity Scheme and blister section testing transmission
