# Two different methods for improving contamination confinement when refurbishing a hot cell

Jean-Paul Grandjean<sup>1</sup> Bernard Autran<sup>2</sup> Jean-Yves Blanc<sup>3</sup>

## Abstract

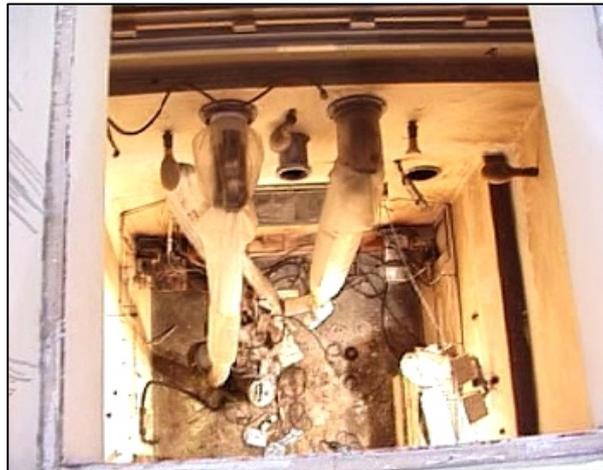
Before refurbishment, cells C7 to C10 were highly contaminated with ambient dose rates of about 1 Gy/h. A certain number of damaged equipment had been stored within, which made it very difficult to access these cells and impossible to carry out any experiments.

Fig. 1: Initial state of cell C9

This phase aimed at reducing the ambient dose rates in the cells to less than 0.25 mSv/h. A first phase of decontamination was performed in the most contaminated cell C9. This phase lasted 3 years and led to a change in methods.

During the first two years, the CEA attempted to decontaminate the cell using standard methods: operators protected by shielded decks working in direct contact. This first phase ended in failure for two reasons: the processes used (chemical decontamination of concrete) were inefficient and the accumulated dosimetry was much higher than set objectives (approximately 30 h.mSv with a residual dose rate higher than 2 mGy). Feedback logically led the CEA to employ remotely-operated means such as the STAUBLI RX-type arm equipped with concrete scabbling tools designed to implement decontamination tools capable of scraping concrete.

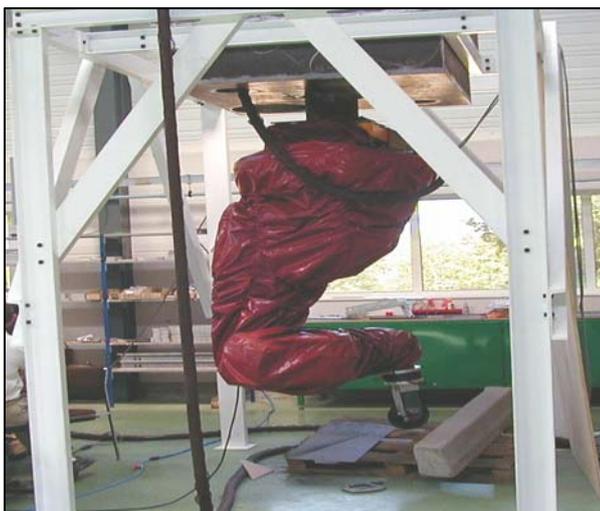
Fig. 2: RX arm equipped with booting

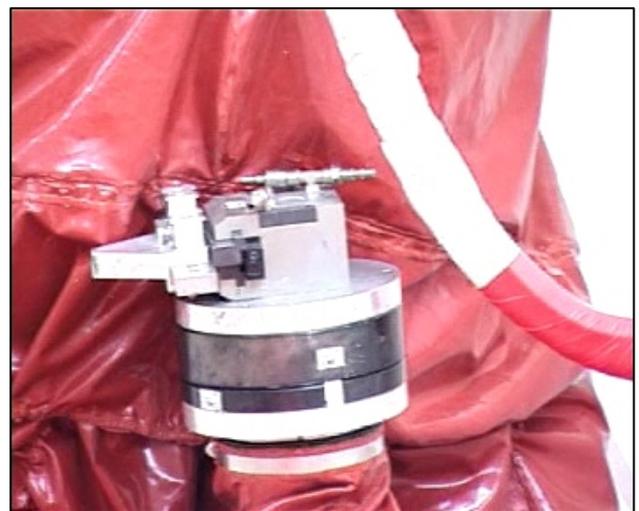
Fig. 3: Tool changer

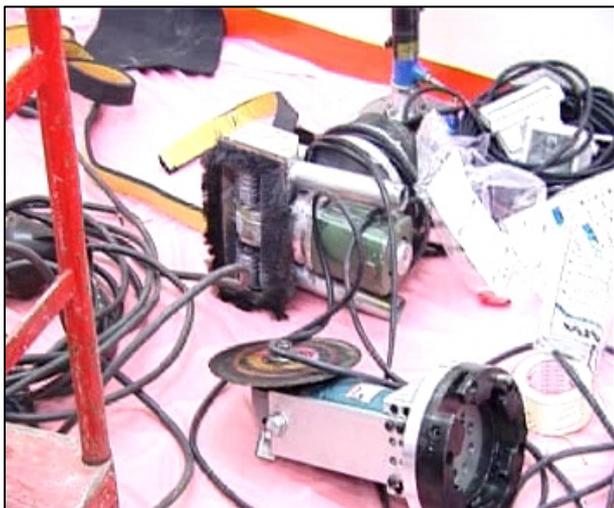
**Fig. 4:** Various tools – disk cutter and concrete scraper

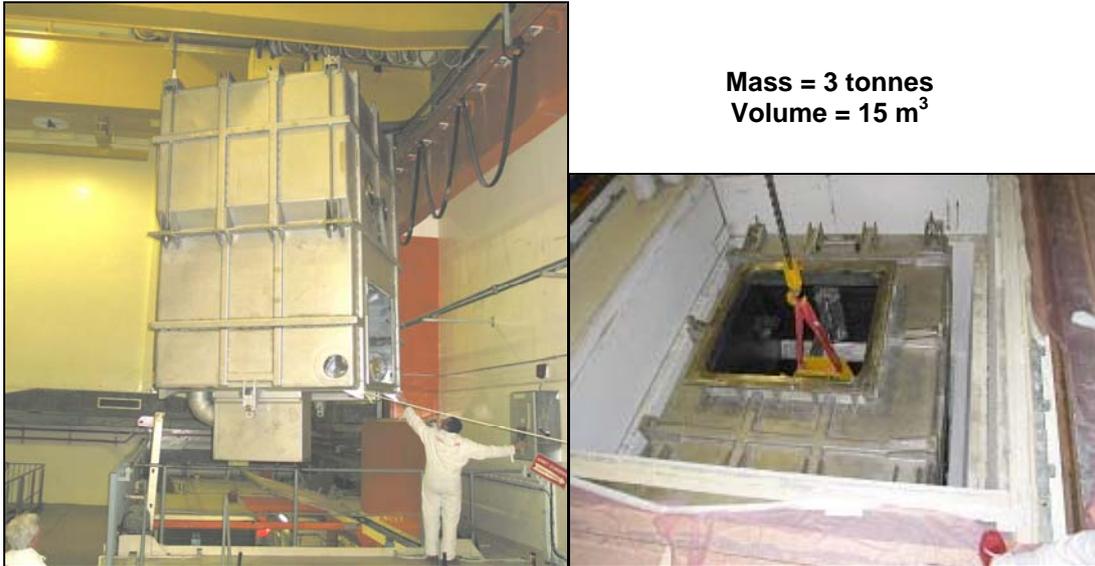
Mass = 3 tonnes  
Volume = 15 m<sup>3</sup>

**Fig. 6:** Inserting a stainless steel box into a cell

This operation consisted in adding a stainless steel box in each cell and rebuilding all passages between the cell and its environment:

Other than being earthquake-proof, the boxes were originally designed to guarantee leaktightness with a leak rate less than  $10^{-2}$  vol/h. It was therefore necessary to build:

- A removable leaktight roof,
- Slide valves on the plugs,
- Rings and bootings on remote manipulators, wall penetrations for electricity and fluids, and alpha-shielding glass in front of the observation port,
- Leaktight cask connexions with double doors for cell C9 and two equipment air locks for cells C10 and C8.

The assembly phase itself lasted two years. Various problems were encountered due to the fact that the existing facility had not been taken into sufficient consideration. For example:

- The boxes were not very adjustable:
  - While positioning the box, the openings were adjusted to correspond with those in the walls and then the box was horizontally attached. When it came to adjusting the hatches and plugs of the main upper hatch, the accumulation of positioning uncertainties, manufacturing tolerances and measurement errors resulted in a difference of several centimetres. It was therefore necessary to modify the boxes.

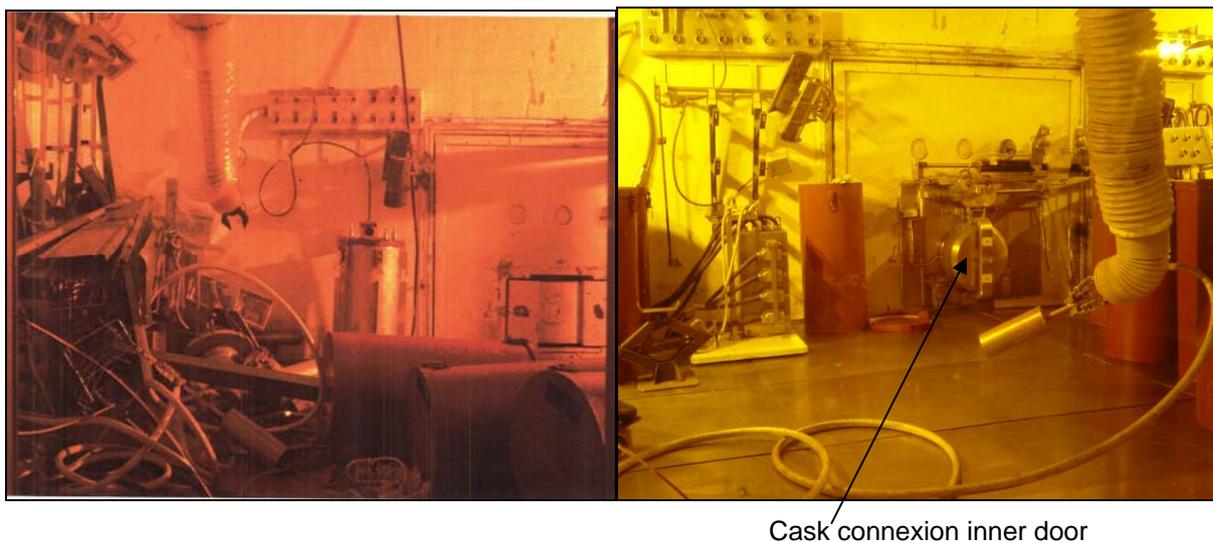
**Fig. 7:** Cell C4 before and after refurbishment

- Dismantling and replacement of pre-filtering boxes,
- Replacement of remote manipulators and ring seals,
- Replacement of cabinets for electrical sockets,
- Upgrading of cask connexions for packagings and transfers in cells C4 and C5,
- Replacement of lifting devices and heavy remote-handling equipment,
- Creation of two equipment air locks.

The equipment air locks were inserted into their sheath from the inside of the cell, with fixtures being attached from the rear zone without any specific problems being encountered. The leaktight inner door of the C4 cask connexion was more problematic seeing that the fixtures were located inside the cell. Assembling by remote operation required decoupling the entire assembling process: a thick steel structure was used to establish a reference position and perform leaktight operations on the cell wall. This plate was assembled and adjusted using a template. Drilling operations required to fix the fastening bolts were then performed using tools mounted on supports designed to bear tool-related loads. Lastly, the door was mounted on its structure. This operation had been well-planned and did not come up against any difficulties.

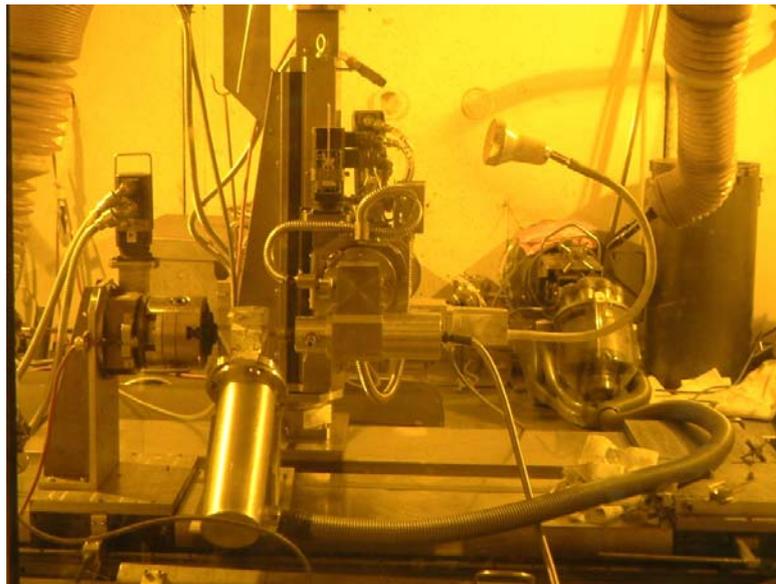
**Fig. 8:** Coralie device equipped with integrated suction

In terms of the experimentation devices, it seems that a third approach is being developed. More and more frequently, the devices themselves ensure the confinement of the fuel on which the experiment is being conducted. The devices are equipped with a leaktight confinement or suction system making it possible – during normal and incidental operation – to confine contamination. The Crocodile leaktight test oven and the Coralie test bench with integrated suction meet such requirements.
