DEVELOPMENT OF AN EDDY CURRENT TESTING TECHNIQUE FOR INSPECTING INNER CORROSION OF CLADDING

NORIKO MIYAJI, KOZO KATSUYAMA and TSUYOSHI NAGAMINE
*Fuels and Materials Department, Japan Atomic Energy Agency
4002 Narita-cho, Oarai-machi, Higashi-ibaraki-gun, Ibaraki pref. 311-1393 – Japan*

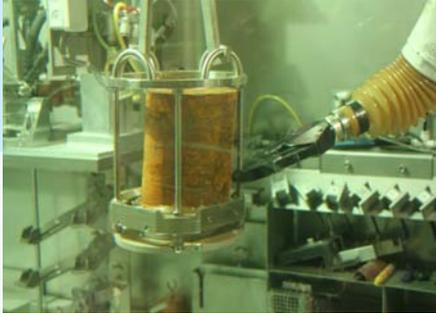
wire EDM machine (AGIECUT CLASSIC)

- cutting of trepans and manufacturing of different specimen types

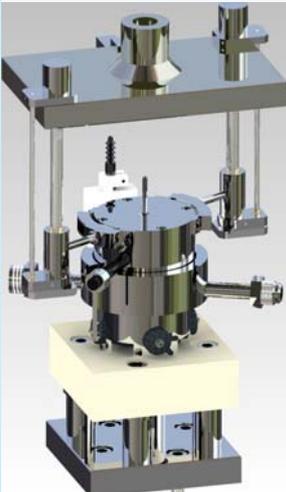
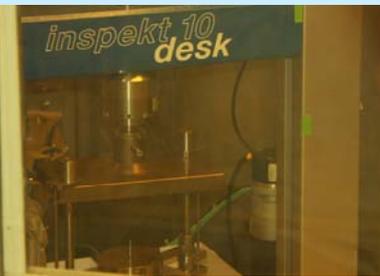
screw-driven testing machine (TestInspekt)

- computer-controlled small punch testing
- 10 kN load frame
- temperature chambers for -150...T...+300° C

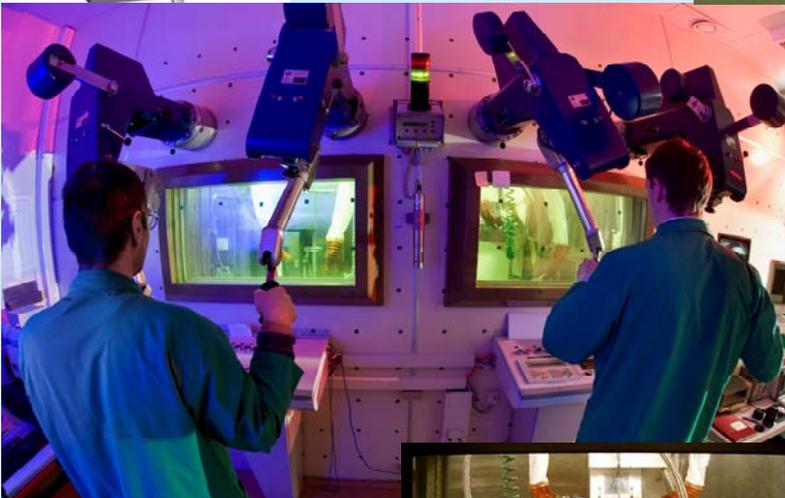
instrumented pendulum impact tester PSD300

- Charpy V-notch specimen testing
- dynamic fracture toughness
- max. impact energy 300 J
- max. velocity 5.5 m/s
- temperature chamber for -115°C...T...+300°C
