# Nuclear Materials Research at the Westinghouse Hot Cells: Supporting Fleet Operations for 40 Years

Paula Freyer  
Fellow Engineer  
Materials Center of Excellence  
Westinghouse Electric Company LLC

HOTLAB 2013

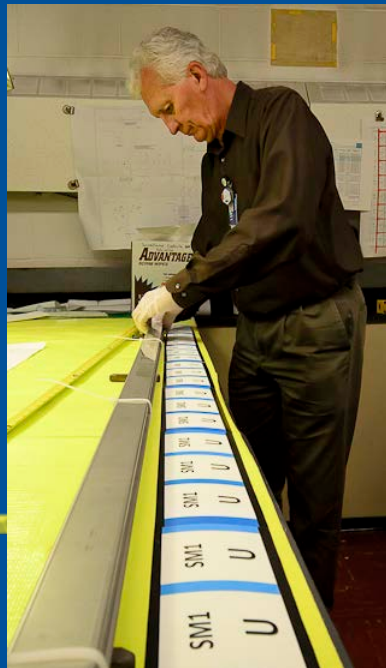
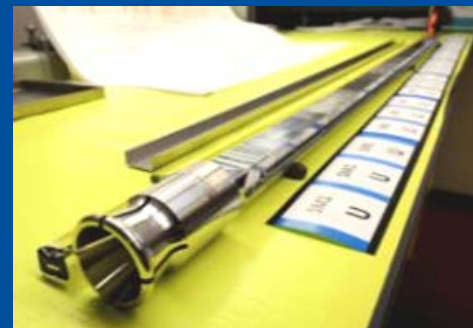
**2013 AP1000 Surveillance Capsule Fabrication**

May 2013: 16 new capsules shipped to China

Sept 2013: 16 capsules being fabricated for VC Summer Unit 2 and Vogtle Unit 3

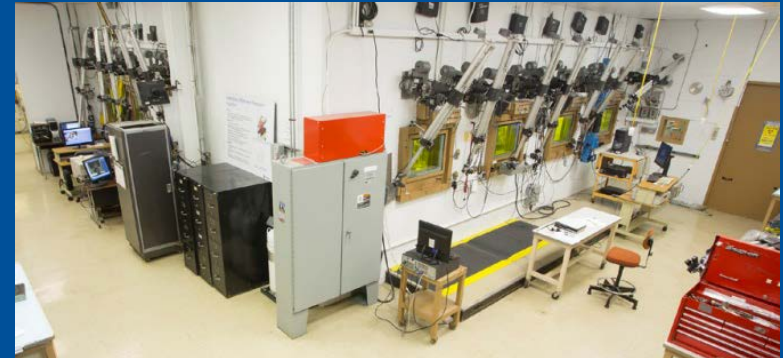
Low level hot cell (left) and high level hot cell (right)

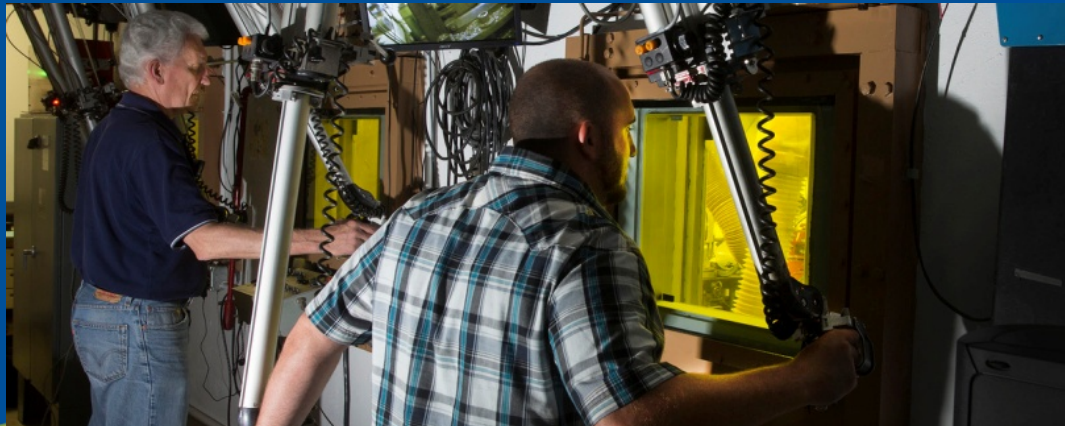
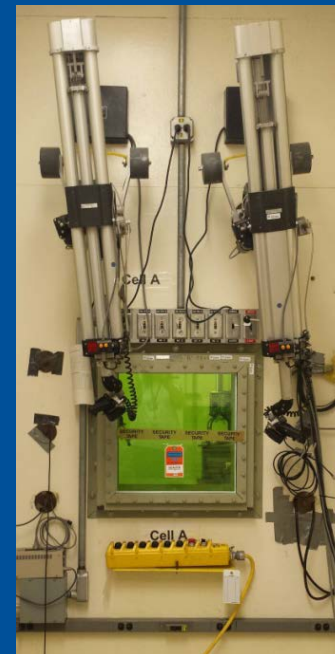
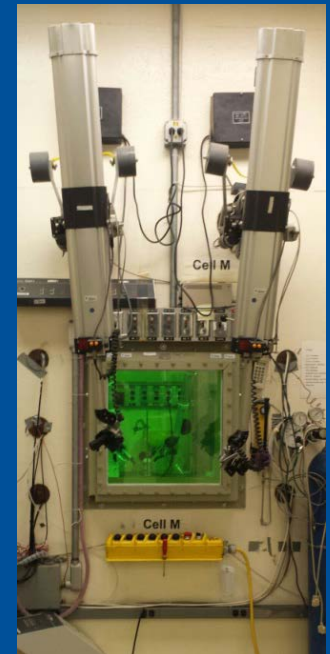
A and M hot cells

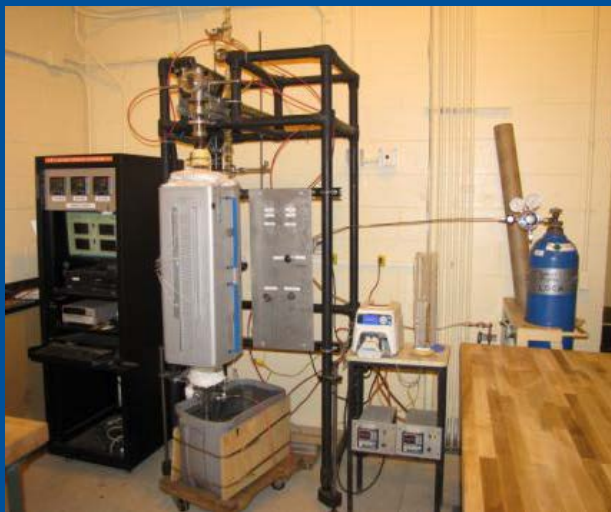
High Temperature Steam Oxidation Unit

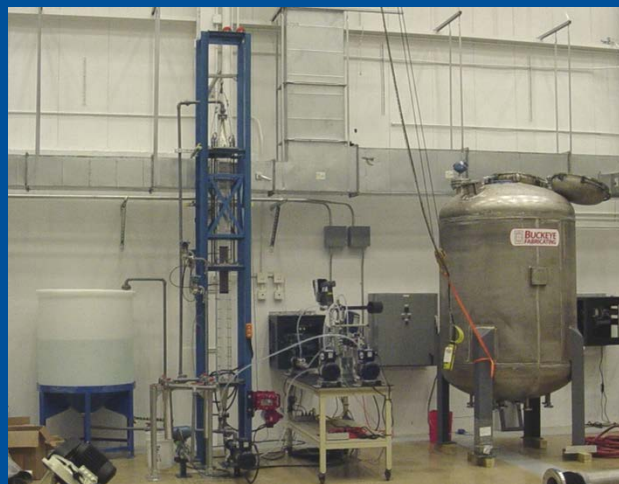
Core Inlet Blockage Intermediate Test Loop  
(under construction)

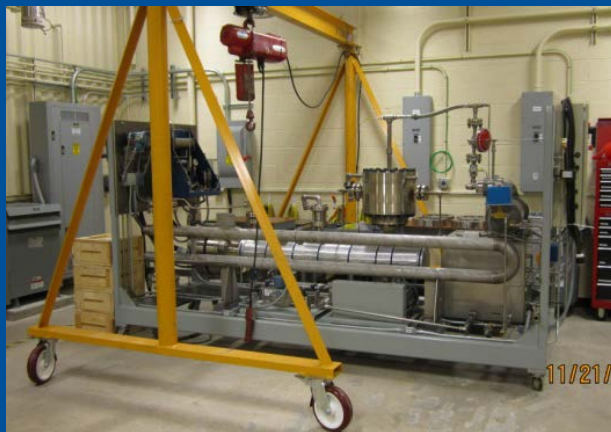
Reactor Coolant Pump Seal Testing  
Laboratory

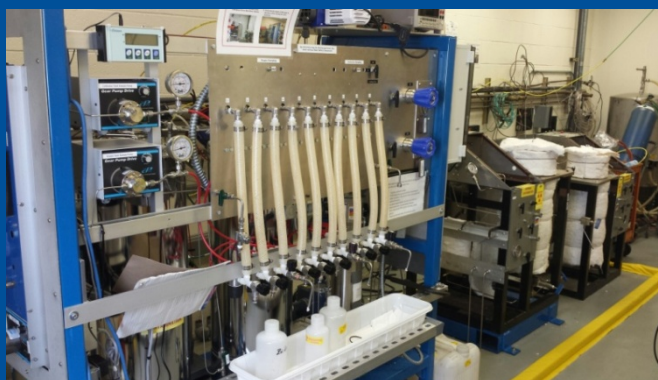
Zinc Effects Test Loop

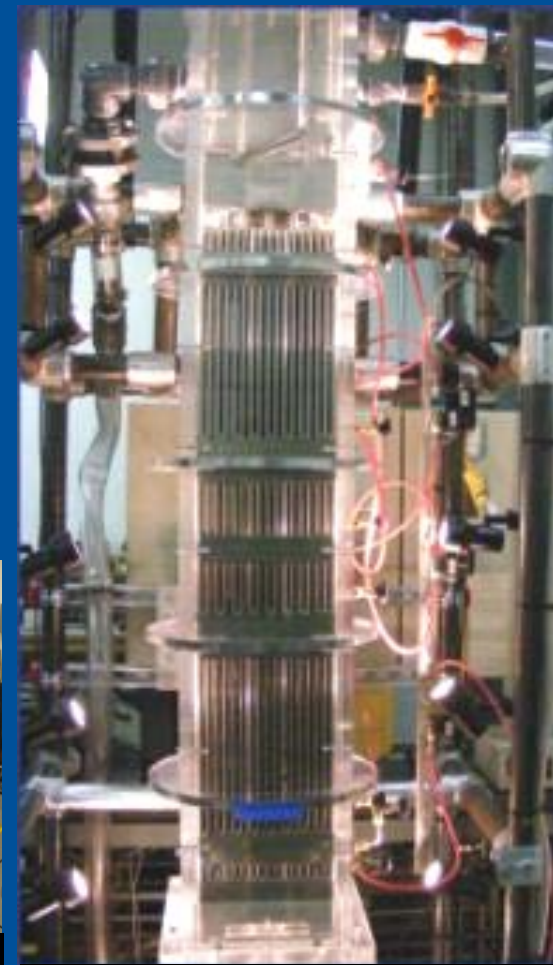
LOCA Debris Blockage Test Facility

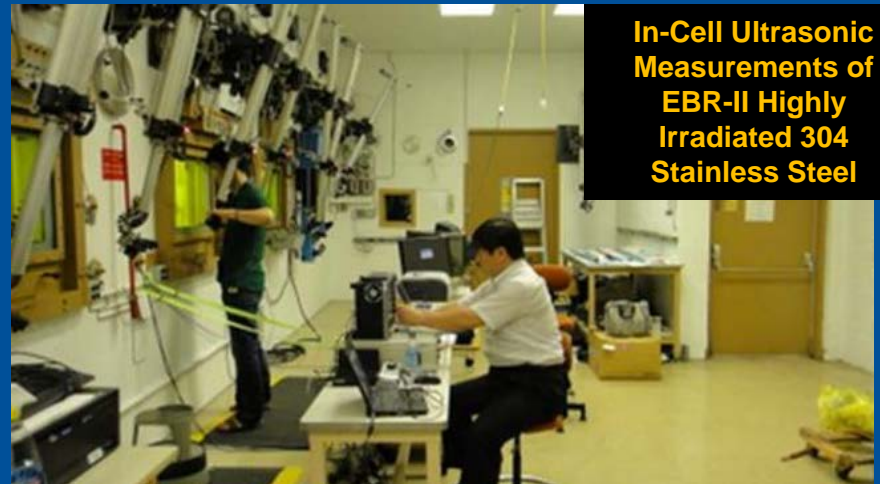
**In-Cell Ultrasonic Measurements of EBR-II Highly Irradiated 304 Stainless Steel**

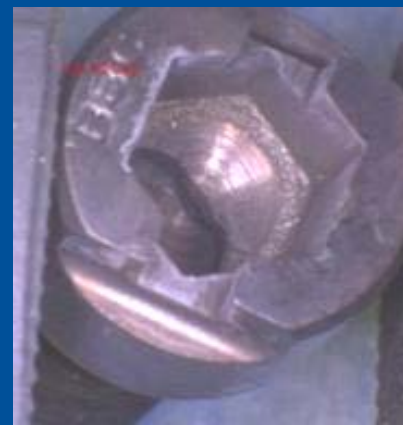
**In-Cell Inspections of Commercial PWR Baffle Bolt**

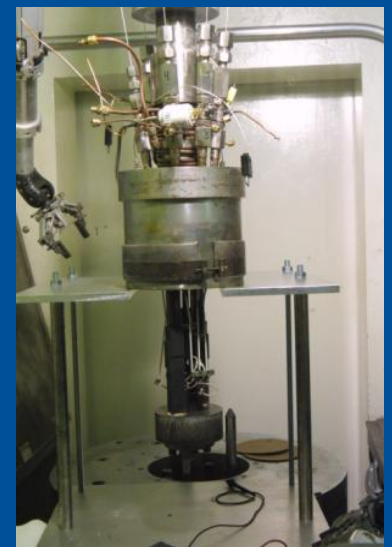
**In-Cell Crack Growth Rate Test Assembly**

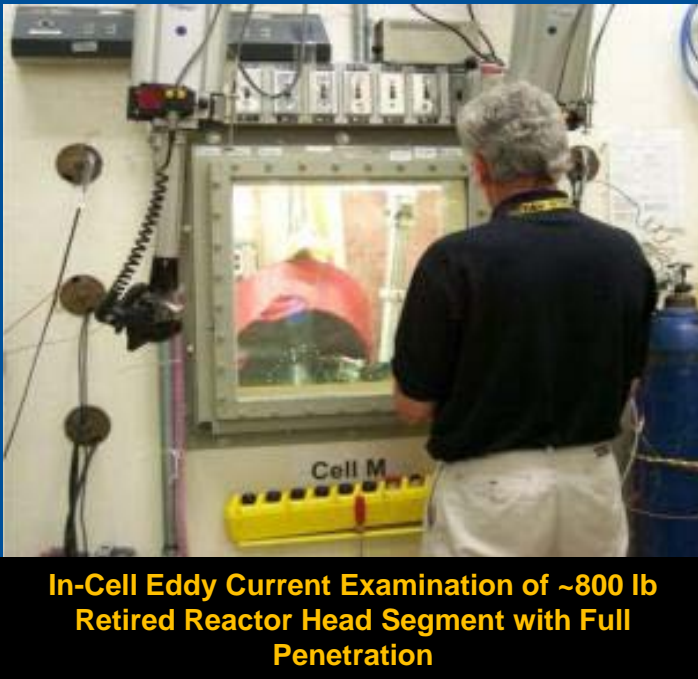
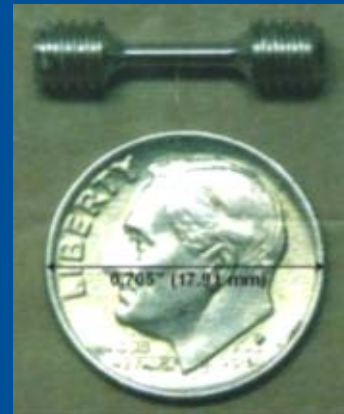
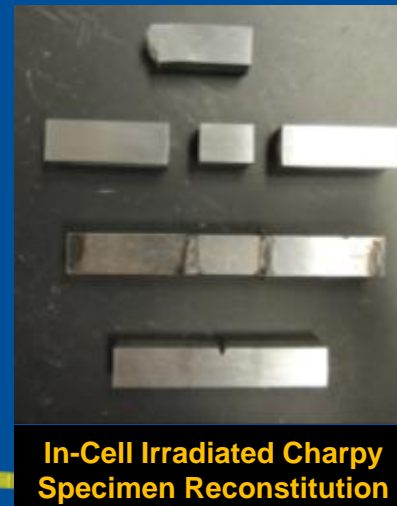
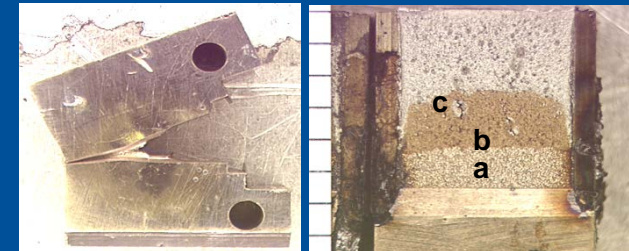
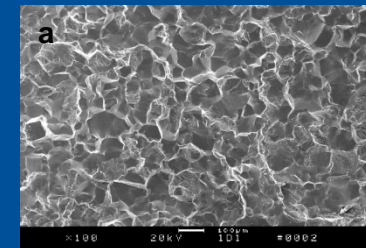
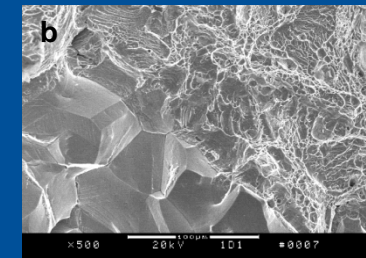
**Specimen from PWR Baffle Plate - In-Cell Fracture Toughness Machining and Testing -**

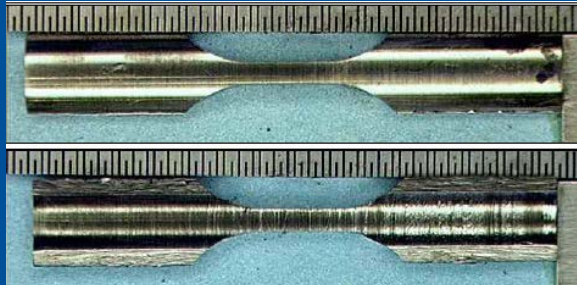
**Highly Irradiated Flux Thimble Tubes Removed from 3-Different Commercial Plants**

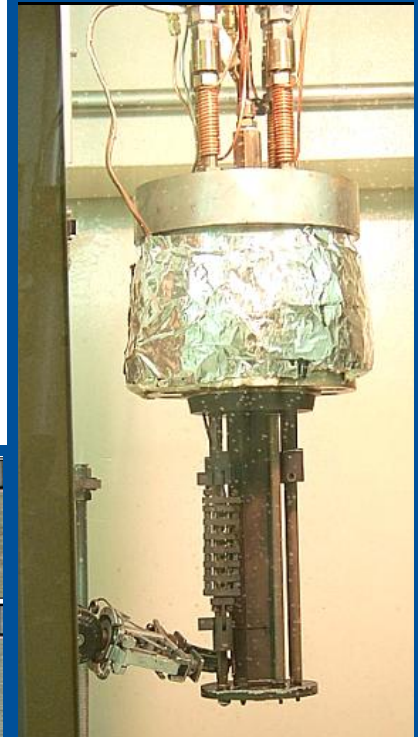
**In-Cell Machining of ~104 Test Specimens from Thimble Tubes Then Testing to Obtain Real Performance Data**

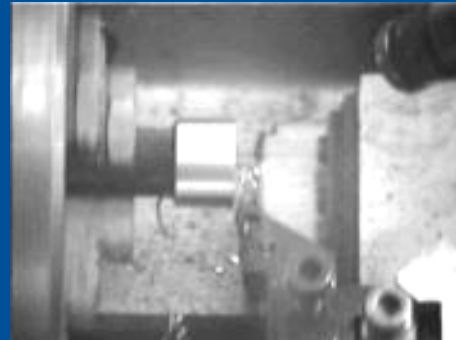
O-ring edge being machined down to target length using carbide cutting tool on lathe

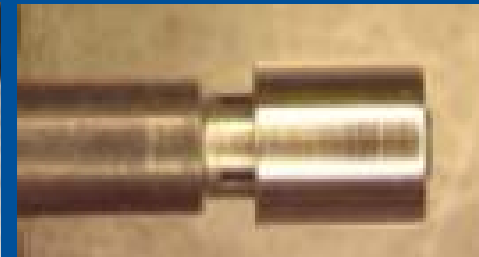
Finished O-ring ready for autoclave testing (shown attached to a split mandrel)

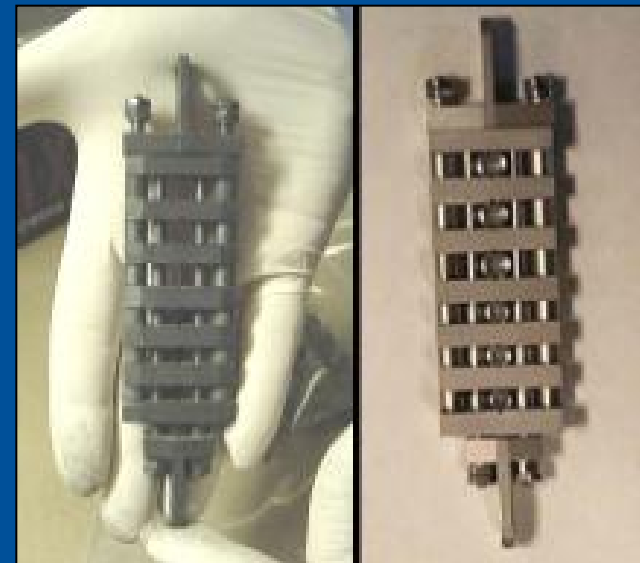
Six O-rings loaded into fixture for subsequent IASCC initiation testing under PWR simulated environmental conditions

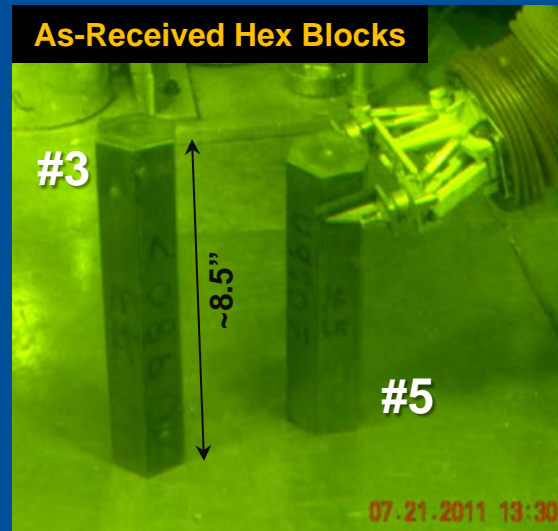
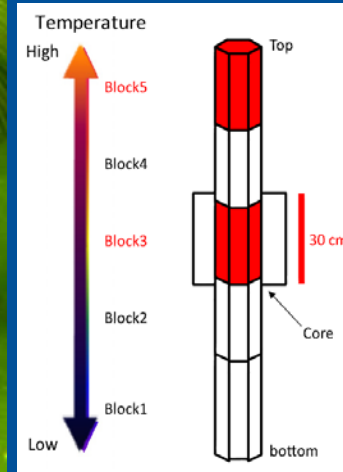
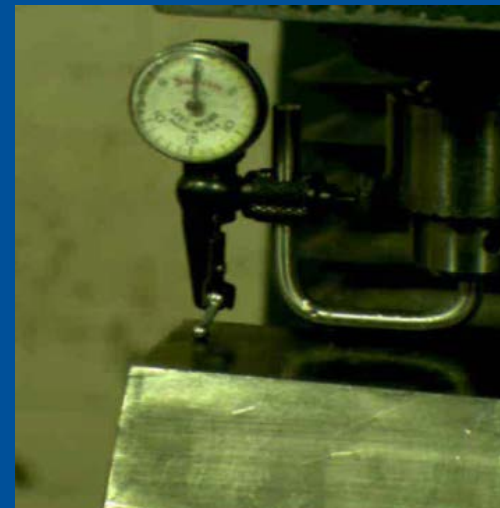
**In-Cell Dimensional Measurements  
to Quantify Physical Distortion due  
to Swelling**

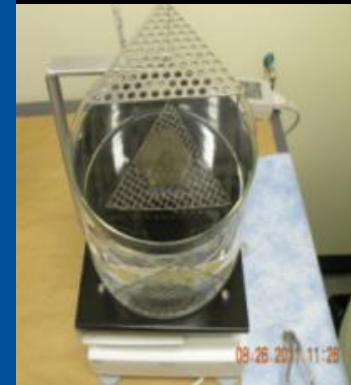
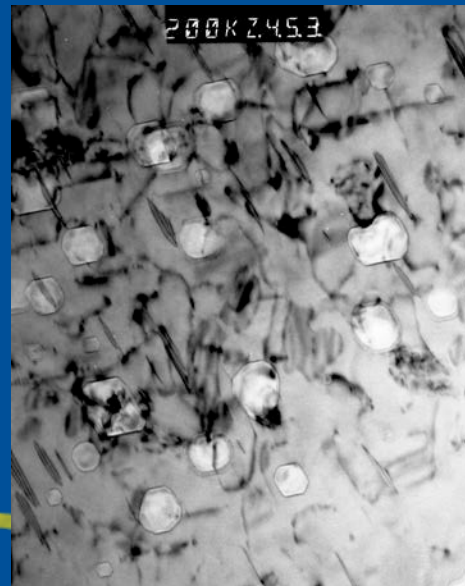
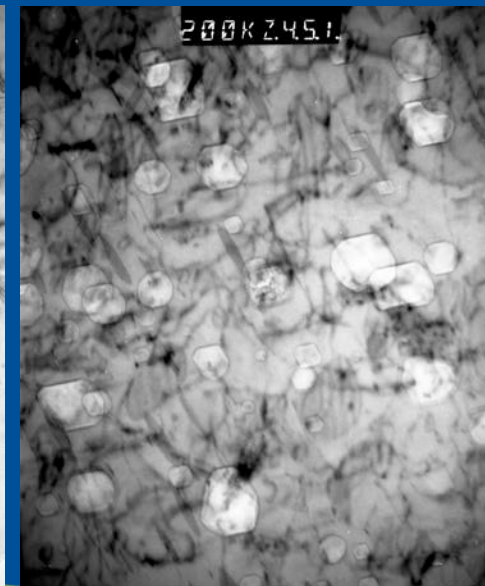
Two of Several Coins  
Precision Cut from  
Blocks

Voids of 1-10 nm

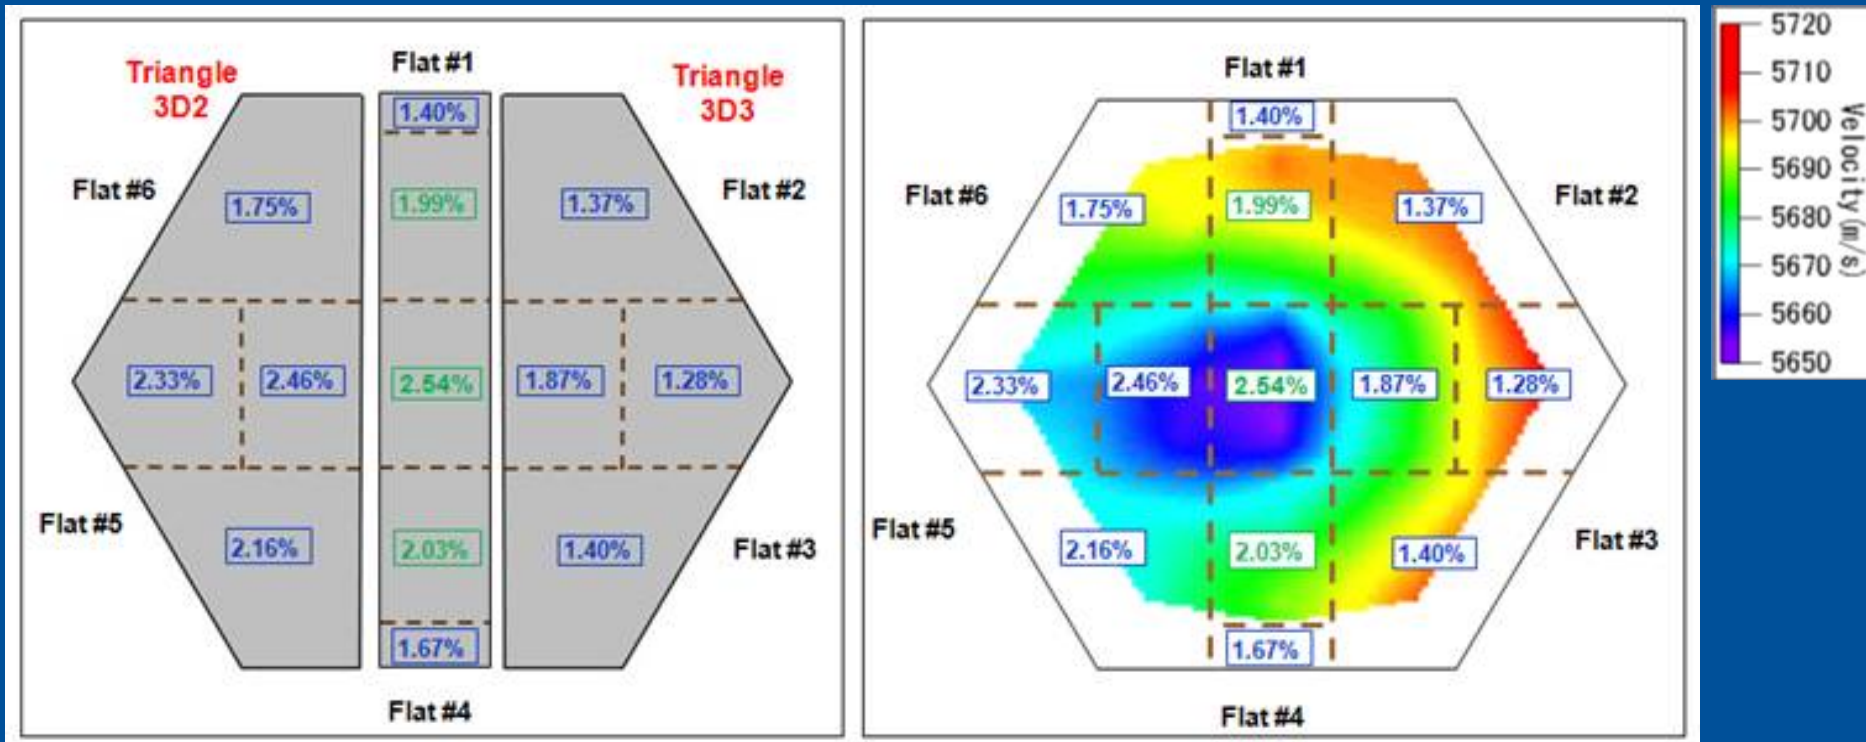
Extensive in-cell sectioning and immersion density measurements of high dose coins to determine swelling of individual pieces

Note: 3.2% swelling maximum determined ultrasonically

- **Key characterization of swelling under known service conditions in thick components**
  - Complex distribution of swelling observed
  - Material shows maximum of ~ 3% swelling
- **Exceptionally sensitive UT data successfully obtained in-cell**
  - Ultrasonic techniques demonstrated to be a valid method of measuring average void swelling across thick components
  - Development of an in-situ measurement tool appears to be possible
- **TEM and immersion density agree well with anticipated swelling distribution**
- **Basis for analysis of commercial plant exposed samples, etc.**
