# The microstructure of post-irradiated A508-3 steel and its effects on Charpy impact energy

Lu Wu, Wei Zhang, Shaoyu Qiu, Xiaoyong Wu,  
Zhen Wang, Wen He, Bang Wen, Haisheng Zhang, Huajun Mo

<sup>1</sup> *The First Sub-institute, Nuclear Power Institute of China*

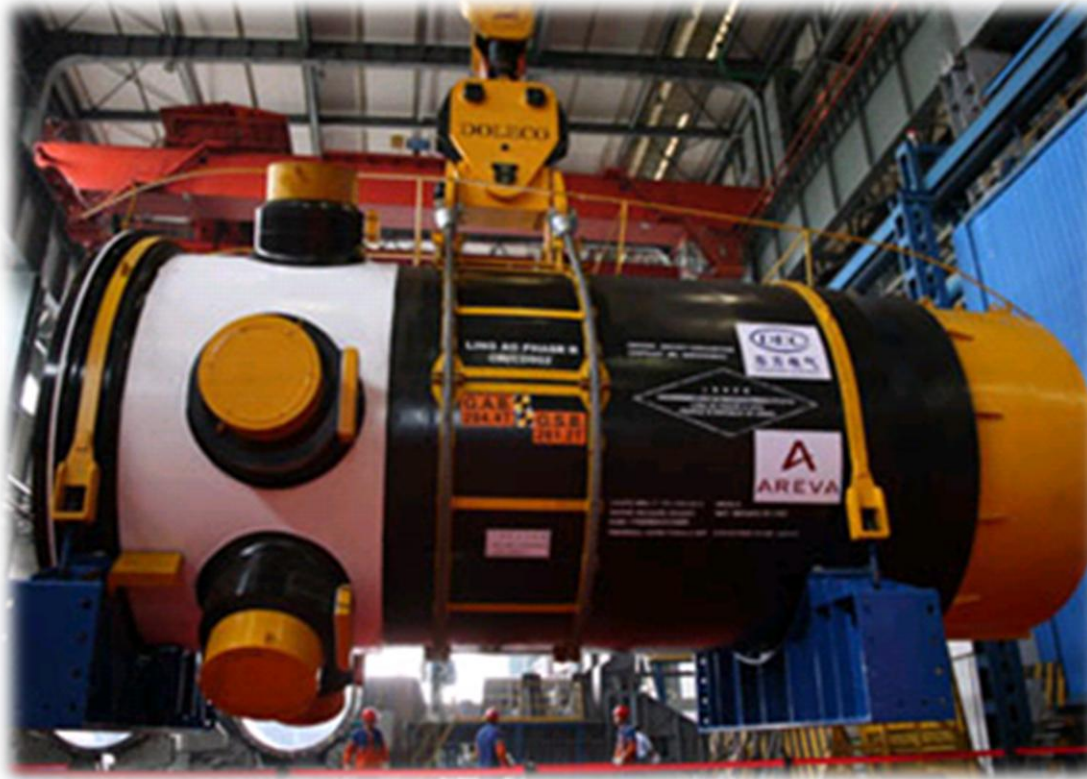
**Reactor Pressure Vessel**

## **Key issues :**

- Irradiation embrittlement

- ✓ One of the most important safety shield of the reactor
- ✓ Cannot change, determined the lifetime of the reactor

## **Severe conditions:**

- Neutron irradiation
- Multi-stress situation
- High temperature and thermal shock
- Water/steam corrosion
- .....

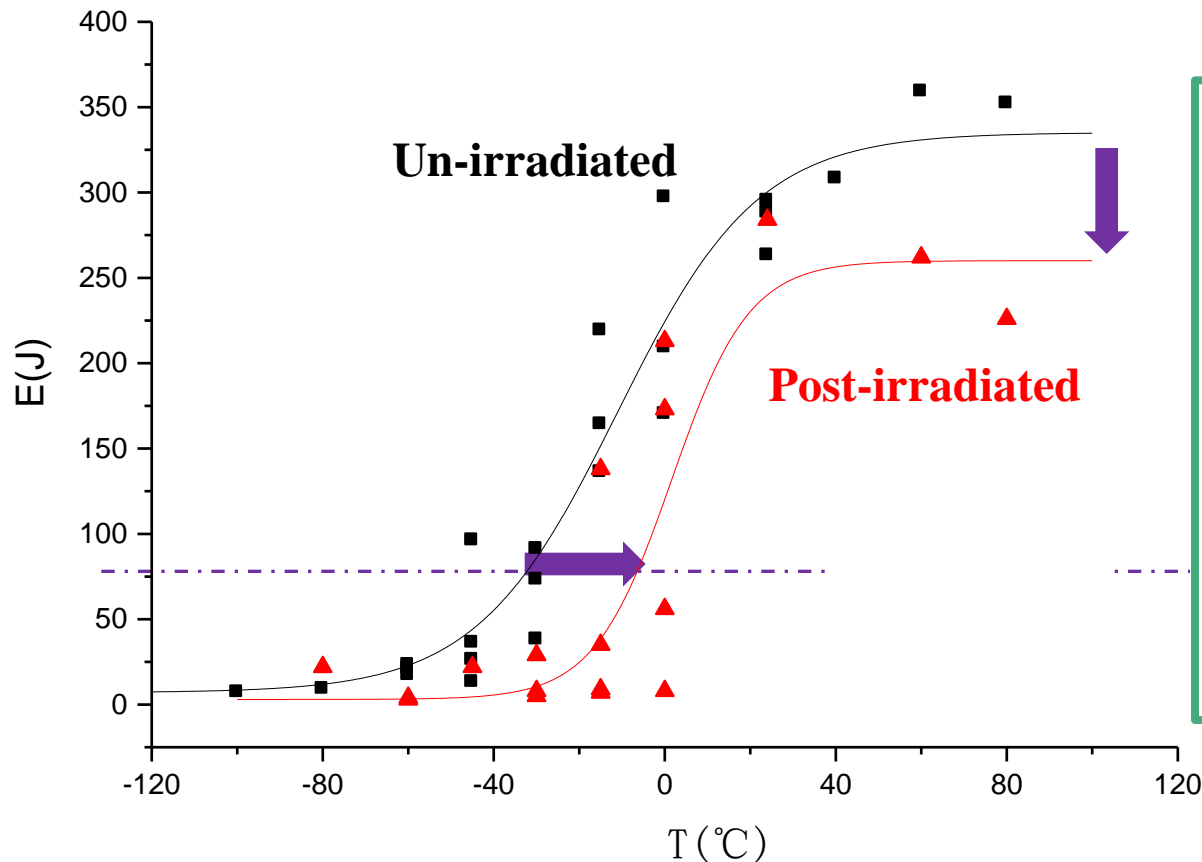
- Ductile-to-brittle transition temperature (DBTT) increase
- Maximum absorb energy decrease
- .....

The Charpy V-notch impact energies of the A508-3 steel from the HFETR as a function of temperature for the un-irradiated and irradiated conditions at neutron fluence of  $2.97 \times 10^{19} \text{ n/cm}^2$

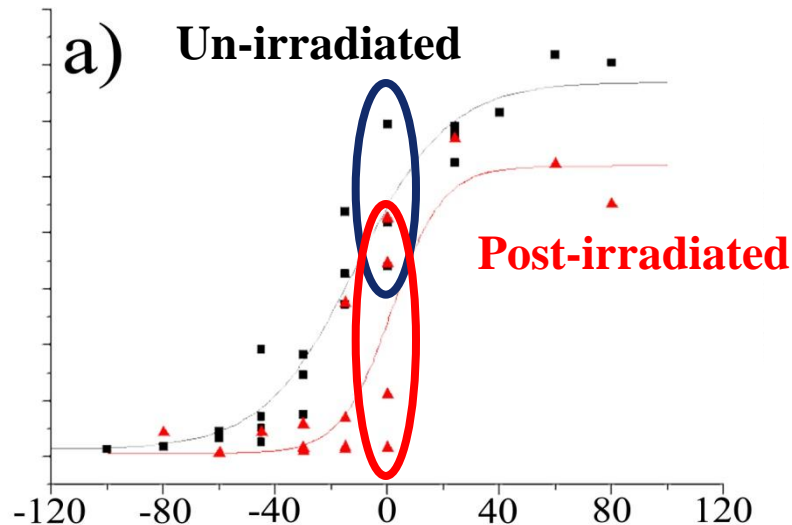
Charpy V-notch impact energy curve of A508-3 steel

*Besides the irradiation embrittlement, the impact energies of un-irradiated and post-irradiated A508-3 steel under the same testing environment are unstable.*

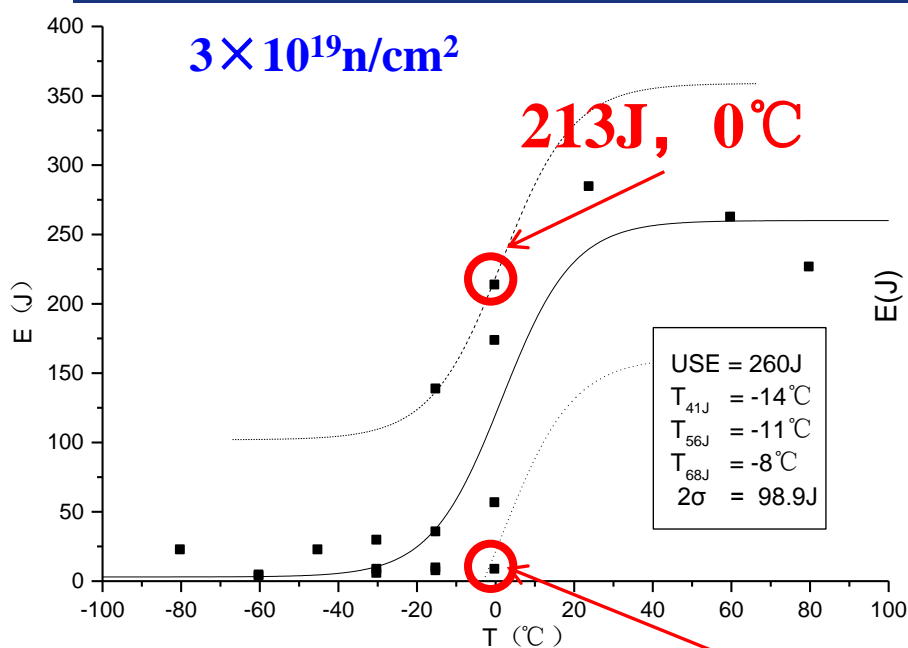
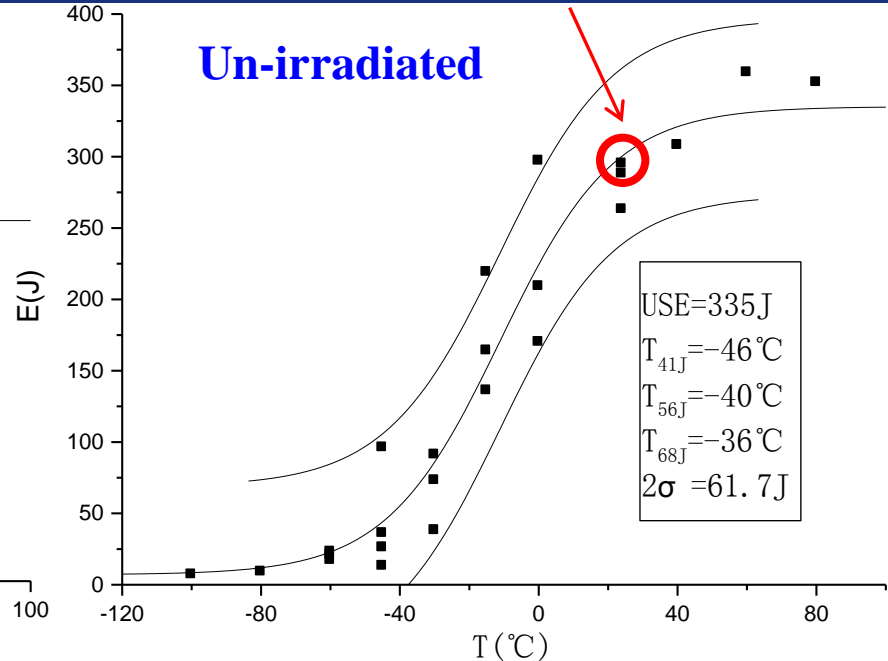
**Charpy V-notch impact energy curves of A508-3 steel**

Samples	Irradiation Temperature	Neutron fluence ( $\text{n/cm}^2$ )	Test temperature	Charpy V-notch impact energy
	T ( $^\circ\text{C}$ )		T ( $^\circ\text{C}$ )	E (J)
1#	/	0	24	263
2#	$290 \pm 15$	$2.97 \times 10^{19}$	0	213
3#	$290 \pm 15$	$2.97 \times 10^{19}$	0	8

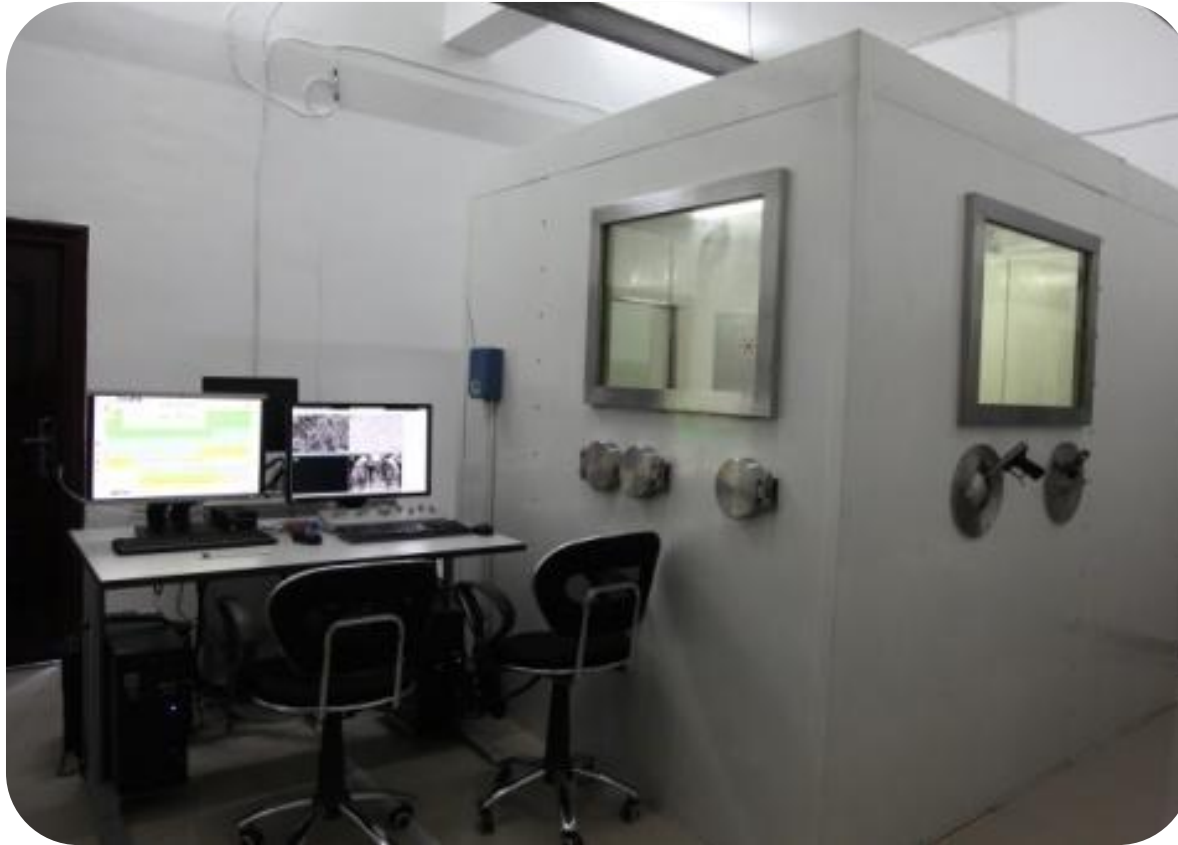
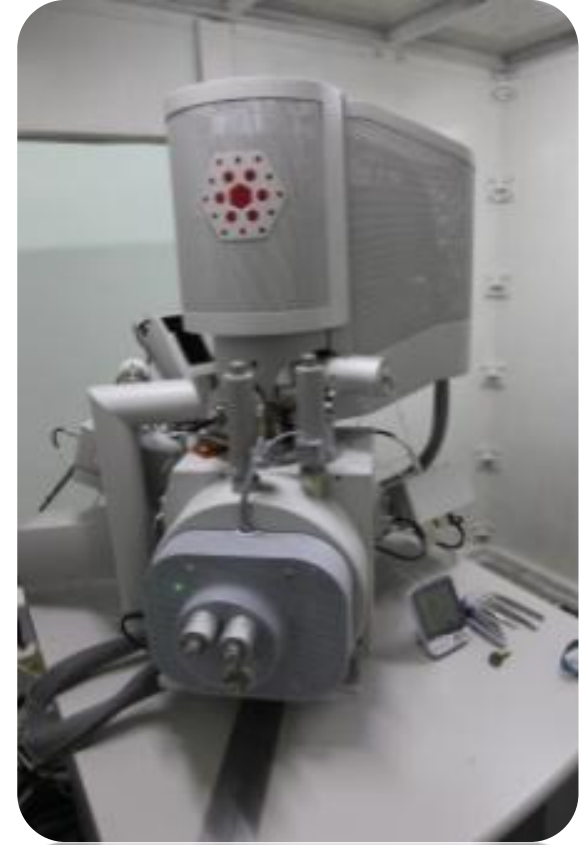
**FEI Quanta 450 FEG field emission scanning electron microscope with EDS  
inside a cast iron cell**
