Maintenance and Upgradation of RML Hot Cell Ventilation System

Indira Gandhi Centre for Atomic Research, Department of Atomic Energy,
Kalpakkam, Tamilnadu, India – 603102,

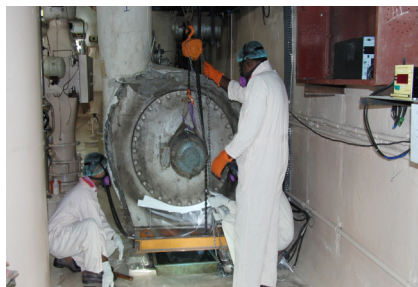
Figure 1. Venti blower of IGRS Loop

Inert environment hot cells of RML have high purity low moisture nitrogen gas inside. An inert gas recirculation system (IGRS) is used for the ventilation of RML hot cells. IGRS draws radio-actively contaminated hot nitrogen gas from the hot cells and supplies back to the hot cells after purification and cooling. IGRS together with inert hot cells forms a closed loop called IGRS loop. IGRS consists of an activated charcoal bed for the removal of organic/inorganic impurities, HEPA filter for the removal fine radioactive particles and cooling coil for the removal of heat from the nitrogen, and a hermetically sealed venti blower for the circulation of nitrogen through IGRS loop. For redundancy, in the loop 100% standby capacity is provided for the components such as HEPA filter, cooling coil and venti blower. The venti blower can develop 400mm water column(WC) pressure and can achieve a recirculation rate of 4000Nm³/hr (Fig.1). A variable frequency drive is used to control the speed of venti blower and thereby the flow through the loop. In two instances which were separated by about a decade, abnormal noises were heard from the venti blower #1. Investigations revealed that the root cause for both the incidents were collection of condensate water in the bottom portion of the blower casing.

Over the years, leak paths like minor cracks were formed in the gaskets and weld joints of IGRS loop. This has resulted in the ingress of ambient air into the IGRS loop which lead to the increase of moisture content in the nitrogen. In the IGRS loop, brine solution is circulated through cooling coil for the removal of heat and moisture from nitrogen gas. A part of the water condensed in the cooling coil carried by nitrogen to the venti blower casing and got accumulated there. Another reason suspected for the incident was the blocking of water flow path in the cooling coil casing. Over the years, the amount of water collected in the blower casing became significant. After isolating the blower, with health physics surveillance, maintenance activities have carried out to remove the water from the blower casing. Fig. 2 shows water stagnated inside the casing of the blower. Execution of the maintenance work involved preparation of operating procedure and obtaining safety clearances and safe disposal of accumulated water. Repair crew with proper personal protective equipment (PPE) carried out the maintenance work. After removal of the condensate water, trial runs were performed to obtain clearance for regular operation of the venti blower.
