Refurbishment of a Nuclear Facility in operation: Focus on the check and thorough maintenance of hot cell's handling equipment

GRUBER Philippe¹, BRUGUIERE Lionel¹ & IDASIAK Jean-Marc¹

¹French Alternative Energies and Atomic Energy Commission, Nuclear Energy Division,
CEA Marcoule – Installation de Surveillance des Assemblages Irradiés, Bagnols sur Cèze, France

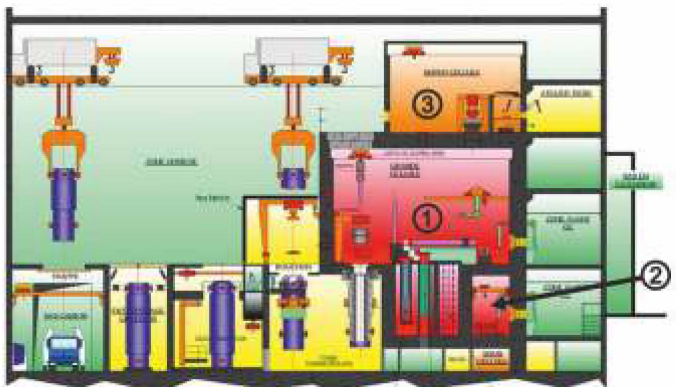
Figure 1 ISAI plan and operation cinematic.

The operation cinematic is organized around the cell's block formed by two hot cells in red zones (totally forbidden for humans) called "Large Cell" (1- figure 1) and "Small Cell" (2-figure 1) and their intervention cells called "Super Cell" (3-figure 1) and "Under Cell" (4-figure 1) respectively.

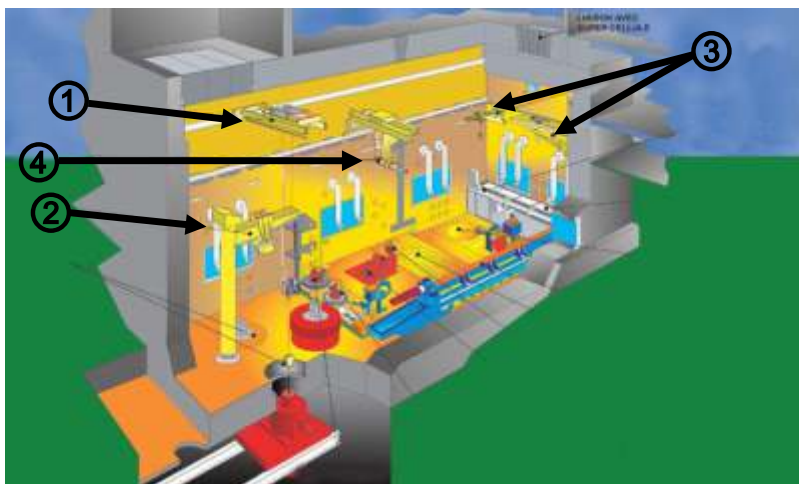
Figure 2. Large Cell Plan

The Large Cell is used to condition highly irradiative elements. It has high dimensions (L 13m x w 6m x h 9m) and is totally covered of stainless steel. It has 8 working stations, each equipped with two master-slave manipulators.

It is also equipped inside with :

A 5-ton double girder overhead travelling crane (1-figure 2),

A 10-ton pillar jib-crane (2-figure 2),

Two single girder wall travelling crane 250 kg and 500kg capacity each (3-figure 2),

A power telemanipulator 250 kg capacity (4-figure 2) on a 2-ton double girder overhead traveling crane.

They were installed between 1983 and 1984 and most of their components are removable and portable in the “super cell” for maintenance or reparation. The Large Cell is a red zone and strictly forbidden to humans' intervention because of radiological conditions.

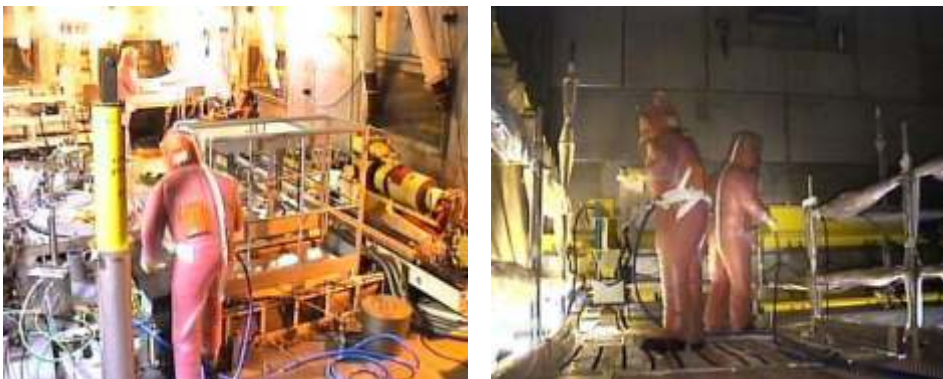
Figure 3. Cleaning-up floor and + 5m

First, a cartography of contamination was made with telemanipulator to determine humans intervention conditions after evacuation of all irradiative source term of the cell. The aim was to attain low contamination to authorize maintenance intervention without Air Fed suits.

The height of handling equipment needed introduction and progressive assembling scaffolding on the entire square of the cell at successive different height (3m, 5m and 7m). For each level, clean-up was necessary.

A complete contamination and irradiation cartography per square meters from floor to ceiling permitted to decommission temporary from red zone to orange one.

The global radiation dosimetry of this operation was approximatively 3,4 mSv for 108 interventions of 2 hours each.

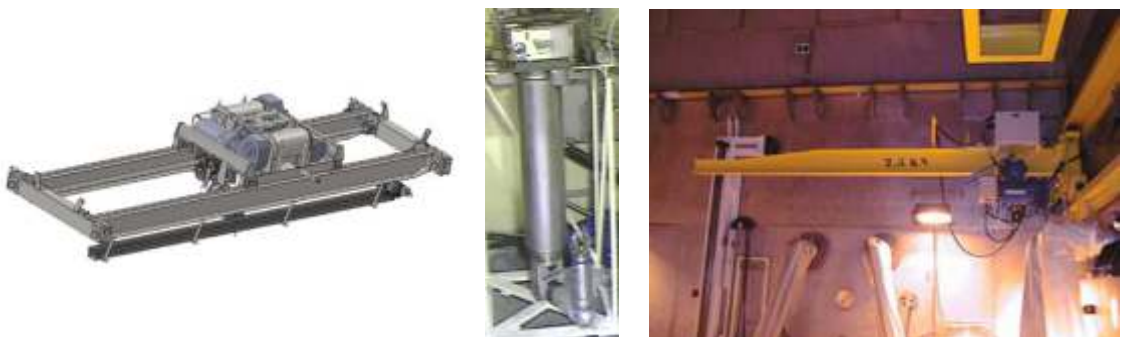
Figure 4. Overhead crane (3D model) - Power telemanipulator - Single girder wall travelling crane

The preparation of this operation consisted in considering each crane to identify unattainable parts and potentially worn parts. All long-lead items were ordered at the earliest.

All final as-built drawings of 1983 were used to fabricate the elements and to model the equipment in three dimensions.

The operators also checked the clamping strength of the handling equipment's anchor in the cell.

The expertises on the different equipment showed the thorough maintenance of unattainable part should permit to limit future operating incident and perturbation on the ISAI evacuation capability.
