**WORKING GROUP "HOT LABORATORY AND REMOTE HANDLING"
PLENARY MEETING 1991**

LHMA-Services to the Nuclear Industry

**L.H.M.A.
TEC/39.NRE39/23/JVdV/fq
June 1991**

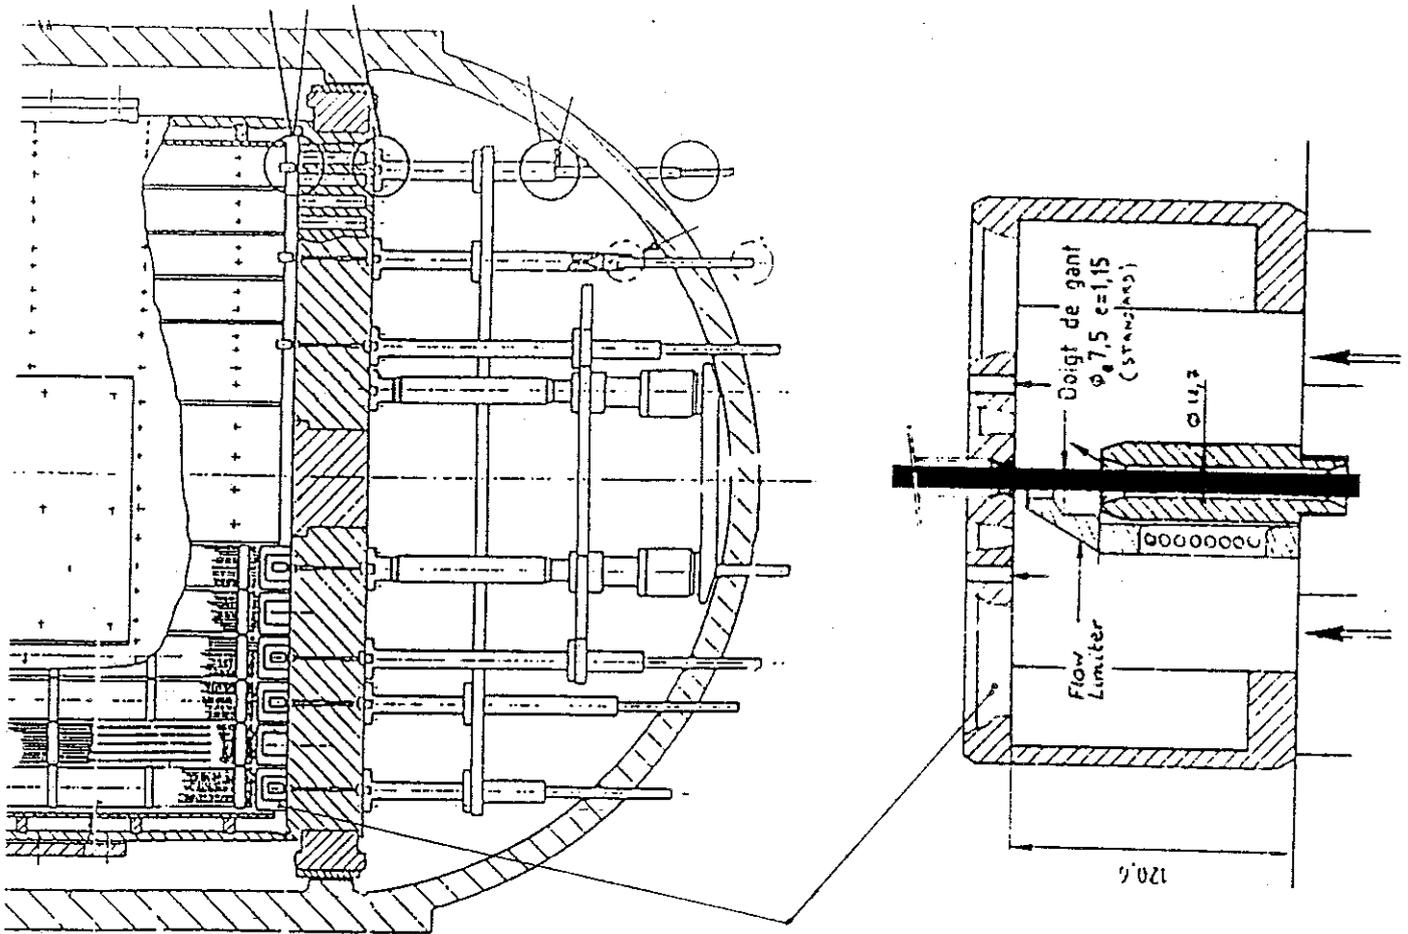
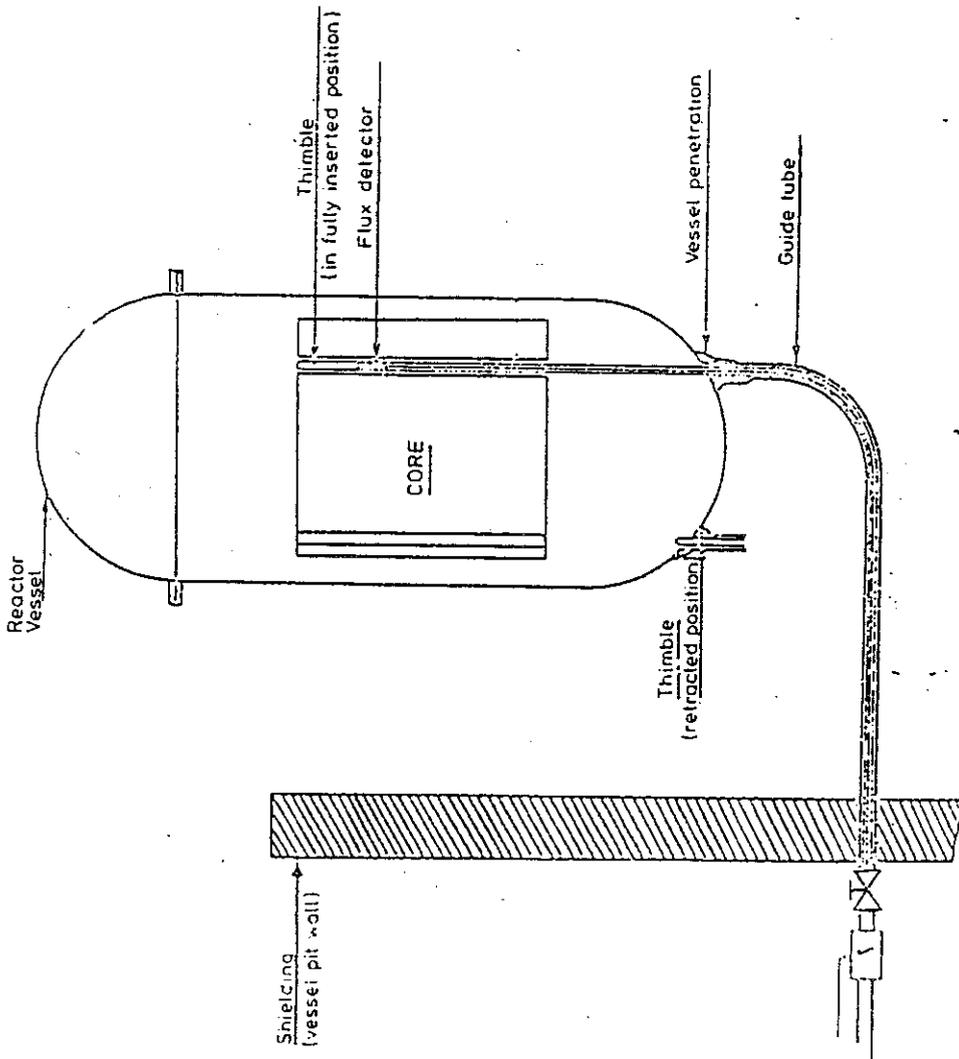
The thimbles are guided at different locations in order to ease their introduction into the fuel assembly and to avoid excessive vibration in normal operation. The thimbles must be able to function as a part of the pressure boundary keeping the core sealed as securely as possible. Fig. 1 gives the general arrangement and incore guiding of the instrumentation system.

Fig. 1.
 Instrumentation system - General arrangement
 and
 Incore instrumentation guiding system.

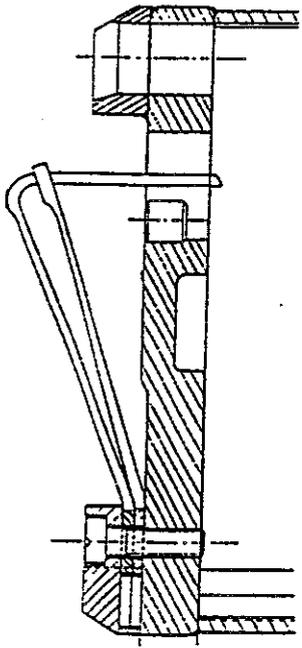
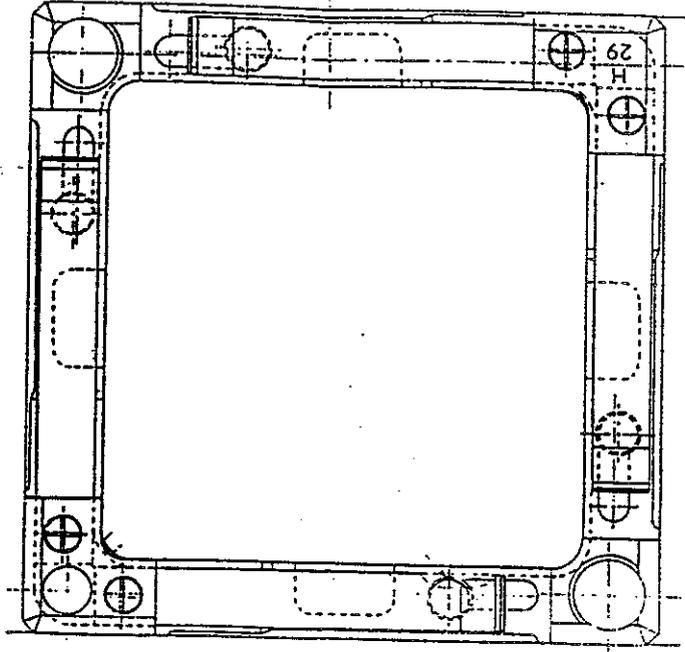
As a result of bolt rupture, the edge clamp and hold-down spring, at the top of fuel assemblies, can be displaced; this might lead to blocking of the control rod movement. Fig. 3 shows the hold down spring clamp system.

- intergranular stress corrosion cracking (SCC) is responsible for the observed damage in the Inconel 600 bolts in primary cooling water at operating temperatures;
- residual surface stresses induced by the peculiar bolt manufacturing techniques at (and close to) the head-shaft connection, are the major source of the stresses required for the SCC mechanism;
- the microstructure of the bolt material is typical of a rather vulnerable Inconel 600 condition;
- on-site ultrasonic testing is not very efficient to identify cracked bolts.

Fig. 3. Fuel assembly and hold down spring clamp system.

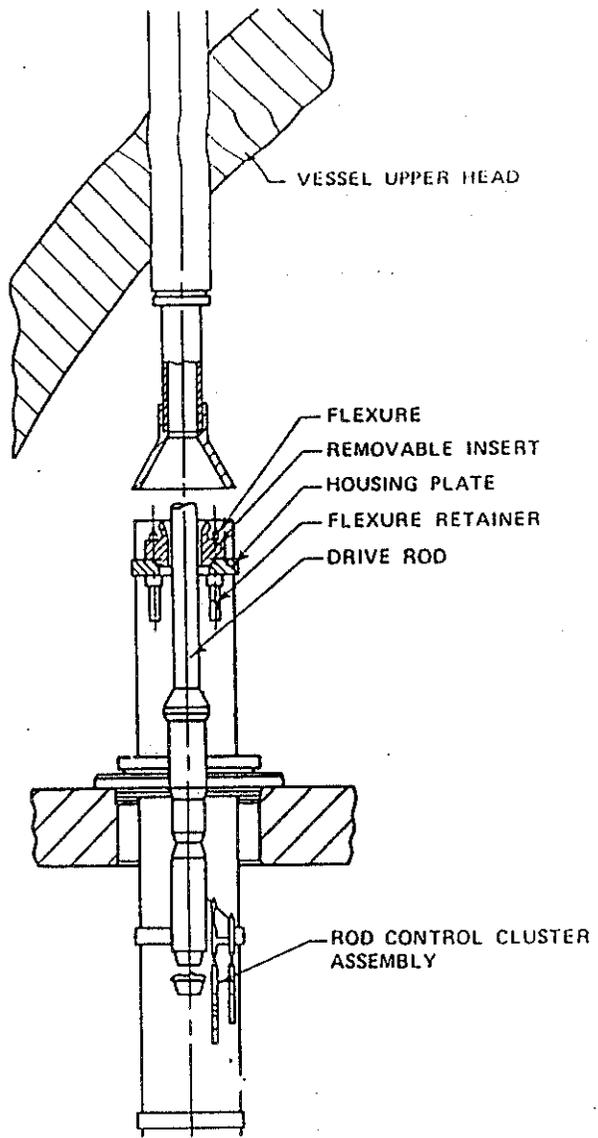
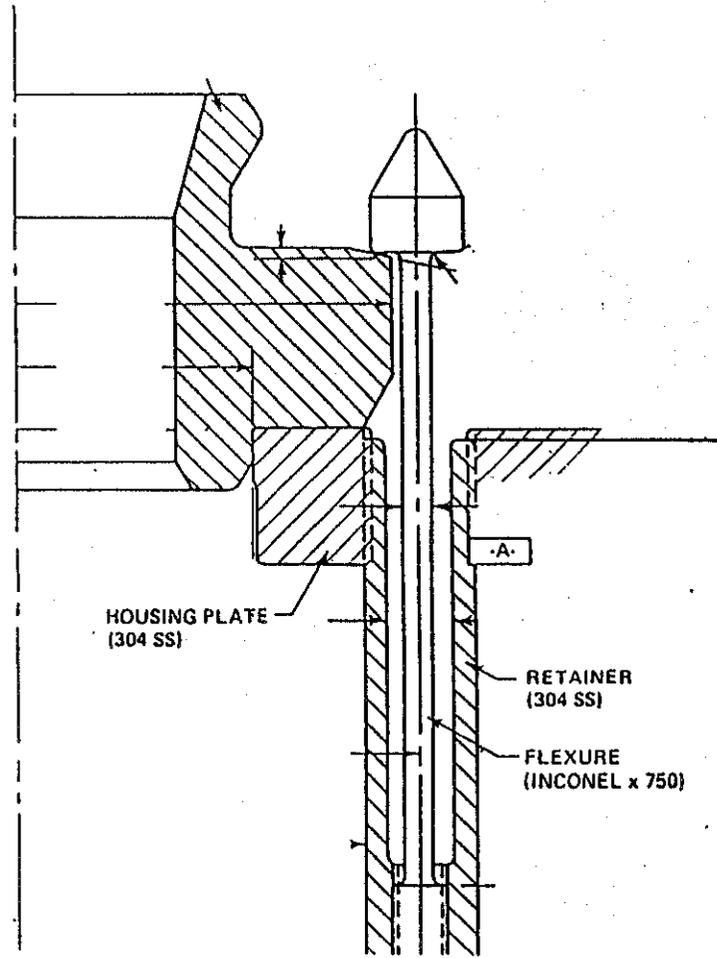
The considered flexures are part of a system - housing removable inserts and retainers - installed to guide the drive rod of the control rod cluster assembly. Fig. 5 shows the control rod hardware and flexure system.

In several PWRs, extensive cracking has been observed in a number of these flexure pins.

Fig.5. Control rod hardware and flexure system.

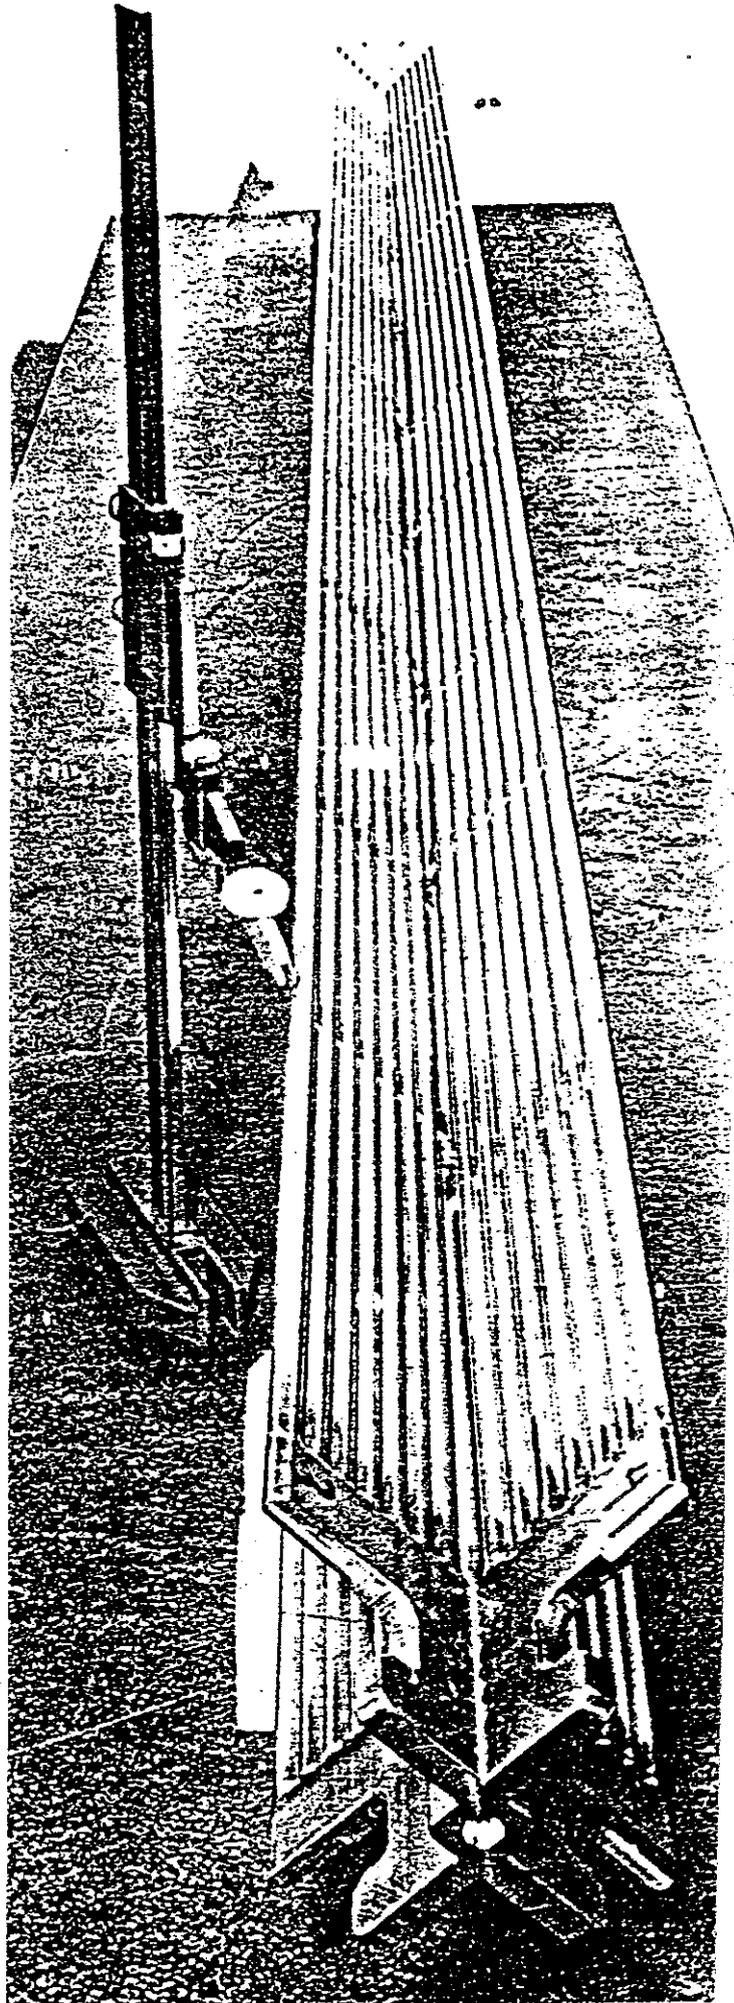
In some of the older PWRs, a cruciform array of cylindrical rods of absorbing material was adopted as reactivity control system. See Fig. 7. The absorber section of these rods is made of extruded bars drawn from a Ag 8% - In 15% - Cd 5% alloy clad in cold-worked type 304 stainless steel tubing.

Irradiation-induced swelling of the absorbant, as well as plastic deformation due to the axial impact forces during the insertions and extractions of the control rod, promote stress increase in the cladding. Embrittlement of the cladding at the lower part of the array is also to be considered as contributing to the cracking process.

Metallographic- and SEM examinations have revealed typical intergranular cracks, initiating at the outer surface of the cladding.

Fig.7. Cruciform array of cylindrical rods.

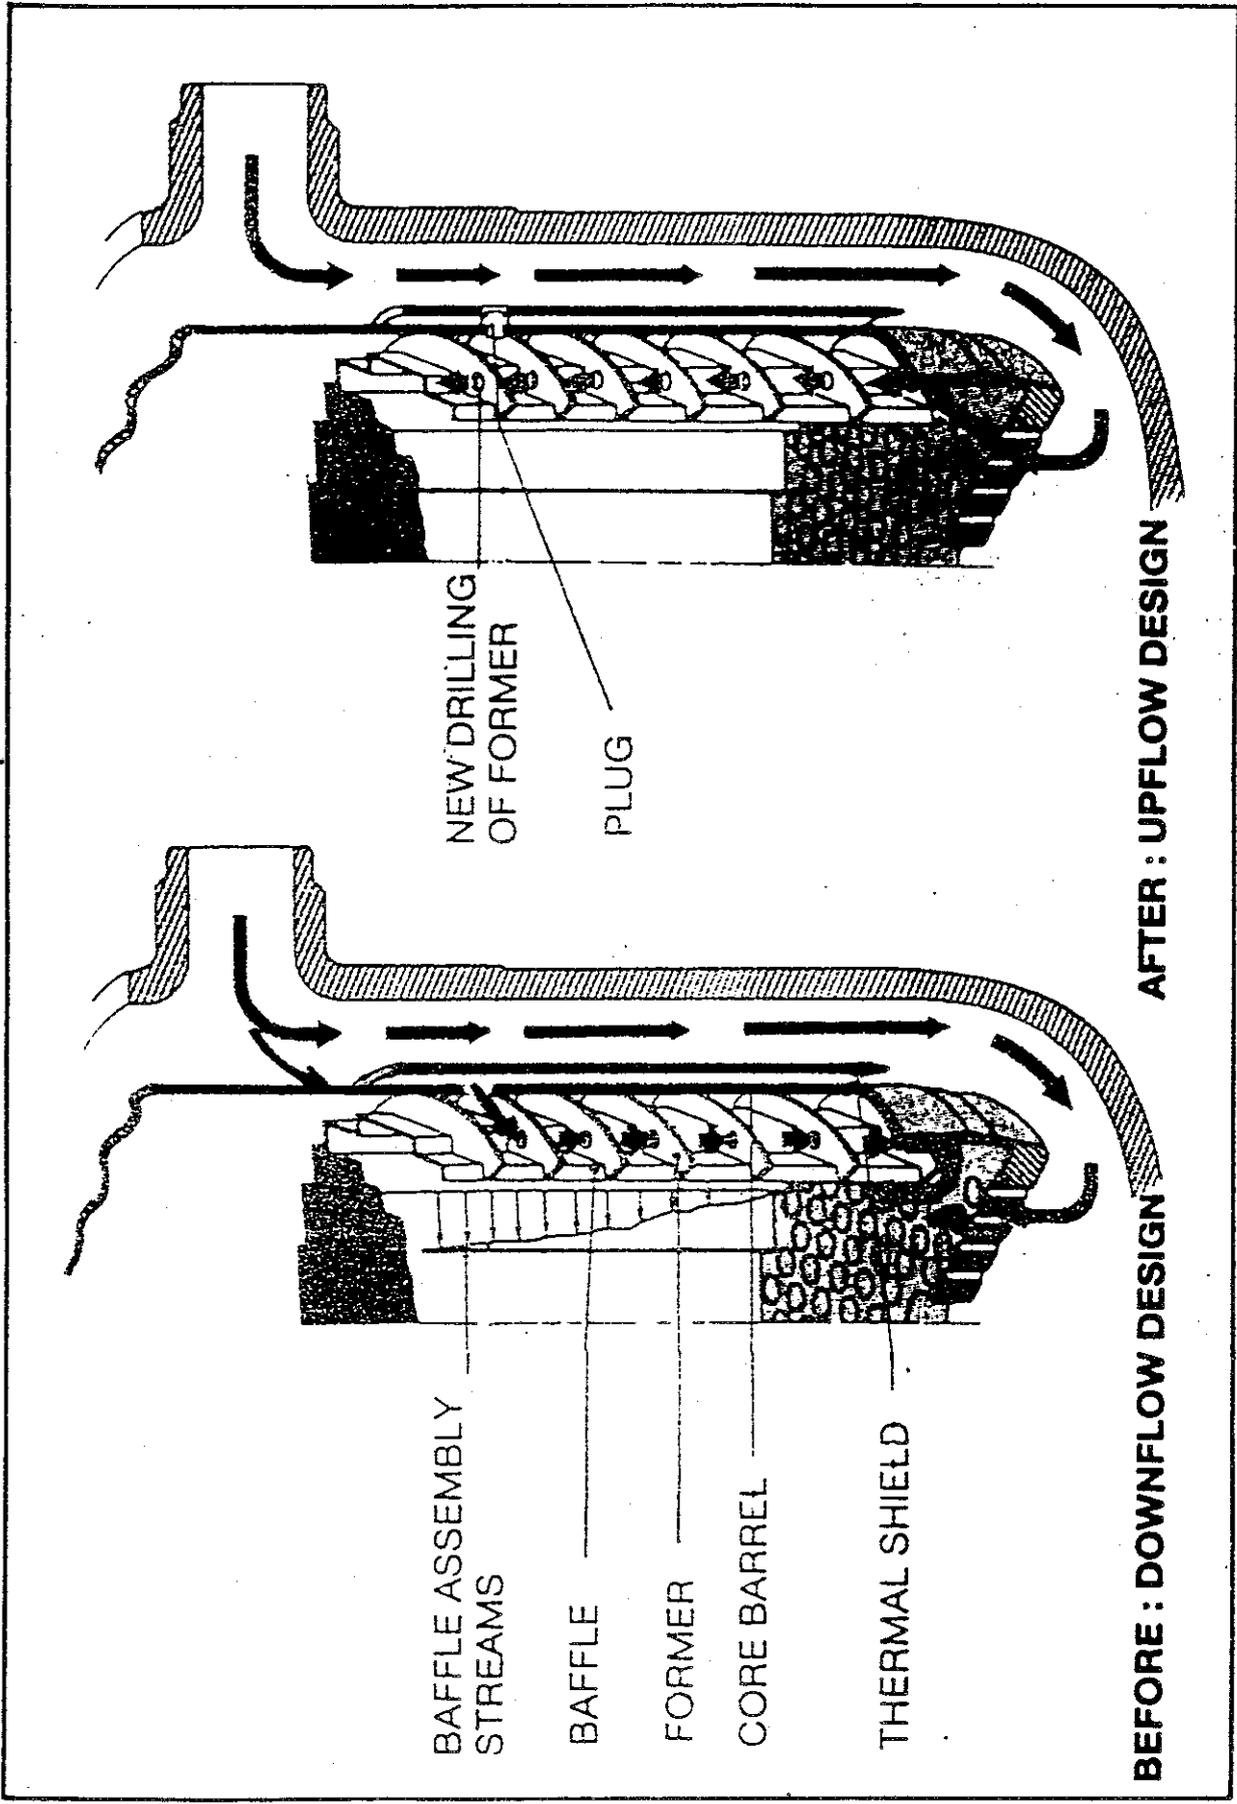
This implies first that all holes drilled through the thermal shield, be aligned with the holes in the concentric core barrel; second, specially designed plugs must be fit through these holes in order to block them off. Fig. 10 illustrates the operations involved.

Fig.10. Results of an upflow conversion

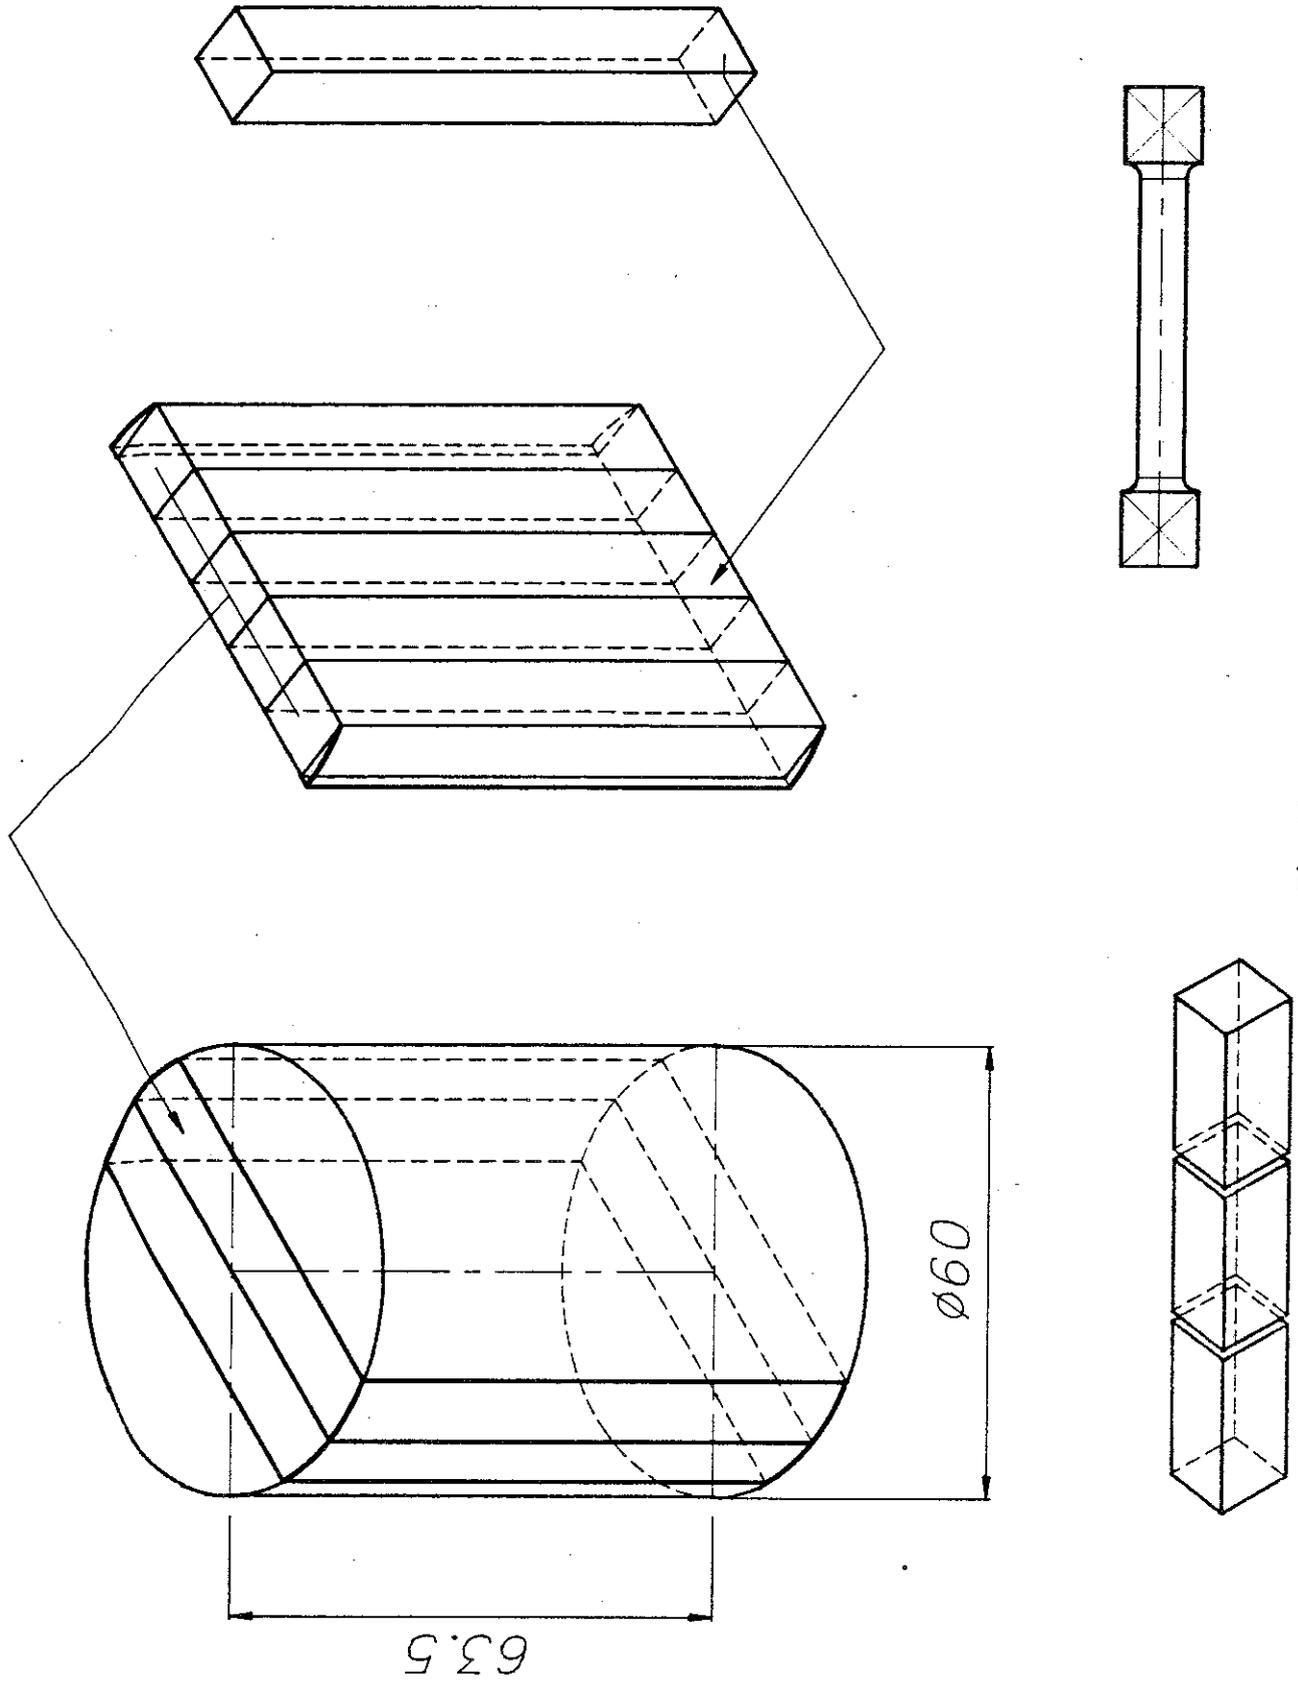
So, out of the massive blocks, different test specimens have been manufactured. See Fig. 11.

Fig.11. Thermal shield steel block and specimen conditioning.
