EXAMINATION OF IRRADIATED CONTROL RODS AT MAGNOX ELECTRIC

**Presentation to the European Working Group
Hot Laboratories & Remote Handling**

Prepared by Magnox Electric Staff

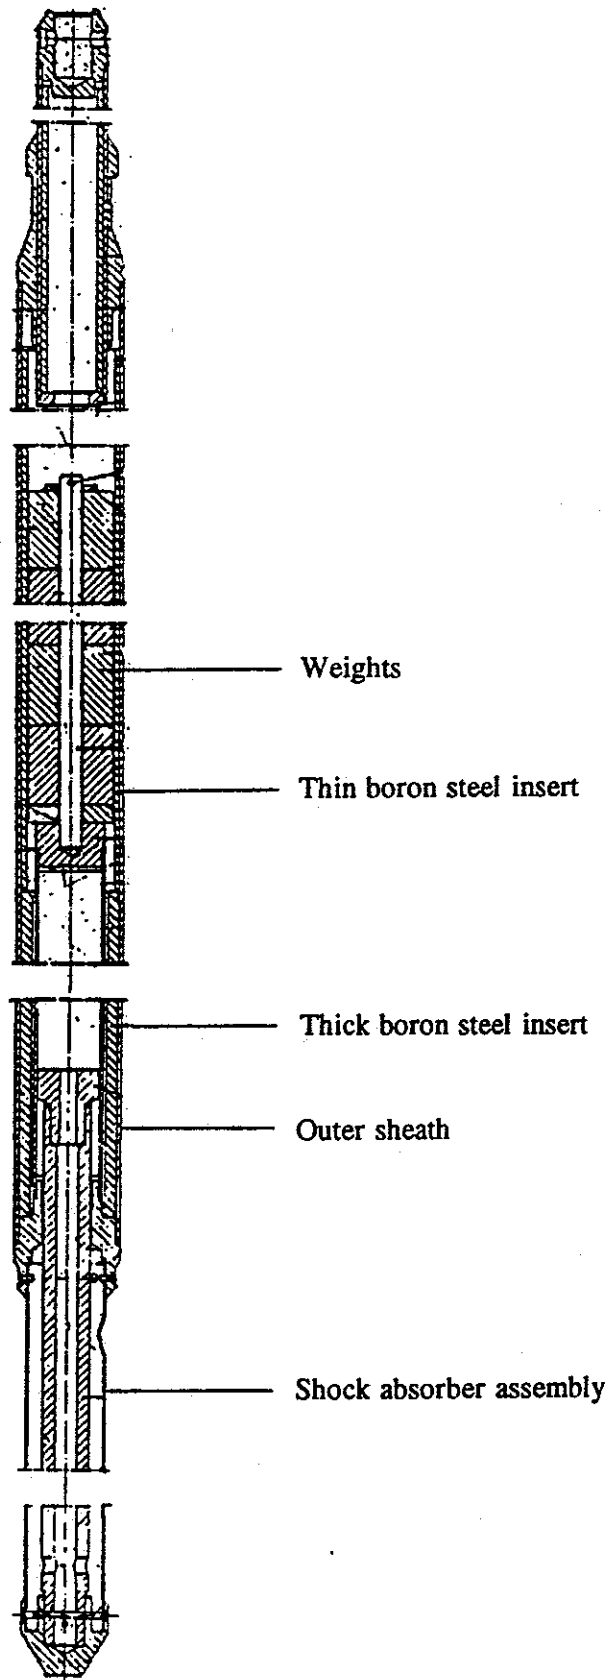
Figure 1: Diagram of control rod

Magnox Power Stations use natural Uranium fuel with magnesium alloy cladding, CO₂ coolant and graphite moderator. Typical inlet and outlet temperatures are 190°C and 360°C, respectively. Primary and secondary control rods have cylindrical boron steel inserts, retained by a ferritic or austenitic steel sheath, Figures 1,2. The insert has a typical boron content of 3-4wt% and is around 5mm thick. The sheath has an outer diameter of 8cm and wall thickness of 2-3mm. Design is station-specific. Slow neutron absorption by the boron steel insert leads to significant swelling as ¹⁰B transmutes to Li and He. The sheath must retain sufficient ductility to accommodate this swelling. In 1992 a control rod removed from the Wylfa station, in Wales, was found to have suffered sheath damage. A substantial programme of Post Irradiation Examination (PIE) was established immediately for this control rod in order to establish the reasons for the apparent loss of sheath ductility.

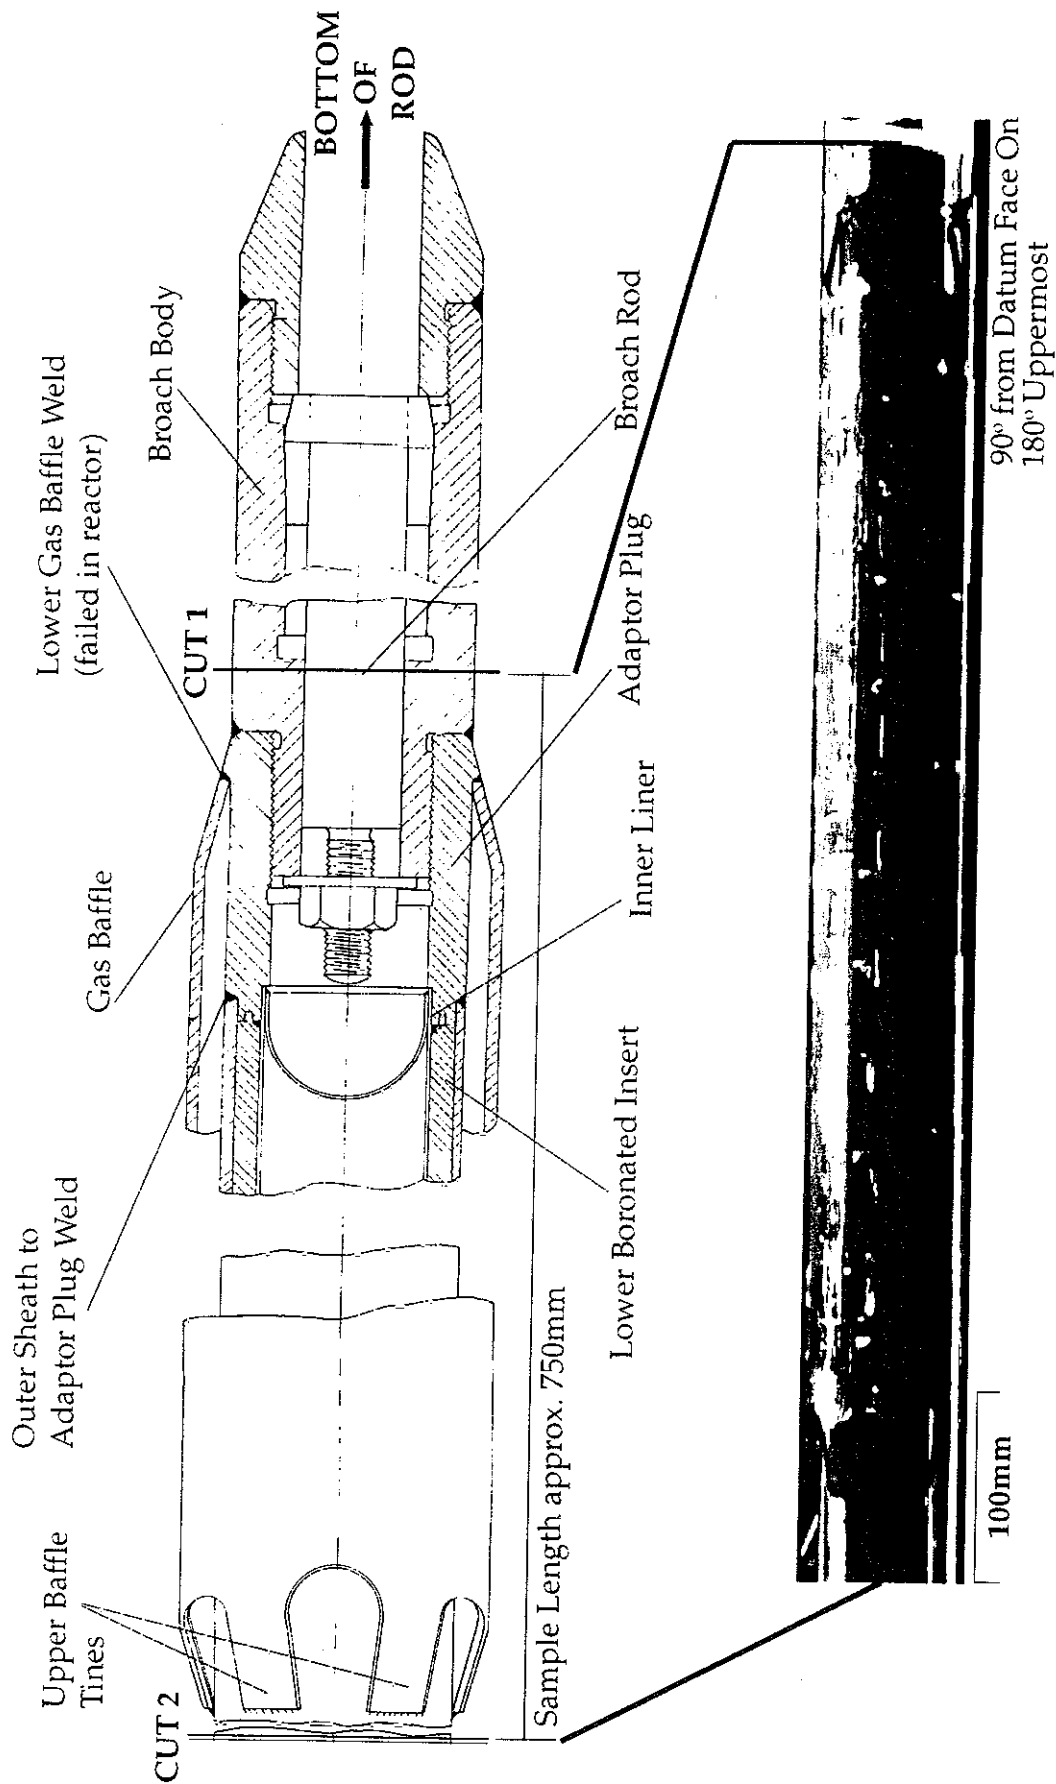
Figure 2: Sample of Bradwell Control Rod BR61 received into the caveline at Berkeley Centre with section of engineering drawing showing location of critical items for PIE.
Note: White markings were applied in-cave.

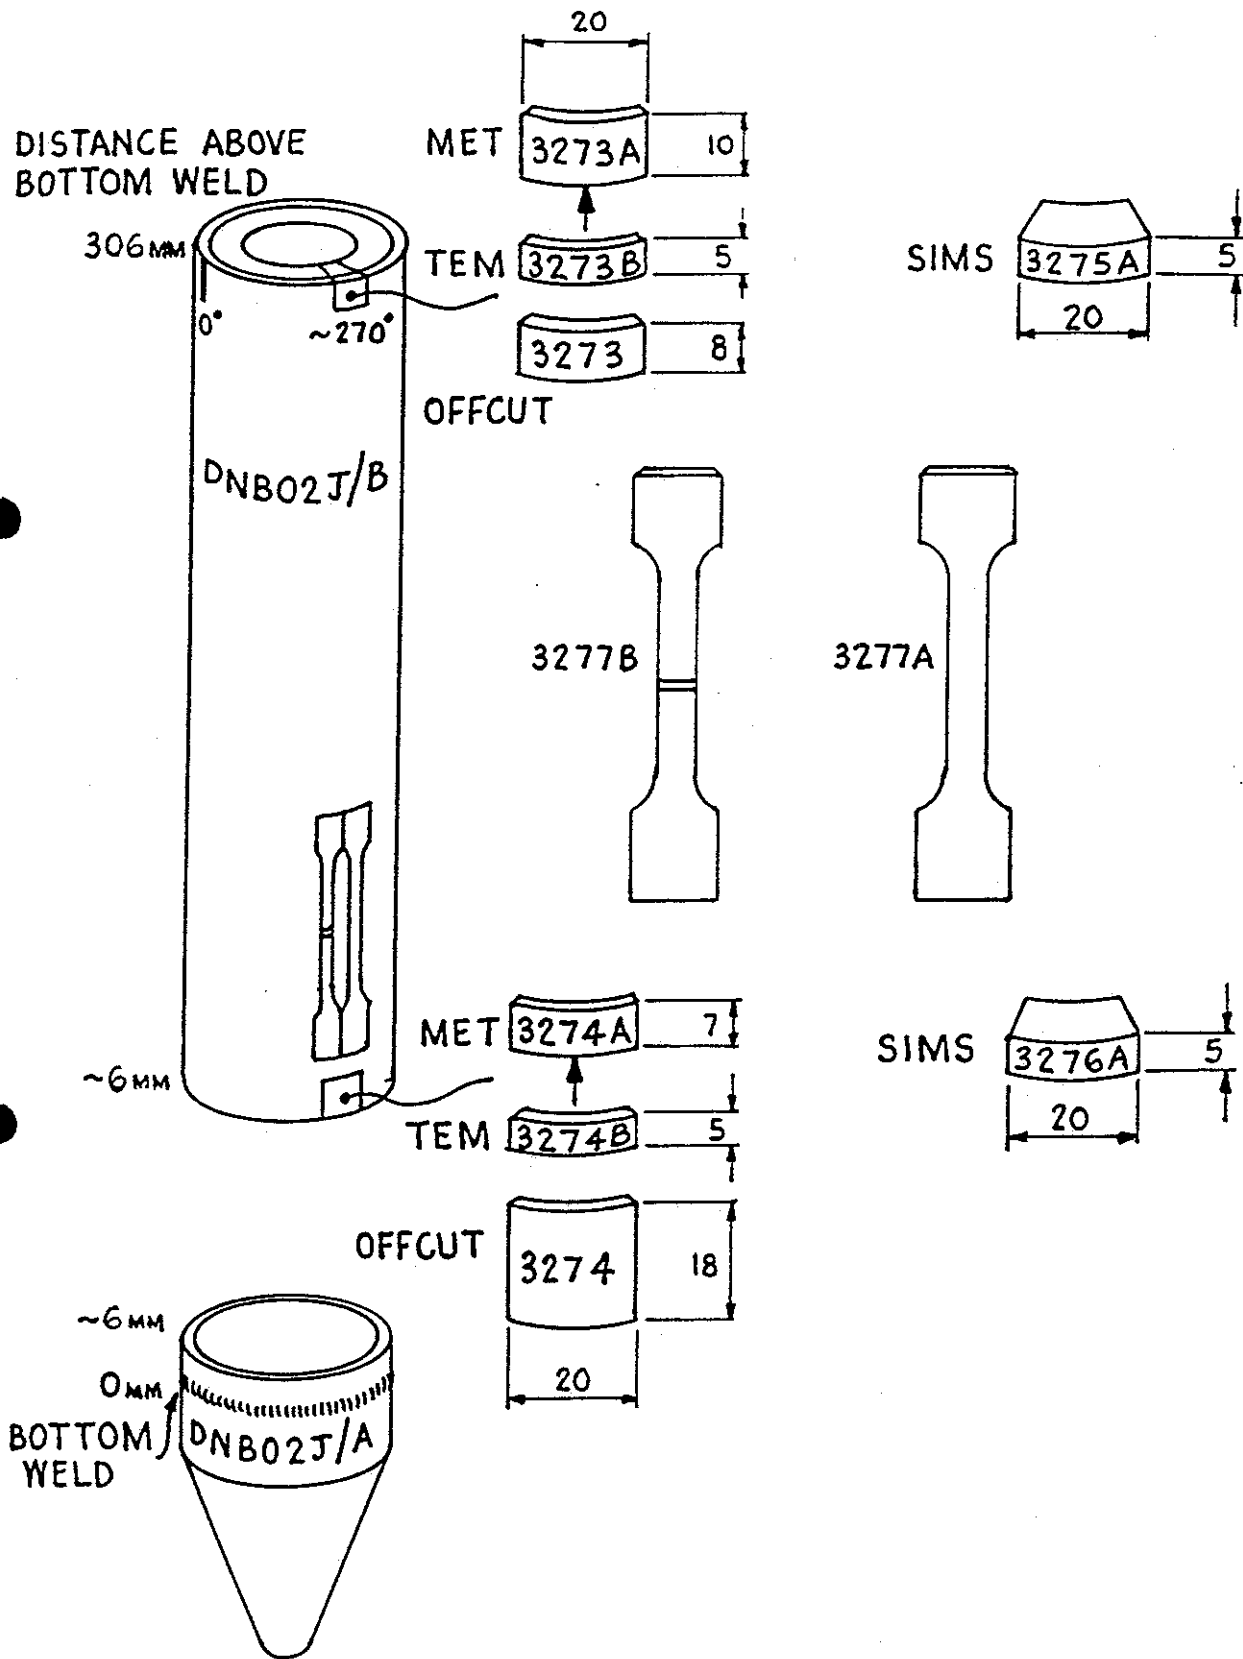
Figure 3: Cutting Diagram for Specimens from Dungeness A Control Rod 02J

Following the macroscopic examinations a cutting programme was designed and the component divided into specimen samples (Fig. 3) using the in-cell hacksaw and slitting machine tools. Those samples identified for tensile testing were finish machined on the in cell CNC milling machine.
