Eddy Current Detection of Cladding Defects Due to Fuel Pellet Imperfections

D. Papaioannou^a, R. Nasyrow^b, N. Niagolova^c, V.V. Rondinella^d, W. Goll^e

Abstract. An eddy current device has been used to localise cladding defects on irradiated fuel rods. The system has been initially tested with cold specimens, providing very good results and is now in regular operation in a hot cell at the Institute for Transuranium Elements (ITU). In this paper we demonstrate the system's performance and present recent results on a series of irradiated fuel rods with PCI-failures and partly long splits (secondary failures). The rods were delivered in tight capsules and only gamma scans could be done in the β -, γ -reception cell. Big defects were well visible through distortions in the gamma profile, whereas the smaller ones were very hardly detectable. They could be precisely localised later on, as soon as we cut the fuel rod and examined the individual segments with the eddy current device in an α -cell. Careful sampling around the defect location, specimen preparation and detailed microscopic analysis confirmed cladding cracks driven by fuel pellet imperfections or, more specifically, by miss

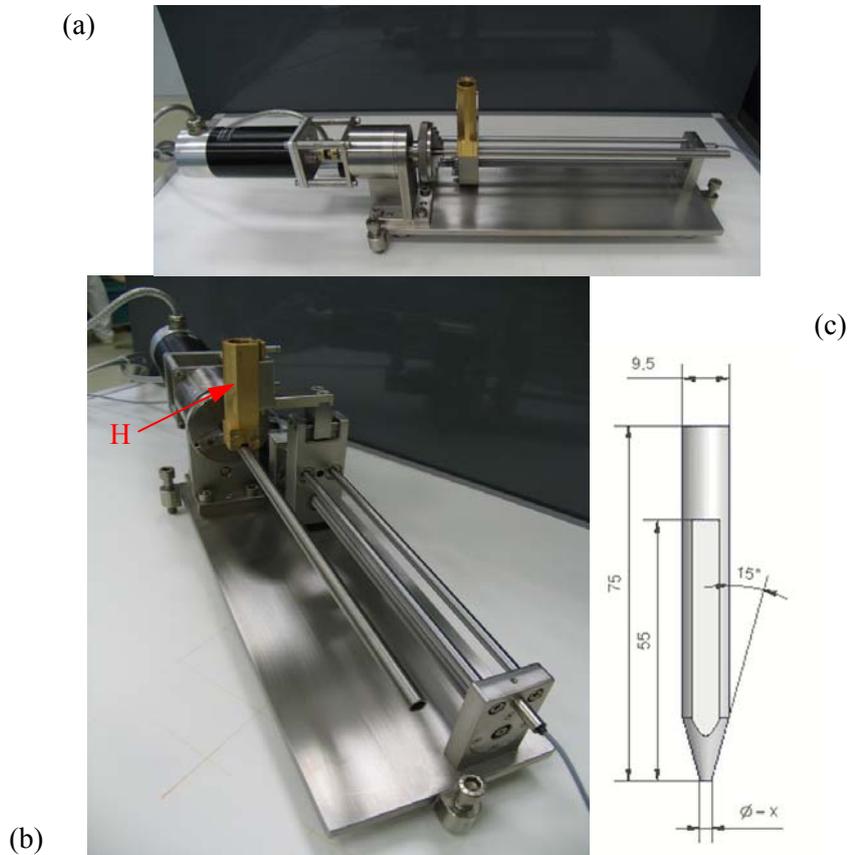
FIG. 2.1. (a), (b) The eddy current device for segment analysis. The sensor shown in the drawing (c) is placed inside the bronze holder, H.
