# Electrochemical corrosion tests for core materials utilized in BWR under conditions containing seawater

Yuta Shizukawa<sup>1</sup>, Yoshihiro Sekio<sup>1</sup>, Isamu Sato<sup>2</sup> and Koji Maeda<sup>1</sup>

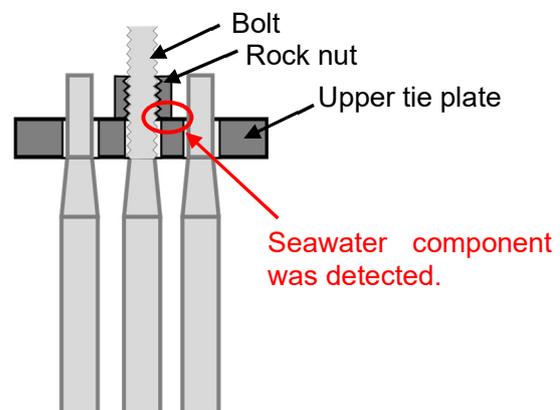
Fig.1. Schematic illustration of the upper end plug.

On the other hand, it has been recently reported to exhibit seawater incursion to the crevice structure between the 304L SS nut of the upper end plug and tie plate (Figure 1), when detail inspections were carried out for the new fuel assemblies that had been stored in the SFP of Unit 4 [3]. Therefore, at the site having the

crevice structure in the fuel assemblies, the crevice corrosion might have occurred during the storage in the SFP and may be continuously progressed in even the common pool. Especially, the strength retention of the fuel assembly structure has been realized by the part of Zircaloy-2 bolt and 304L SS rock nut in the upper end plug, which has the crevice structure. During the future long storage of the fuel assemblies, the structure strength must be also kept suppressing fuel recriticality by fracturing of them. Therefore, the crevice corrosion behavior of 304L SS should be preferentially evaluated because it is expected that corrosion resistance of 304L SS would be lower than that of Zircaloy-2.

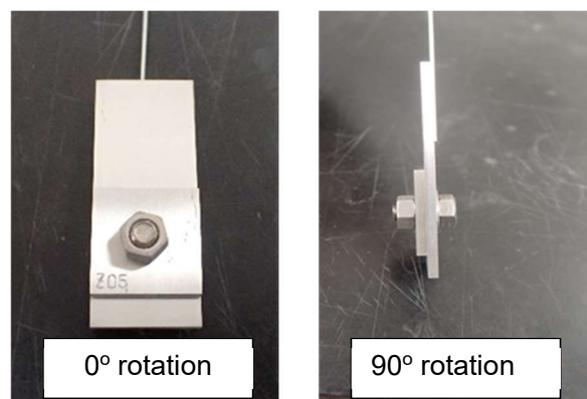
Fig.2. Appearance of assembled test electrode.

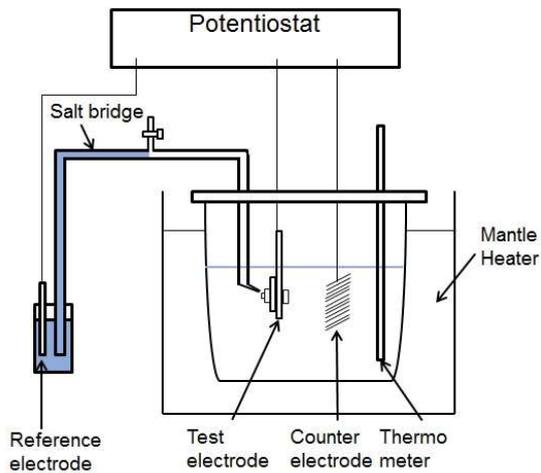
Fig.3. Test apparatus for the method of determining the  $E_{R,CREV}$ .

The crevice corrosion tests were conducted using the crevice corrosion test pieces of 304L SS and a potentiostat (SYRINX, SERM-614), and  $E_{R,CREV}$  were measured by three times in accordance with JIS G 0592 [4]. The test apparatus is shown in Figure 3. The apparatus consists of three electrodes namely the test electrode of 304L SS, the counter electrode of platinum and the reference electrode of the saturated KCl-Ag/AgCl. The procedure of crevice corrosion test is shown in Figure 4. The creviced specimen was anodically polarized at a rate of 30 mV/min up to 200  $\mu$ A of current value (Step1). The current value was kept for two hours (Step2). After that, potentiostatic polarization of up to two hours was performed (Step3). As the rise of anodic current was observed here, further 10 mV of the potential was lowered and the potentiostatic

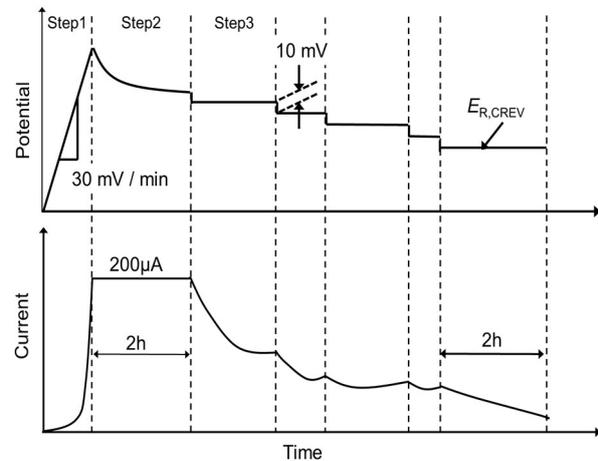
Fig.4. Test procedure of measuring the  $E_{R,CREV}$ .

polarization of up to two hours was also performed. Step3 was performed repeatedly and the  $E_{R,CREV}$  was determined as the potential where the anodic current upward trend was no longer observed during potentiostatic polarization for two hours. After crevice corrosion test, the formation of corrosion products was investigated in order to evaluate the corrosion mode.

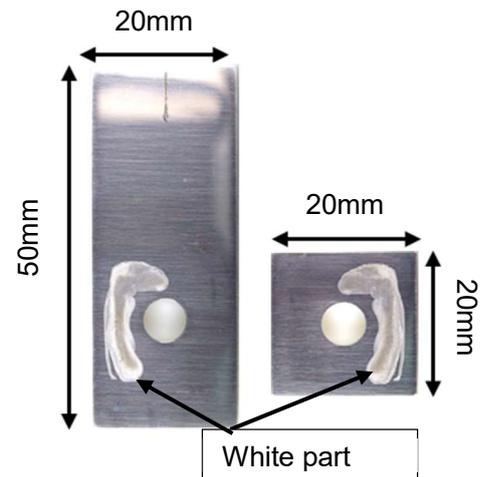
Fig.5. Appearance of the contact surface of specimen after crevice corrosion test at RT 10ppm.

At first, the typical observation images of the crevice test pieces after electrochemical corrosion tests are shown in Figure 5 and 6. Figure 5 shows the specimen surface after the crevice corrosion test at RT in 10 ppm chloride ions. Figure 6 shows the specimen surface after the crevice corrosion test at 80 °C in 100 ppm chloride ions. For both image, white parts were observed in contact surface. Further, brown films were observed along the edge of the large and small specimens in Fig.6. These products were typically observed in the case of corrosion for stainless steels [9]. Namely, it seems that the brown films correspond to Fe-rich oxides as indicated by below reaction formulas in the test electrode.

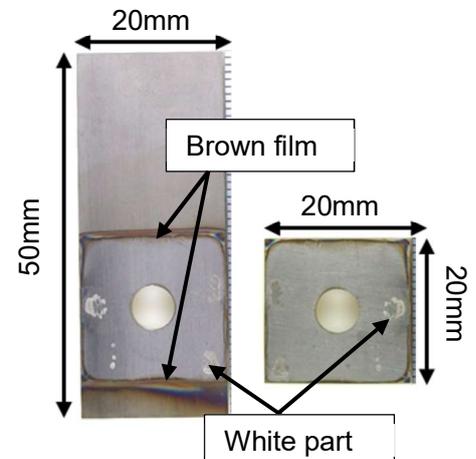
Fig.6. Appearance of the contact surface of specimen after crevice corrosion test at 80°C 100ppm.

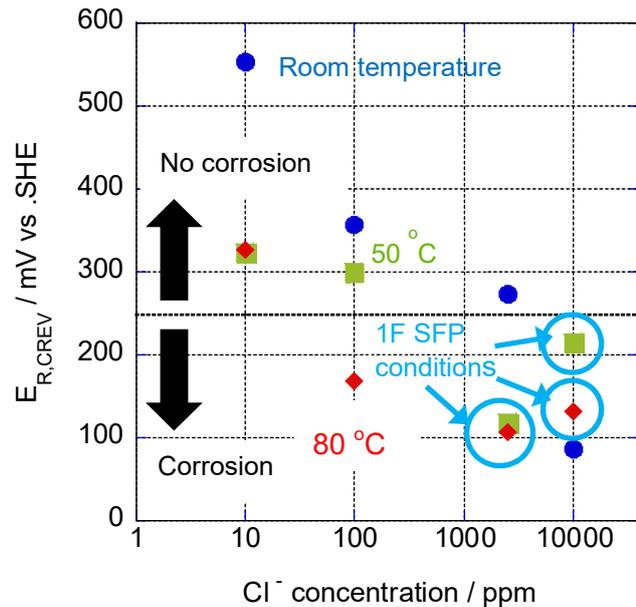
Fig.7. Relation between  $E_{R,CREV}$  and Cl<sup>-</sup> concentration.

Next, the obtained average  $E_{R,CREV}$  values of the 304L SS are shown in Figure 7. The blue symbol indicates the  $E_{R,CREV}$  of RT measurements. The green and red ones are the  $E_{R,CREV}$  of the 50 °C and 80 °C measurements, respectively. Here, the value of  $E_{SP}$  was described based on the following equation [10] which was reported by Nakayama et al.

In this study, the value of pH of the solution was set at 8.2. Therefore, the value of  $E_{SP}$  indicated at 249 mV vs SHE. Comparing the obtained  $E_{R,CREV}$  with  $E_{SP}$  in Fig. 7, the  $E_{R,CREV}$  was lower than the  $E_{SP}$  when the chloride ion concentration was under 100 ppm and the temperature was 80 °C. Furthermore, when the temperature was 50 °C,  $E_{R,CREV}$  was lower than  $E_{SP}$  under 2500 ppm of chloride ion concentration. In the case of RT,  $E_{R,CREV}$  was lower than  $E_{SP}$  under 10000 ppm. In general, crevice corrosion will occur in the case that the  $E_{R,CREV}$  is lower than  $E_{SP}$ . On the other hand, when the  $E_{R,CREV}$  is higher than  $E_{SP}$ , no crevice corrosion will occur because of crevice specimens are repassivated. Therefore, in these conditions ( $\geq 100$  ppm at 80 °C,  $\geq 2500$  ppm at 50 °C,  $\geq 10000$  ppm at RT), it means that there is a possibility of crevice corrosion. For the tests of 10 ppm chloride ions, it was clear that crevice corrosion would not occur at three temperatures.

Focusing on the values of  $E_{R,CREV}$  over 100 ppm chloride ion concentrations, they were regularly independent of temperature and chloride ion concentration which were parameters for corrosion in stainless steels. As other corrosion parameters, the effect of dissolved oxygen concentration is considered. Amount of dissolved oxygen is decreased with increase of temperature in solution [11]. Dissolved oxygen also influences corrosion of stainless steels. However, the values of  $E_{R,CREV}$  were also independence of dissolved oxygen concentration. This implies that the effects of temperature, chloride ion concentration and dissolved oxygen concentration on the probability of crevice corrosion occurrence would be complexly competed in 304L SS.

Consequently, from these results, it was clear that there is a possibility that crevice corrosion of 304L SS will occur beyond 80 °C and 100 ppm chloride concentration. In addition, crevice corrosion may occur when the temperature is over 50 °C and chloride concentration is over 2500 ppm. Furthermore, crevice corrosion can occur when the temperature is RT, and chloride concentration is over 10000 ppm. According to the water quality environment change in the SFP of the 1F accident, the condition of RT and high chloride concentration and that of 80 °C and low chloride concentration need not to be considered. However, the condition of 2500 ppm chloride concentration at over 50 °C or that of 2500 ppm at over 80 °C are included in the SFP water quality conditions. Therefore, in the 304L SS parts of the 1F fuel assemblies that experienced seawater exposure, there is a possibility of crevice corrosion occurrence. However, the corrosion rate at each condition could not be accurately estimated. Additionally, not only the influence of the oxide film which is formed on the 304L SS surface during reactor operation but also the effect of dissolved oxygen concentration on the crevice corrosion behavior must be appropriately evaluated.
