TEM INVESTIGATION OF NEUTRON IRRADIATED AND ELECTRON BEAM EXPOSED TUNGSTEN

ABSTRACT

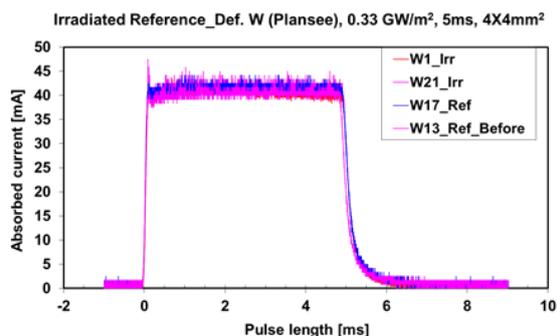
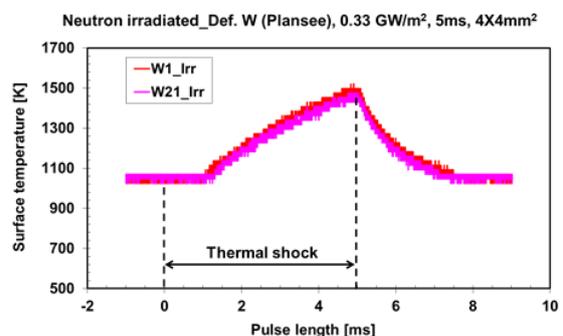
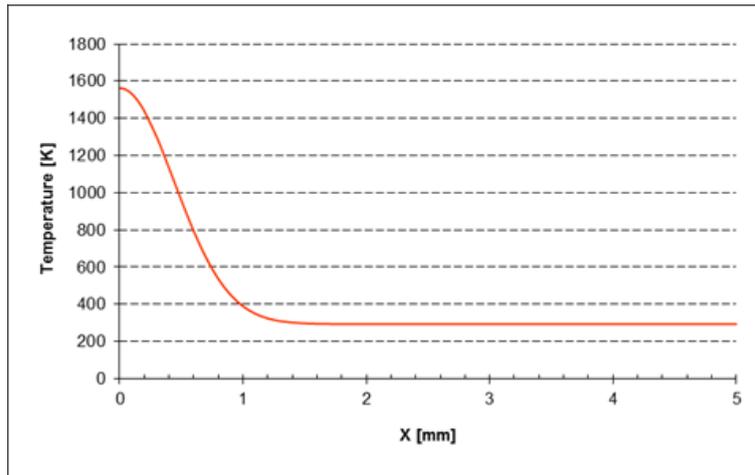
Fig. 1. Graphs showing a) the absorbed current as a function of the pulse length, b) the measured average surface temperature as a function of pulse length and c) calculated evolution of the maximal temperature as a function of the distance to the surface.

After neutron irradiation, both samples were exposed to the electron beam of the JUDITH I facility at FZ Jülich. They were exposed to one pulse of 5 ms on an area of 4×4 mm² and the absorbed power density was 0.33 GW/m². These loading conditions are representative of a plasma disruption. In Fig. 1a, the absorbed current is plotted as a function of the pulse length. The evolution of the average surface temperature was measured with a pyrometer and the result is given in Fig. 1b. The pyrometer is not sensitive to temperatures below 1100 K and therefore the temperature seems to increase only after 1.5 ms pulse length, but in reality it starts to increase from the start. It was measured that the surface temperature increased to 1520 K at the end of the pulse, after which the temperature drops to below 1100 K in 3 ms. The temperature of 1520 K is below the recrystallisation temperature but above the limit for vacancy migration. Fig. 1c shows the calculated temperature as a function of the distance to the surface. The temperature at the surface ($x = 0$ mm) is in good agreement with the measured temperature. As a result of the long exposure pulse, the temperature increase reaches a depth of 1.2 mm. The effect of the electron beam exposure was studied with SEM in a JEOL 6310 instrument.

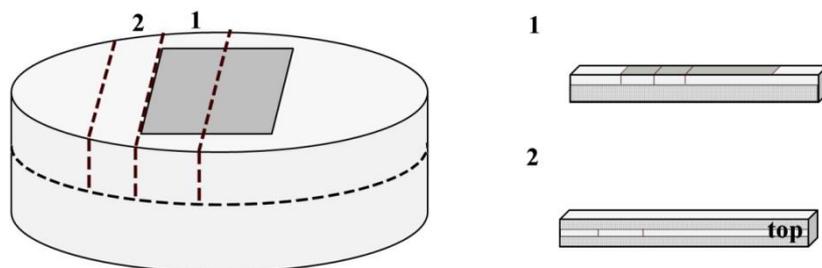
Fig. 2. Schematic representation of the sample preparation. The dark grey area was exposed to the electron beam. The dashed lines are the cutting lines and the light grey area is the material removed during polishing.

For this study, five samples were produced from the three discs. From the reference material, only a bulk sample was prepared. From the irradiated samples, one sample was prepared from the bulk and one sample was prepared close to the surface. The difficulty with the latter sample is that it needs to be prepared as close to the surface as possible. The sample preparation is schematically represented in Fig. 2. First a 1.5 mm thick disc is cut from the sample. Two laths are cut from this disc. A first lath (no. 1 in the figure) has a width of about 2 mm and contains the exposed area. The bottom part of this lath is removed by mechanical polishing on SiC paper until the thickness is reduced to 0.1 mm. A platelet was taken from the exposed part of the surface. The second lath (no. 2 in the figure) has a width of about 1 mm. This sample was flipped (top indicates the top surface from the disc) and mechanically polished from both sides to reduce the thickness to 0.1 mm. One platelet was cut off, giving the cross-section orientation.

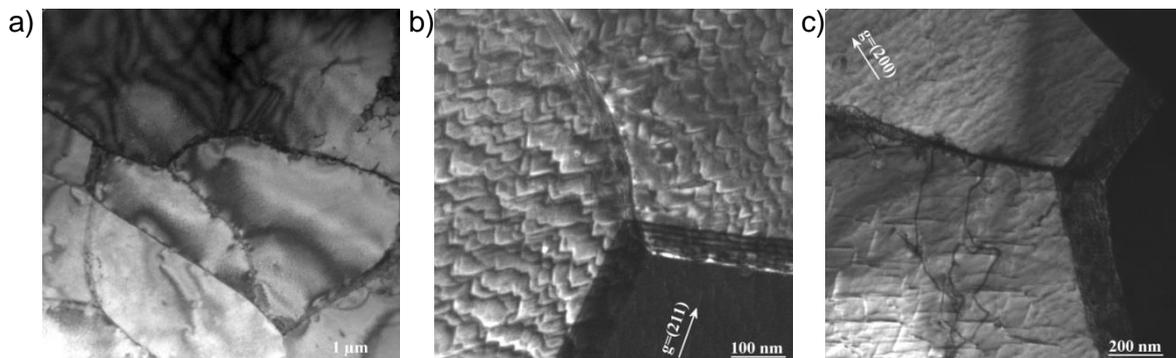
Fig. 3. a) Bright field image of the grain structure of the reference material. b) Dark field image at a triple junction of a small-angle and a large-angle grain boundary and c) dark field image a few line dislocations near the grain boundary.

The grain structure obtained from the TEM investigation is shown in Fig. 3. These images reveal that the crystal grains have a sub-grain structure. The difference in orientation between part of the grains is small and they are separated by small-angle grain boundaries, but other grains have a completely different orientation and they are separated by large-angle grain boundaries. An example of both types of grain boundaries is shown in Fig. 3b. Tungsten materials with a sub-grain structure, studied previously [4,5] did not have large-angle sub-grain boundaries and also the difference in grain orientation at the low-angle grain boundaries is larger in this material. The average size of the sub-grains is 1.6 μm .

Apart from the grain boundaries, very few defects are present. Most of the contrast in Fig. 3b is due to polishing effects which resulted in a stepped surface. There are no defects visible in the interior of the grain and only near the grain boundaries some line dislocations can be observed. **Error! Reference source not found.** From the verification of the extinction conditions it can be concluded that most of the dislocations are $a/2\langle 111 \rangle$ type. In general the Burgers vector is also parallel to the dislocation line, which means that they are screw dislocations. A minority of the line dislocations have an $a\langle 100 \rangle$ Burgers vector. These

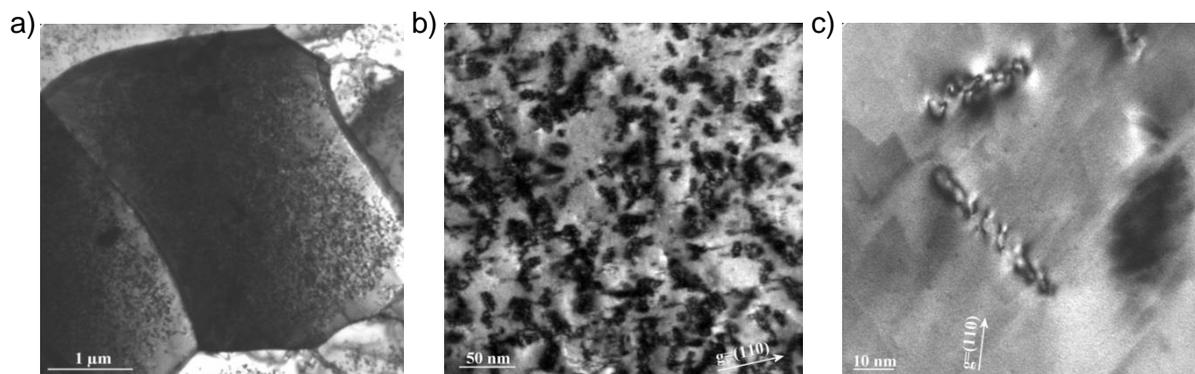
Fig. 4. a) Bright field dark field image of the grain structure in the bulk of the low dose sample, neutron irradiated to 1.47×10^{20} n/cm². b) Bright field image of the radiation induced defects. c) Higher magnification image of the convoluted dislocation loops.

The temperature of the neutron irradiation is too low to have an effect on the grain structure and this is confirmed in the low dose sample. Typical grains of the sample are shown in Fig. 4a. A sub-grain structure can be observed which is limited by both low-angle and high-angle grain boundaries. The average size of the sub-grains is still of the order of 2 μm . The interior of the grains is covered with a large amount of typical radiation induced defects.

In the image recorded at higher magnification, Fig. 4b and 4c, the radiation induced defects can be identified. Black dots, which are small dislocation loops, can be observed all over the grain. They were identified as $a/2\langle 111 \rangle$ type loops but they are too small to be further characterized in detail. In between the loops, larger defect features were observed. They are lying on $\{111\}$ type planes and they are extinct for a diffraction vector which is lying in the same $\{111\}$ plane. The displacement vectors characterizing these defects are parallel to the $\langle 111 \rangle$ directions. All have the same Burgers vector and habit plane. The defect most likely corresponding to this kind of contrast is a convoluted dislocation loop [6].

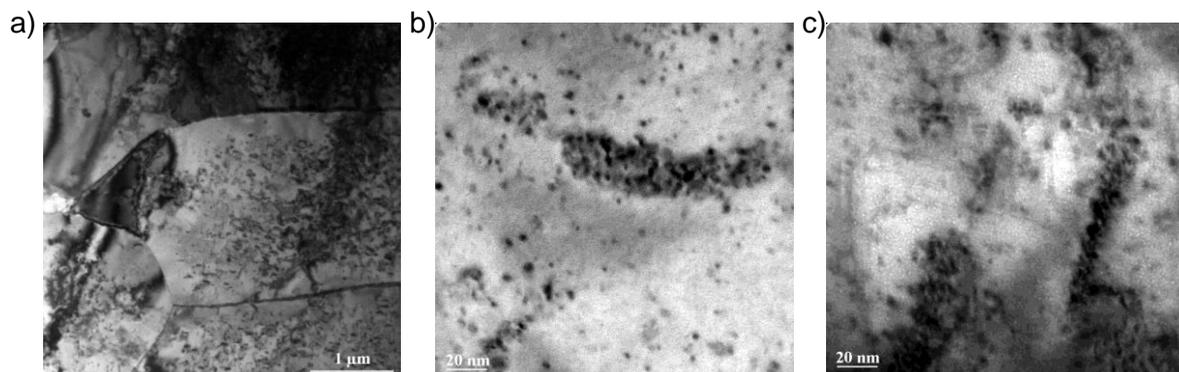
Fig. 5. a) Bright field image of the grain structure in the high dose sample. b) Bright field images of the radiation induced defects and c) under-focus image revealing voids.

The grain structure of the high dose sample is given in Fig. 5a. Similar to the sample before irradiation the grains are divided in a sub-grain structure separated by small-angle as well as large-angle grain boundaries. The size of the sub-grains is 2 μm , which is comparable to the reference material.

Fig. 5b shows a typical bright field image of the radiation induced defects. A large amount of black dots can be observed, which can be designated as radiation induced dislocation loops. From the analysis of extinction conditions, it can be concluded that the neutron irradiation resulted in the formation of $a/2\langle 111 \rangle$ type loops. The loops are too small to determine the habit plane and it cannot be concluded from this investigation whether the loops are interstitial or vacancy loops.

The formation of nanometre sized voids was verified in out-of-focus imaging conditions as in Fig. 5c. Contrary to the sample irradiated to 1.47×10^{20} n/cm², a high density of small voids could be observed in this sample. In numbers, the void density equals 2.9×10^{23} /m³, and the average size was found to be (1.0 ± 0.2) nm, giving a volume fraction of 0.03%.

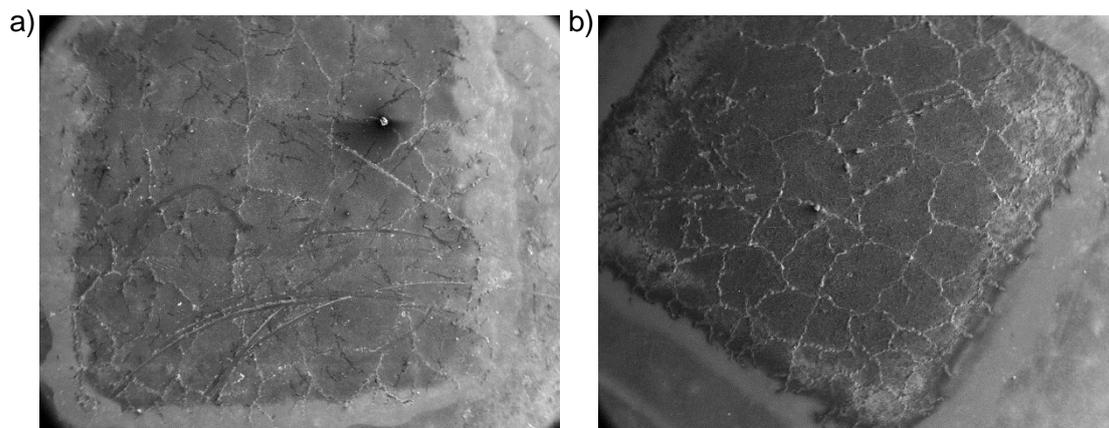
Fig. 6. Scanning electron microscopy images of the surface of neutron irradiated samples a) low dose and b) high dose after electron beam exposure.

The effect of the electron beam exposure on the surface of the low dose and high dose samples can be observed in the SEM images of Fig. 6. Both samples were exposed to the electron beam under similar conditions. Therefore, the effect on the surface integrity is also comparable. A regular pattern of cracks was observed at the surface, which is in agreement with the expected effect for these exposure conditions [8].

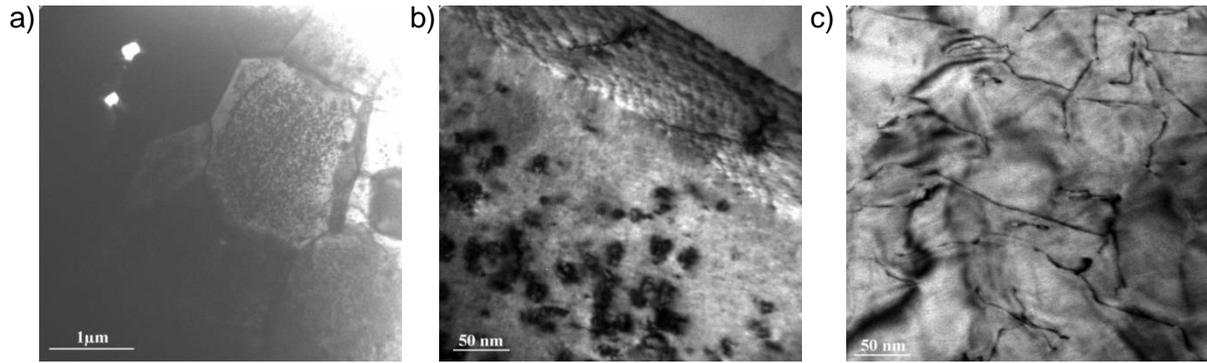
Fig. 7 a) Bright field image of the grain structure near the electron beam exposed surface of the low dose sample. b) A grain still containing convoluted dislocation loops. c) Typical defect structure in the high dose sample where almost all irradiation induced defects were removed and a dislocation network was formed.

On a microstructural level, electron beam exposure had a significant effect on the defect structure. Even though, the grain structure, as shown in Fig. 7a, is not affected by the electron beam exposure, the effect on the defects is not straight forward. In some grains, like in Fig 7b, the convoluted dislocation loops were not affected by the electron beam exposure. In other grains, all convoluted dislocation loops were removed and a network of line dislocations was formed. The formation of line dislocations results from the thermal shock during the electron beam exposure and was observed in previous experiments as well [4,5]. From extinction conditions it was determined that the majority of the line dislocations have an $a/2\langle 111 \rangle$ Burgers vector, while a minority have an $a\langle 100 \rangle$ Burgers vector. This result is typical for all clusters of line dislocations in all samples.

Also in the sample irradiated to higher fluence, the electron beam exposure had no effect on the grain structure. On the other hand, the amount of line dislocations has significantly increased compared to the bulk material before and after neutron irradiation and dislocation networks are present over the entire sample. The amount of dislocation loops was drastically reduced. Contrary to the low dose sample, all dislocation rafts and almost all dislocation loops were removed in this sample.
