Reliability improvement of the evacuation route of fuel elements of Phénix

F. DOMINJON, H. DUPORT, F. LAURENT

INTRODUCTION

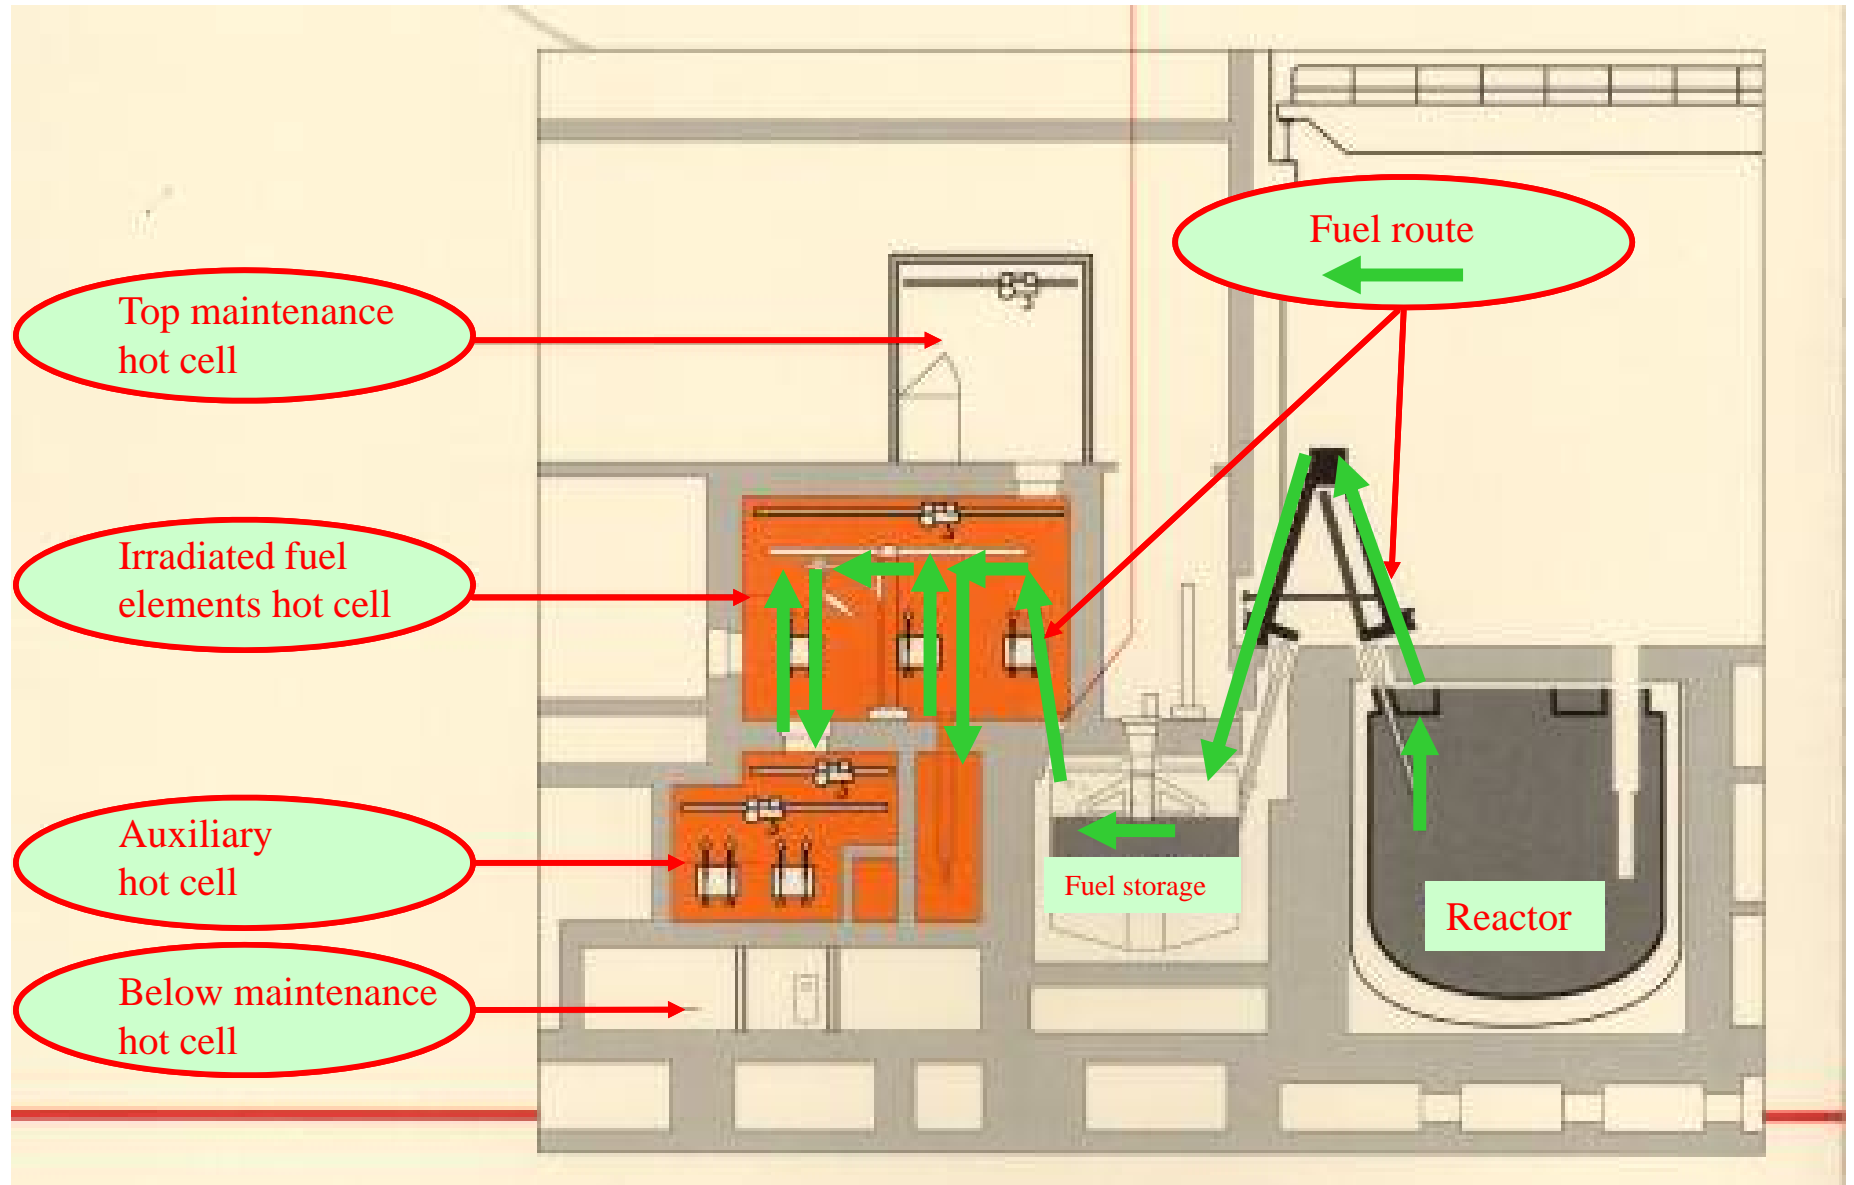
- The evacuation of the fuel elements and of the lateral neutron shielding assemblies uses the same route to get out of the plant. This way, called handling route, needs the availability of several equipments, mainly handling equipments.
- This handling route has been used around 1800 times already. It will be used around 1600 additional times till the end of evacuation. So this handling route is only at half of its life.
- The schedule of evacuation is planned for five years for fuel assembly and 7 years for LNSA. This schedule is based on two teams per day and a reliability of 80% of the handling route.

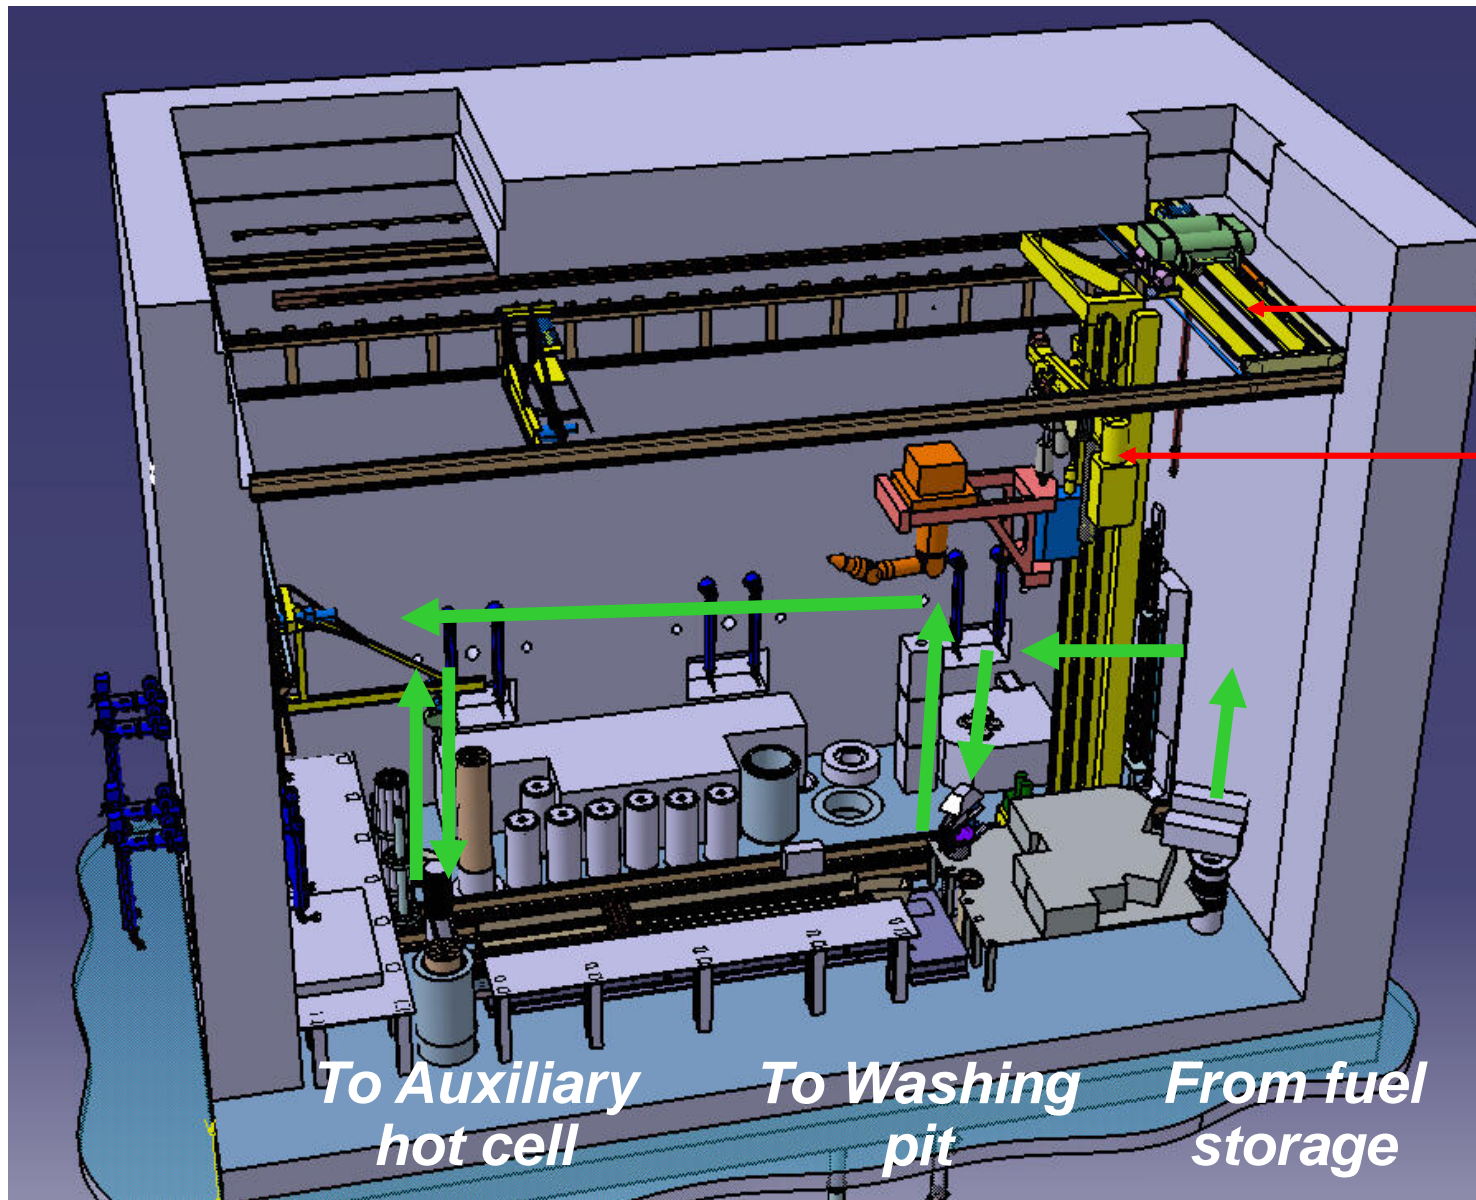
Irradiated fuel elements hot cell

Replaced in 2012

Main Lifting Unit
HOTLAB 2013

Heavy Manipulator
HOTLAB 2014

To Auxiliary
hot cell

To Washing
pit

From fuel
storage

- In 2009, the main crane of the hot cell of the handling route broke down (presented in HOTLAB 2013); in 2010 the heavy manipulator in the cell failed too (presented in HOTLAB 2014), other equipments may face problems. Crane and heavy manipulator failure and replacement stopped the evacuation during around 3 years.
- The reliability of the handling route is estimated at 50% of availability (80% needed).

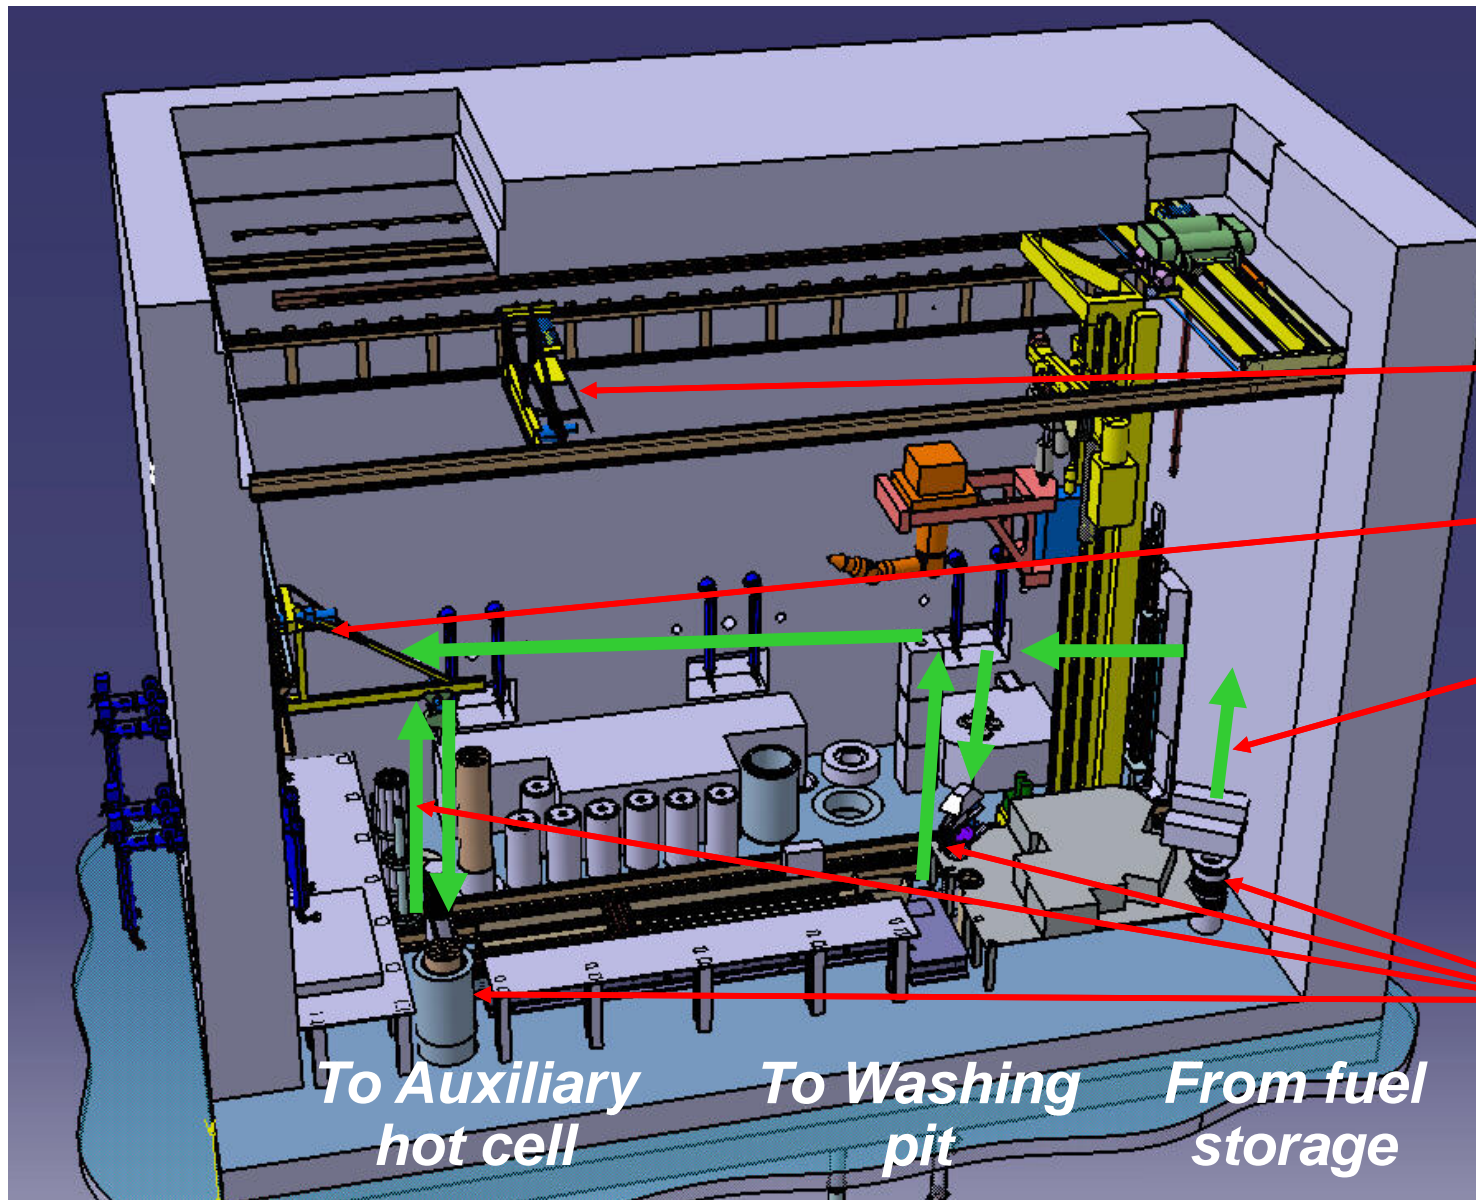
Irradiated fuel elements hot cell

Replacement planned in 2017

West Lifting Unit
Total replacement

South Lifting Unit
Total replacement

Transfer Lifting Unit
Total replacement

Replacement planned in 2016

Link between cells
Refurbishing

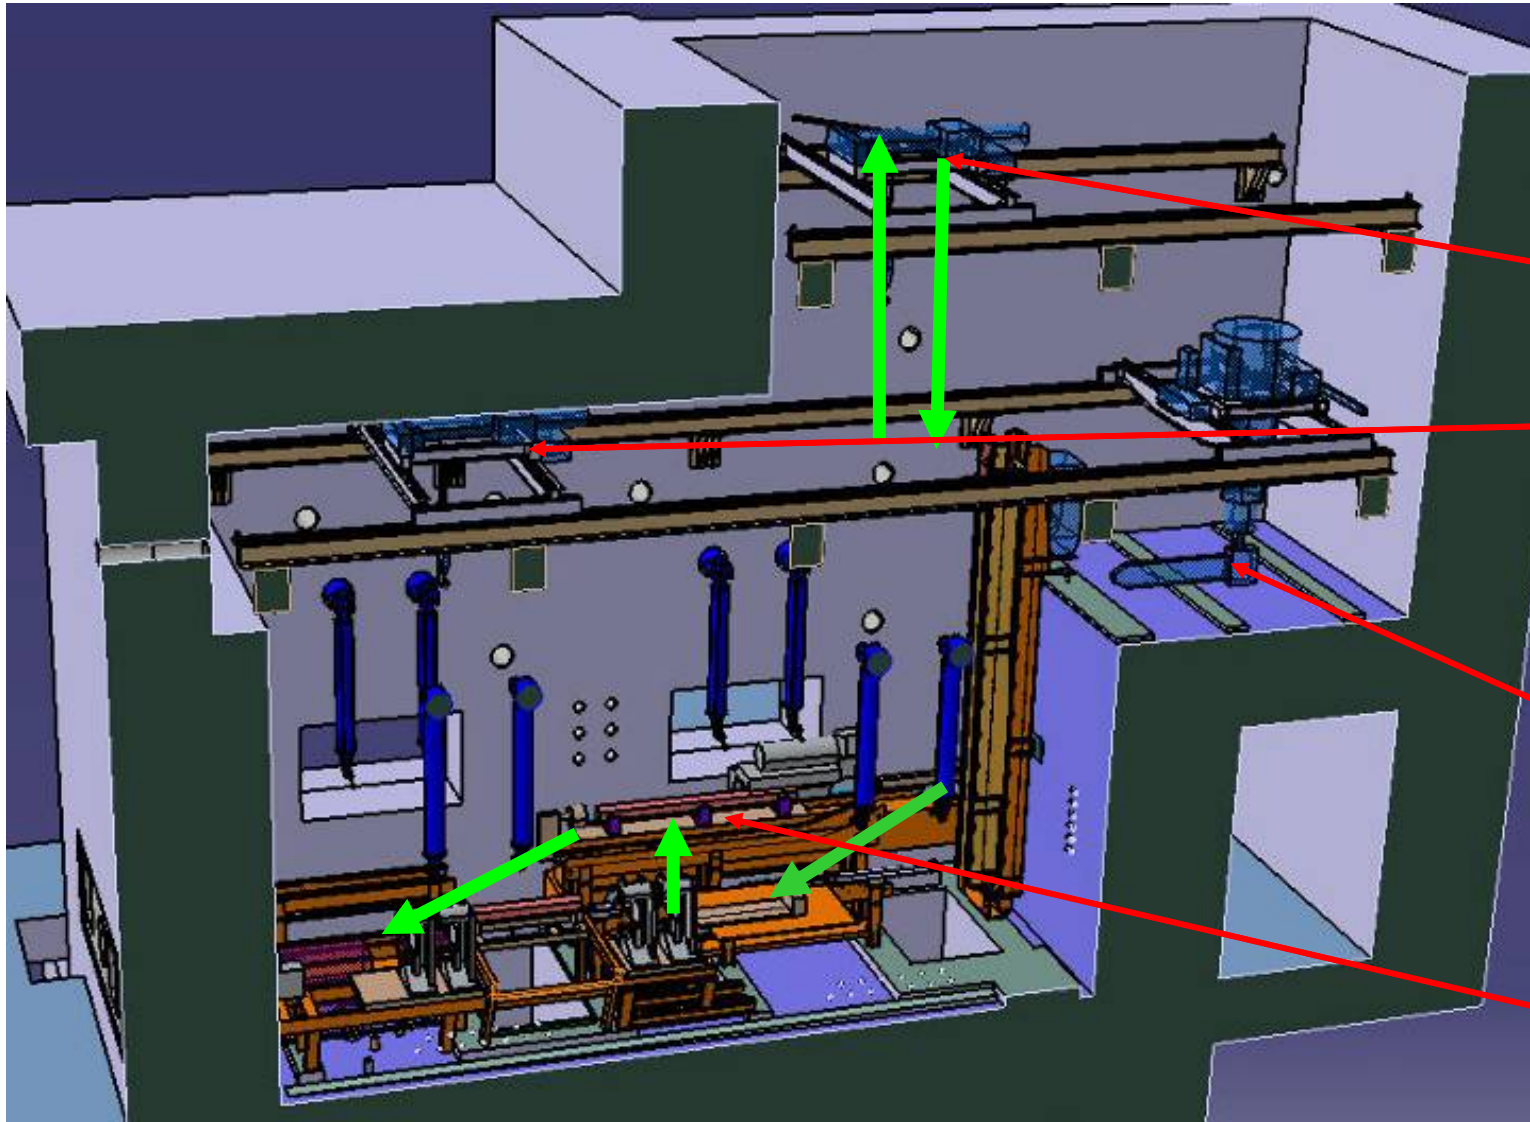
Auxiliary hot cell

Replacement planned in 2017

Top Lifting Unit
Partial replacement

Below Lifting Unit
Partial replacement

Replacement planned in 2018

Heavy Manipulator
Total replacement

Replacement planned in 2016

Milling bench
Important refurbishing
